NDIC Brine Pond Study

Phase II: Site Assessments

June 25, 2018

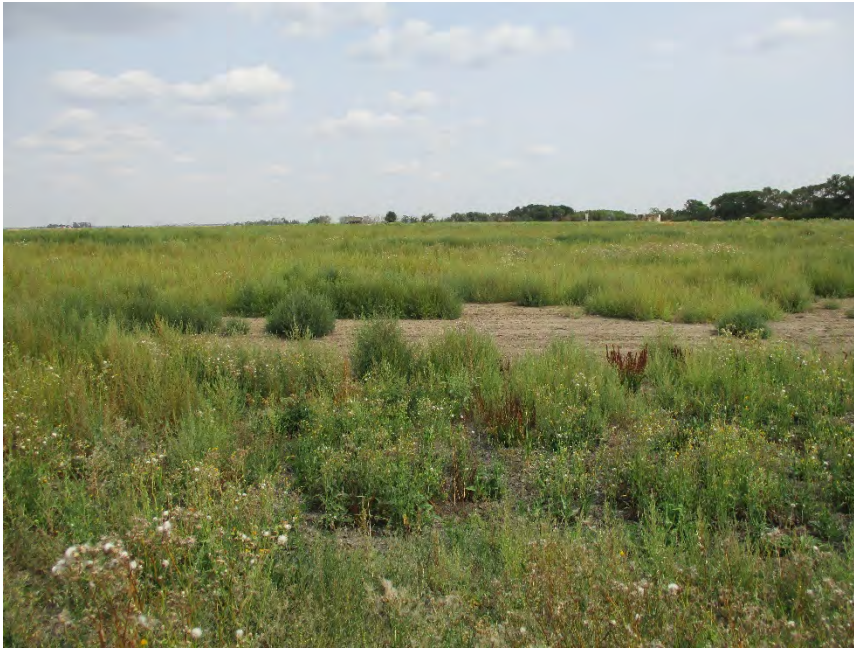
Photograph facing northeast off of an oilfield lease road showing the northern portion of the visually impacted area. Barren ground and stressed vegetation were observed in an area measuring approximately 100 feet by 20 feet.

B2-1 was revisited on August 20th, 2018. During the initial inspection, the site had recently been plowed, and no impacts could be observed. This follow-up investigation identified visual impacts consisting of barren ground and stressed vegetation in an area measuring approximately 100 feet by 20 feet.

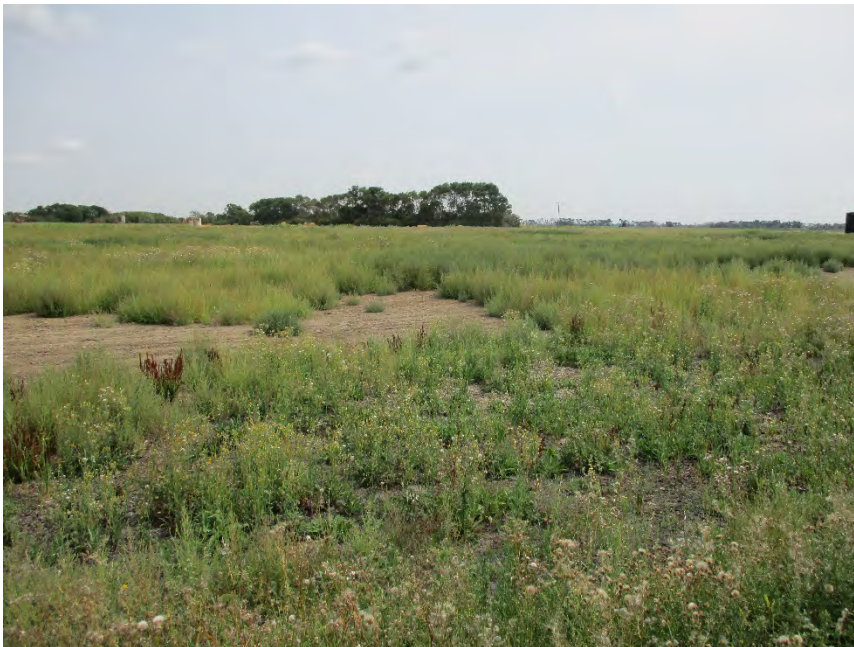
Photograph facing southeast off of an oilfield lease road showing the southern portion of the visually impacted area.

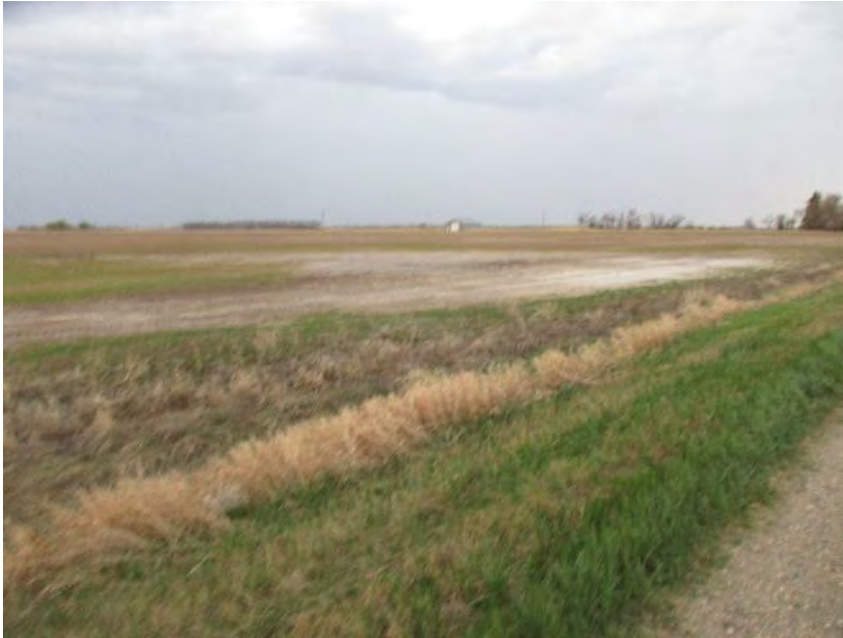
Photograph facing southwest off of 108th St NW. Barren soils with little to no vegetation and salt residues were observed.

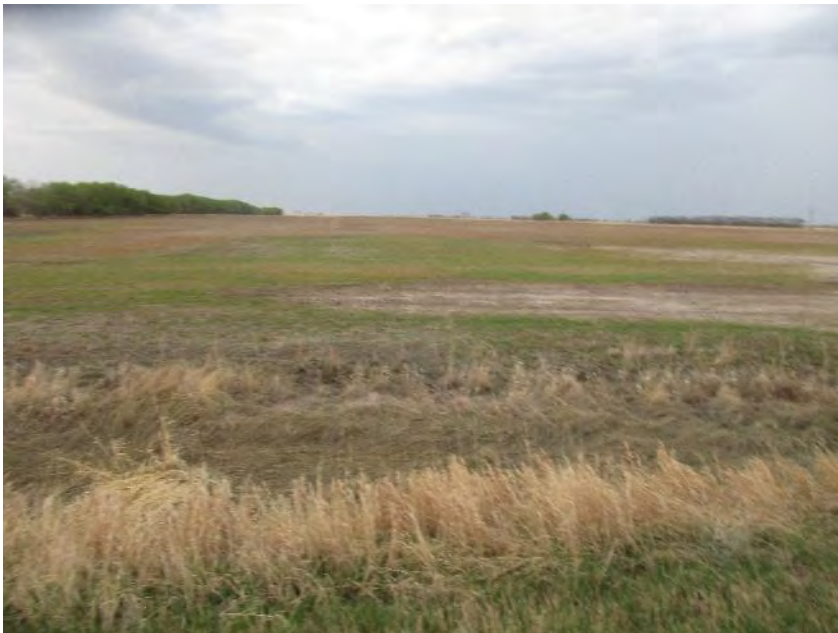
Photograph facing south off of 108th St NW, showing the eastern extent of the area of visual impacts.

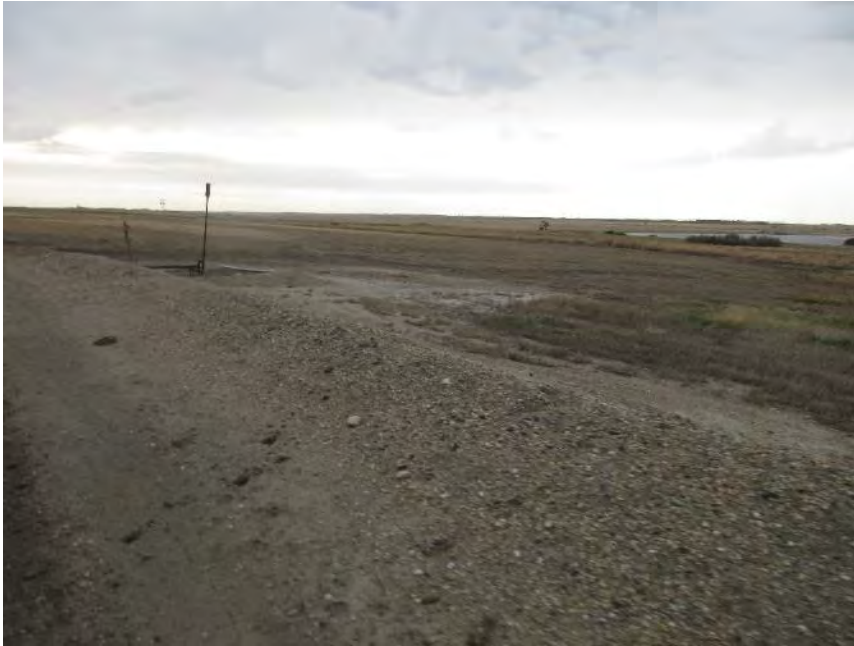
Photograph facing east off of an oilfield lease road, showing an area of stressed vegetation and salt residues.

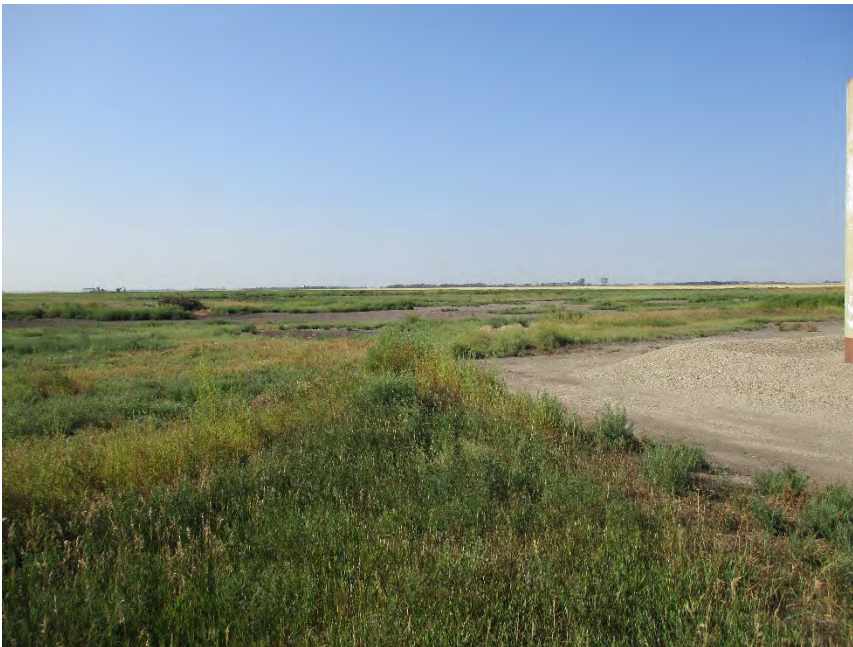
Photograph facing southeast off of an oilfield lease road showing a visually impacted area. Aboveground storage tanks are visible to the right of the picture, located north of the site.

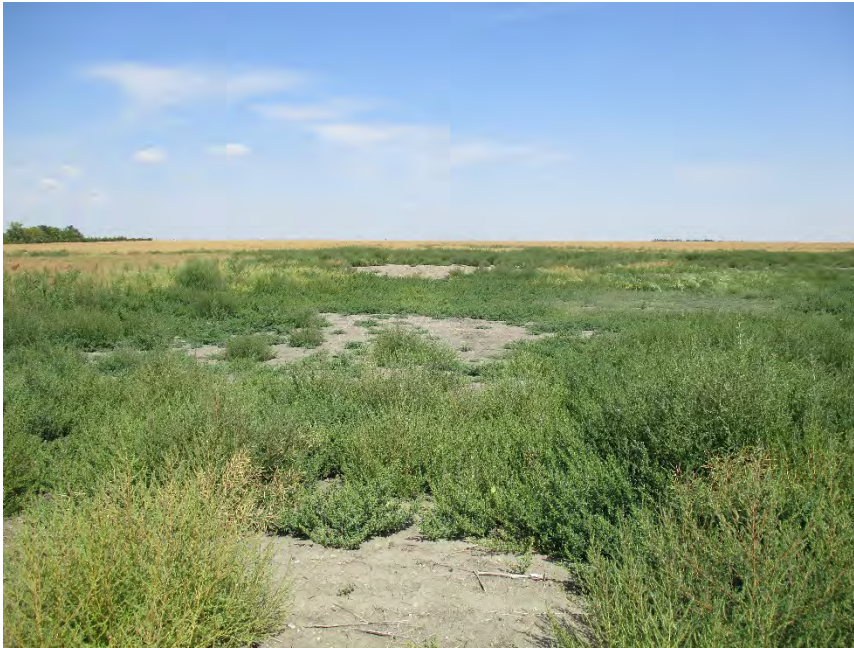
Photograph facing north off of 97th St. NW. The site is located approximately 100 feet north of 97th St. NW in a field used in agricultural production. Visual impacts consisting of barren ground and stressed vegetation were observed in three distinct areas.

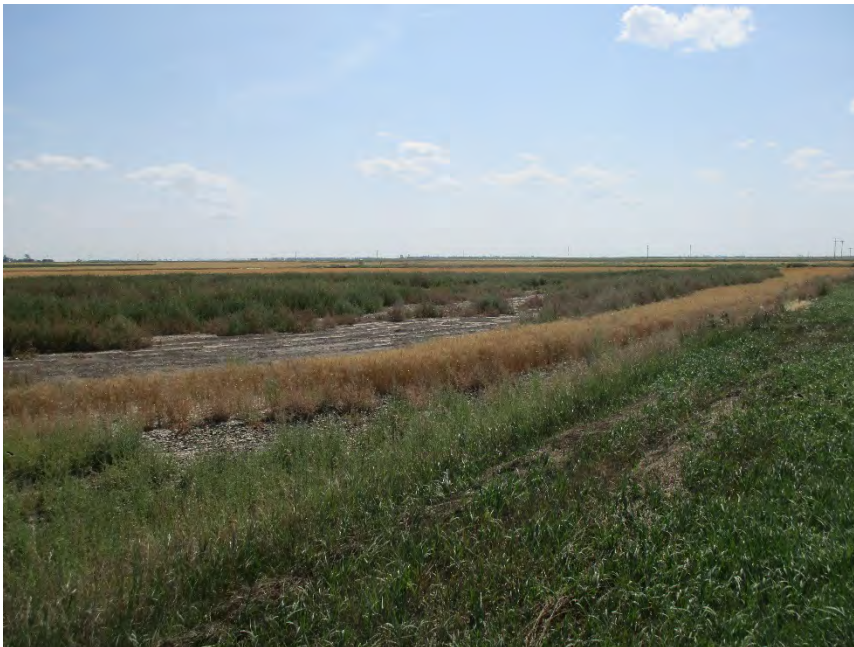
Photograph facing southeast off of 12th Ave NW showing the visually impacted area.

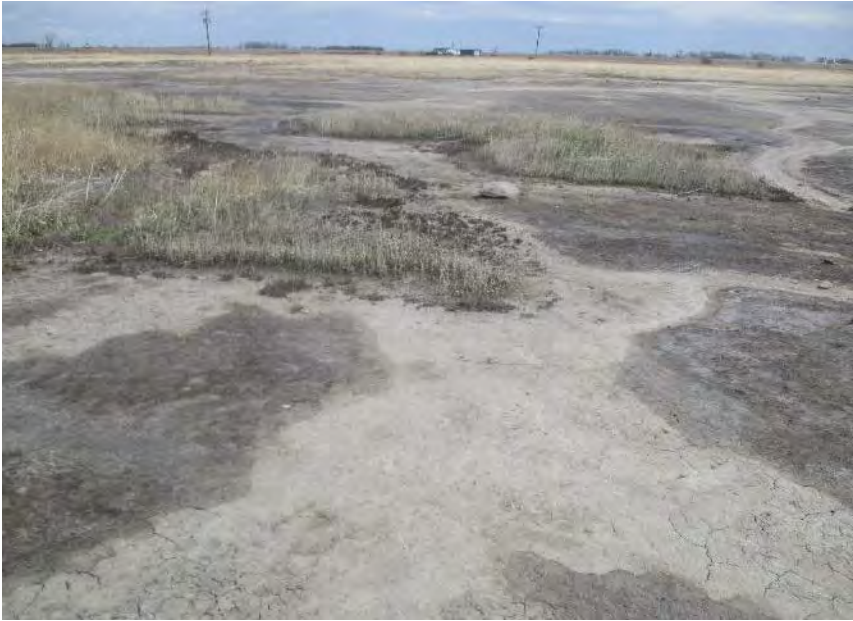
Photograph facing northeast off of an oilfield lease road showing visually impacted area. Extensive dead zones, salt crusts, and soil cracks were observed. The site is on native grassland adjacent to agricultural land. Residential areas and wetlands were observed to the northeast.

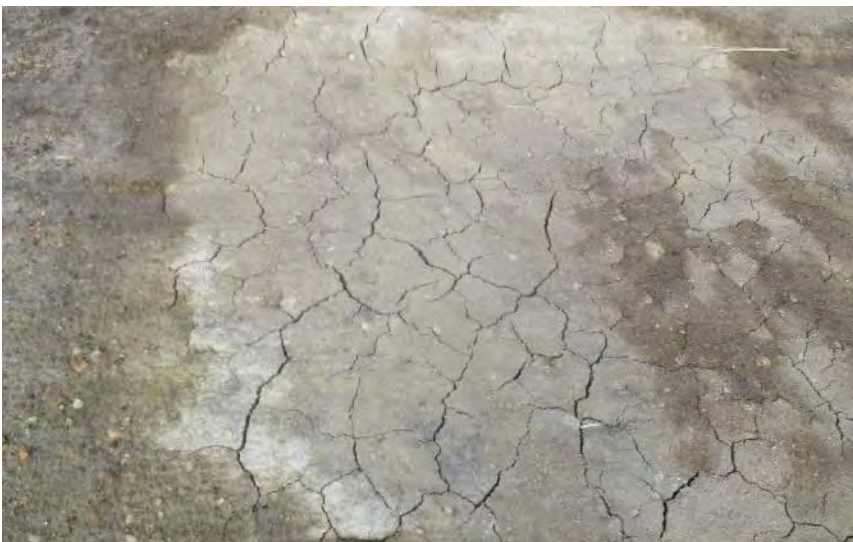
Photograph showing a closer view of soil cracks with slight salt crusts on site.

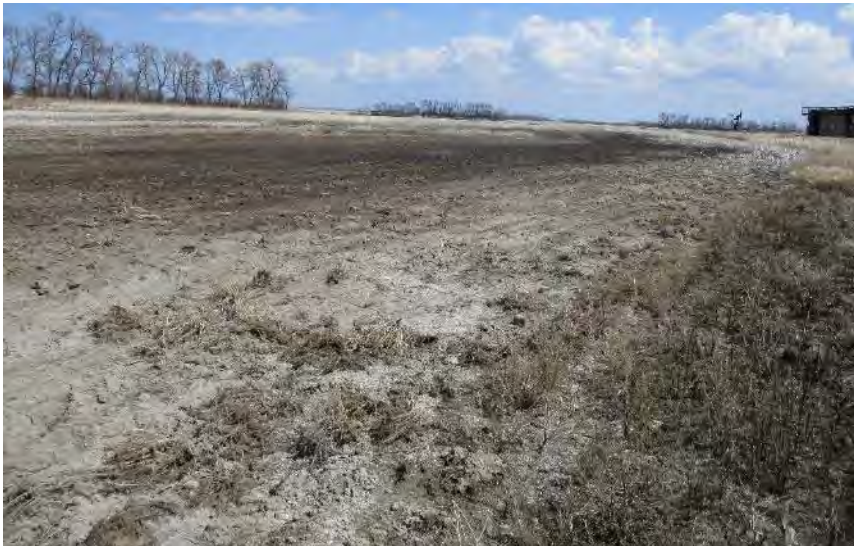
Photograph facing northeast off of an oilfield lease road showing stressed vegetation, white residue, and salt crusts. Aboveground storage tanks are visible on an oilfield production pad in the background.

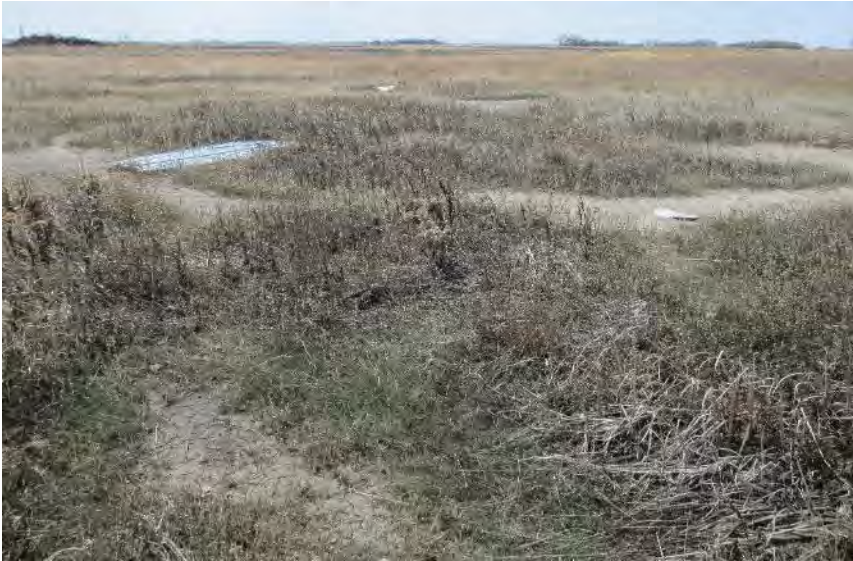
Photograph facing south off of an oilfield lease road showing the site. Patches of barren soil and dead zones were observed in an approximately 50 feet by 20 feet area.

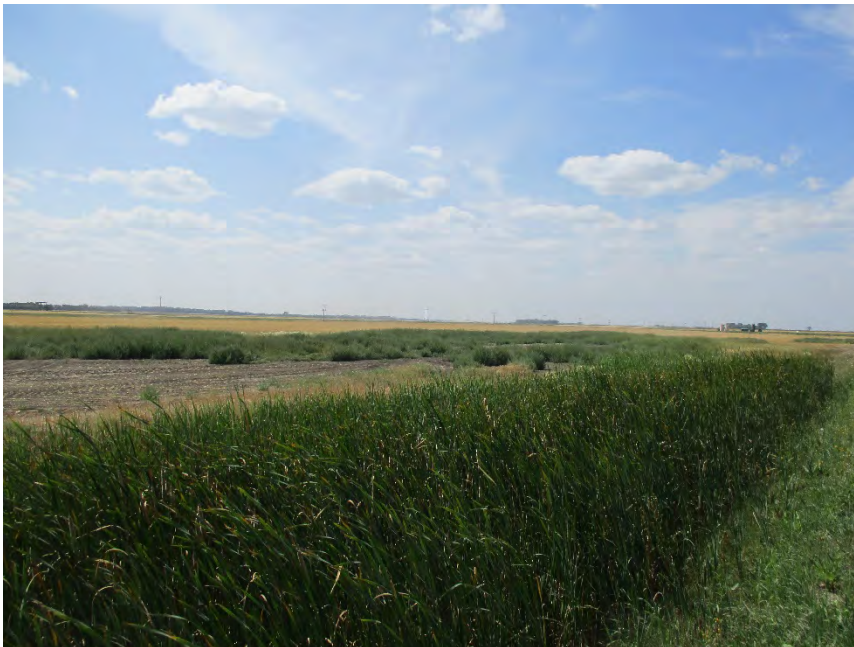
Photograph facing southwest off of an oilfield lease road showing the western portion of the visually impacted area.

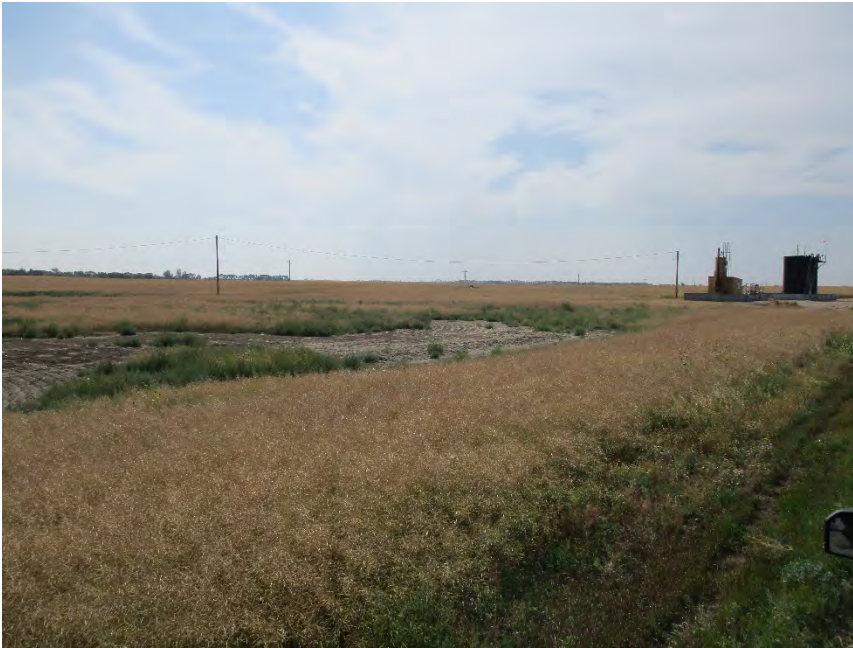
Photograph facing southwest off of an oilfield lease road showing the visually impacted area. Barren ground and stressed vegetation were observed in an area measuring approximately 100 feet by 100 feet.

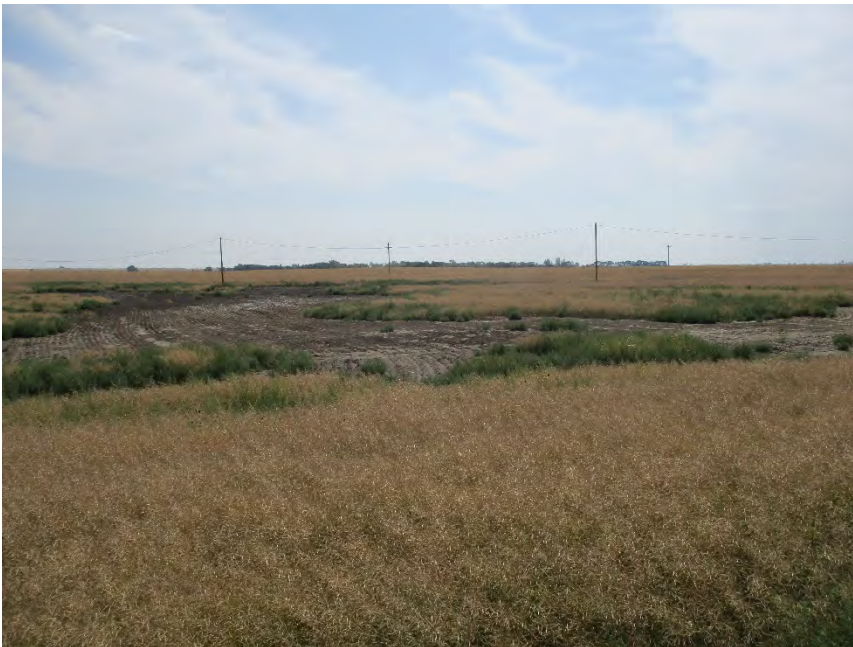
Photograph facing west southwest off of an oilfield lease road showing the visually impacted area.
