NDIC Brine Pond Study

Phase II: Site Assessments

June 25, 2018

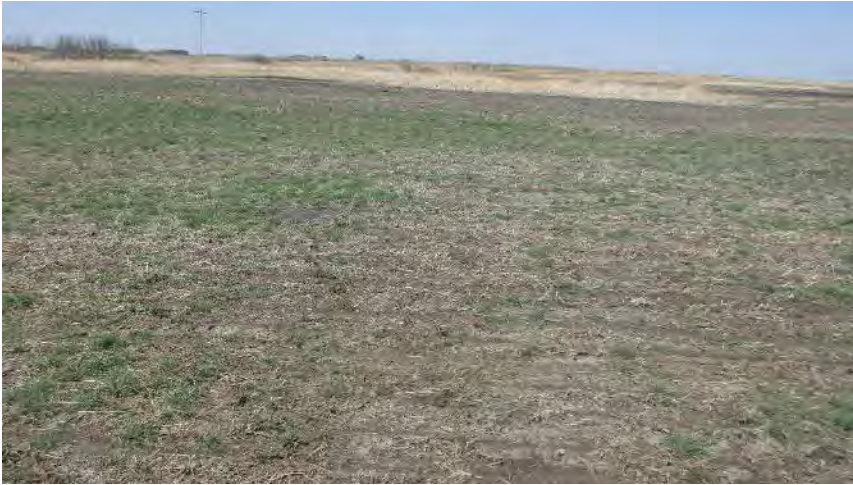
Photograph facing north off of an oilfield lease road showing no visual impacts in agricultural field. Wetlands were observed northwest of the site.

B1-2 was inspected on May 15th, 2018, and is located approximately 200 feet north of oilfield lease road. The site could not be accessed at the time of the site visit. The site is currently an agricultural field that was recently plowed, and is surrounded by agricultural fields. Visual impacts were not observed from a distance at the time of the site visit. A wetland was observed to the north of the site. The site topography is generally flat and slopes to the northwest. Aboveground powerlines were observed approximately 100 feet north of the site.

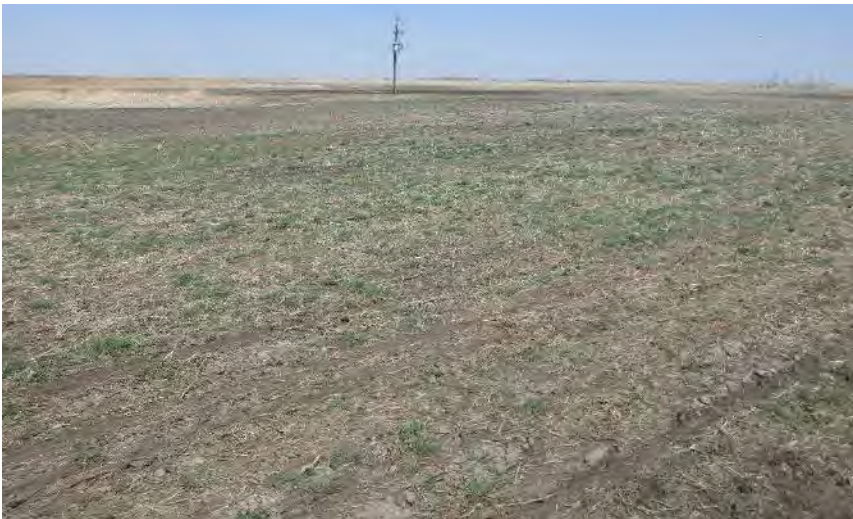
Photograph facing northeast off of an oilfield lease road showing no visual impacts in agricultural field. Aboveground powerlines were observed north of the site.

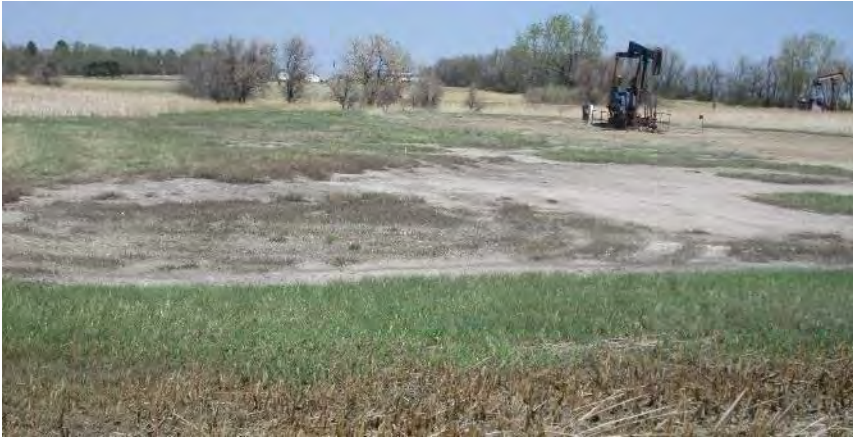
Photograph facing north off of an oilfield lease road showing a visually impacted area. Barren ground and stressed vegetation is visible in an approximately 100 feet by 100 feet area. A pump jack pad is located 75 feet to the northeast.

B1-3 was inspected on May 15th, 2018, and is located approximately 200 feet east of 32nd Ave NW and 50 feet north of an oilfield lease road. The site is currently native grassland, and is surrounded by grasslands. An oil & gas facility consisting of one pump jack was observed to the northeast of the site. Visual impacts were observed, including an area of barren ground with stressed vegetation; the area of visual impacts measured approximately 100 feet by 100 feet. The impacted area appeared to have been migrating from the pump jack to the northeast. A wetland was observed to the southeast of the site. The site topography is generally flat and slopes to the southwest. Aboveground powerlines were observed to the west of the site.

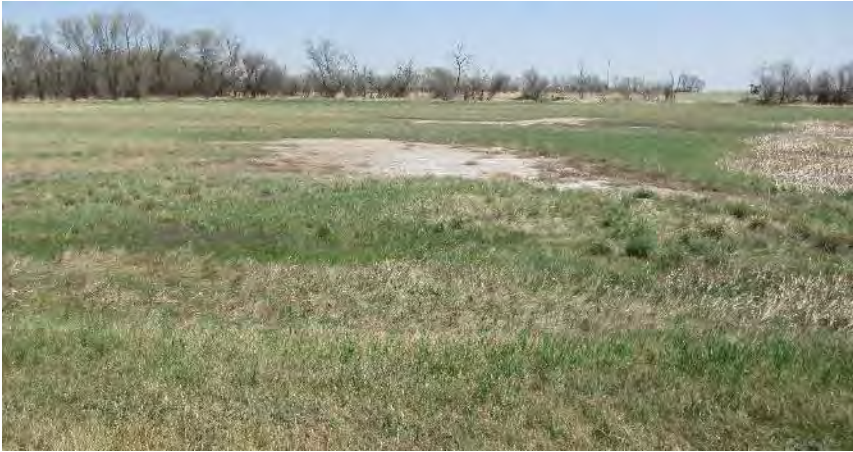
Photograph facing east off of an oilfield lease road showing visual impacts. Two areas were observed with barren ground, a lack of vegetation, and salt crusts.

B1-4 was inspected on May 15th, 2018, and is located approximately 50 feet east of an oilfield lease road. The site is currently native grassland, and is surrounded by grasslands. An oil & gas facility consisting of one pump jack was observed to the northwest of the site. Visual impacts were observed, including two areas of barren ground with little to no vegetation and salt crusting. The areas measured approximately 50 feet by 40 feet and approximately 40 feet by 40 feet. A wetland was observed to the south of the site. The site topography is generally flat and slopes to the southwest. Aboveground powerlines were observed to the west of the site.

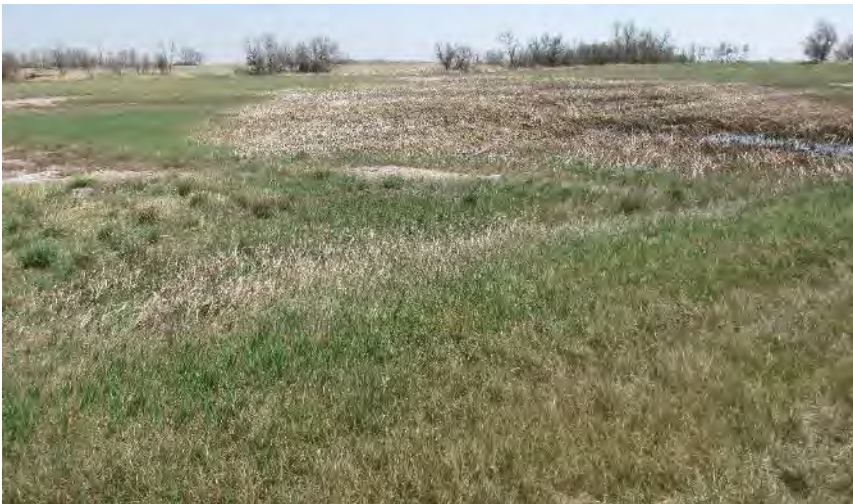
Photograph facing southeast off of an oilfield lease road showing one of the two visually impacted areas and a wetland to the south.

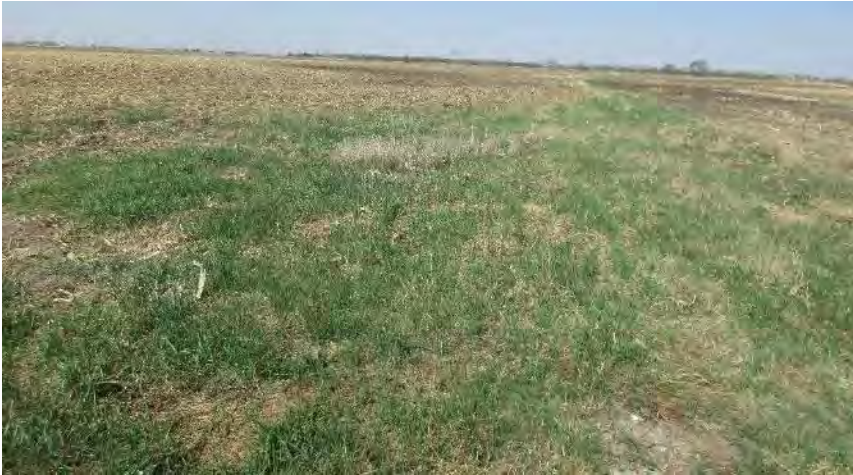
Photograph facing northwest off of an oilfield lease road showing agricultural fields. The site is located 1,000 feet further northwest and could not be accessed.

B1-5 was inspected on May 16th, 2018, and is located approximately 1,000 feet northwest of an oilfield lease road. The site could not be accessed at the time of the site visit. The site is currently used for agricultural purposes, and is surrounded by agricultural fields. No visual impacts could be observed at the time of site visit due to access limitations. The site topography is generally flat but a drainage direction could not be assessed due to access limitations.

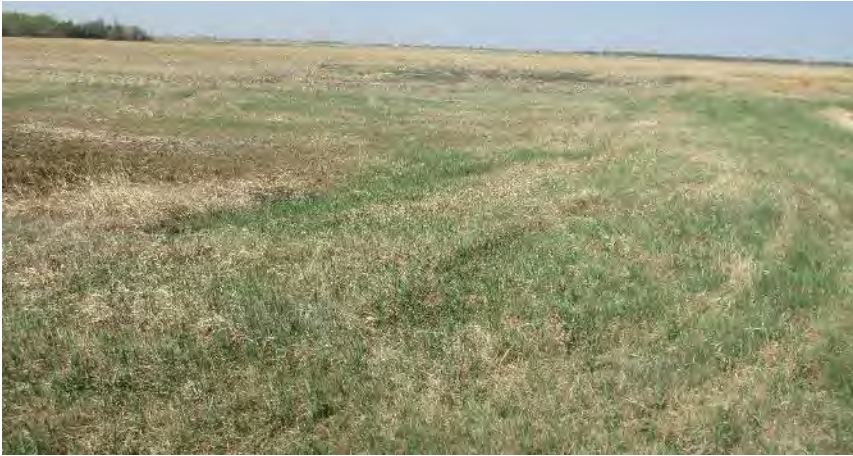
Photograph facing west from 30th Ave NW showing a visually impacted area. Depression and stressed vegetation are visible from the road approximately 500 feet west.

B1-6 was inspected on May 16th, 2018, and is located approximately 500 feet west of 30th Ave NW. The site could not be accessed at the time of the site visit. The site is currently used for agricultural purposes, and is surrounded by agricultural fields. From the road, a slight depression with stressed vegetation could be observed. However, the area could not be measured because of access limitations. The site topography is generally flat and seems to drain towards the north to northwest.

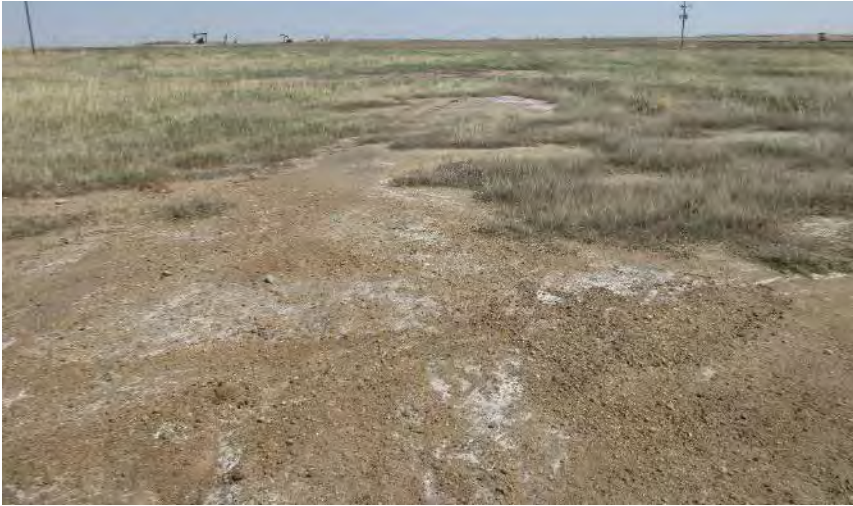
Photograph facing east off of an oilfield lease road showing a visually impacted area. Extensive dead zones with salt crusts were visible in an area approximately 80 feet by 30 feet. Aboveground powerlines were observed to the east.

B1-7 was inspected on May 15th, 2018, and is located approximately 150 feet south of 104th St NW and 50 feet east of an oilfield lease road. The site is currently native grassland. Native grasslands lie to the east and south, and agricultural fields lie to the north. An oil & gas facility consisting of 11 aboveground storage tanks, one pump jack, and three heater-treaters was observed to the west of the site. Visual impacts were observed, including an area of barren ground with stressed vegetation and salt crusting; the area of visual impacts measured approximately 80 feet by 30 feet. The site topography is generally flat and slopes to the southeast. Aboveground powerlines were observed to the east of the site, and underground oil & gas pipelines were observed to the north, just south of 104th St NW.

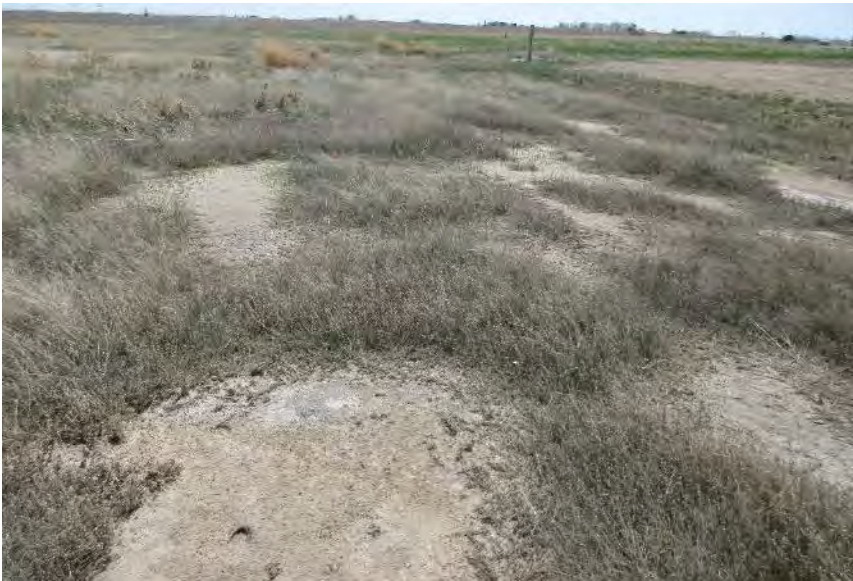
Photograph facing southwest off of an oilfield lease road showing a visually impacted area. Cracks and salt crusts were observed.

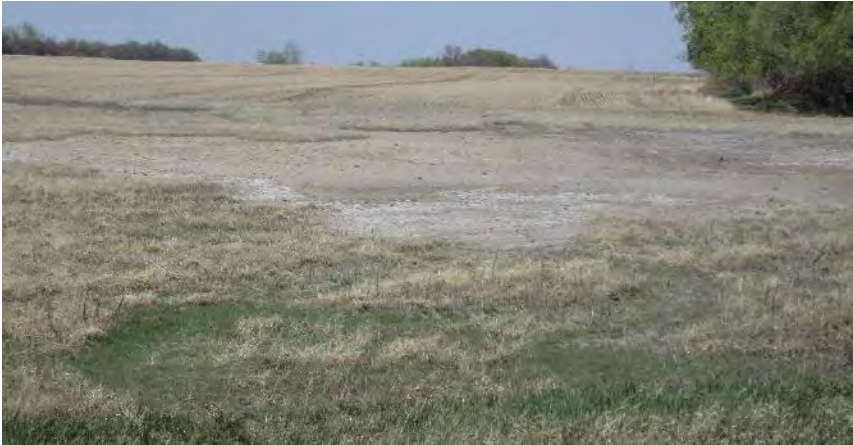
Photograph facing north off of 104th St NW showing a visually impacted area. Extensive dead zones and salt crusts were observed.

B1-8 was inspected on May 15th, 2018, and is located approximately 100 feet north of 104th St NW and 200 feet west of an oilfield lease road. The site is currently used for agricultural purposes, and is surrounded by agricultural fields. Visual impacts were observed, including an area of barren ground with stressed vegetation and salt crusting; the area of visual impacts measured approximately 125 feet by 100 feet. The site topography slopes steeply to the south. Aboveground powerlines were observed to the south of the site.

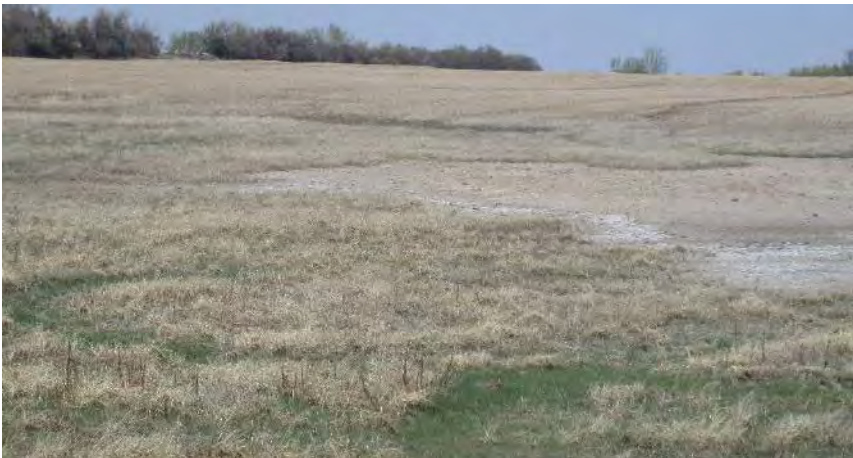
Photograph facing northwest off of 104th St NW showing visually impacted area with salt crusts in an agricultural field.

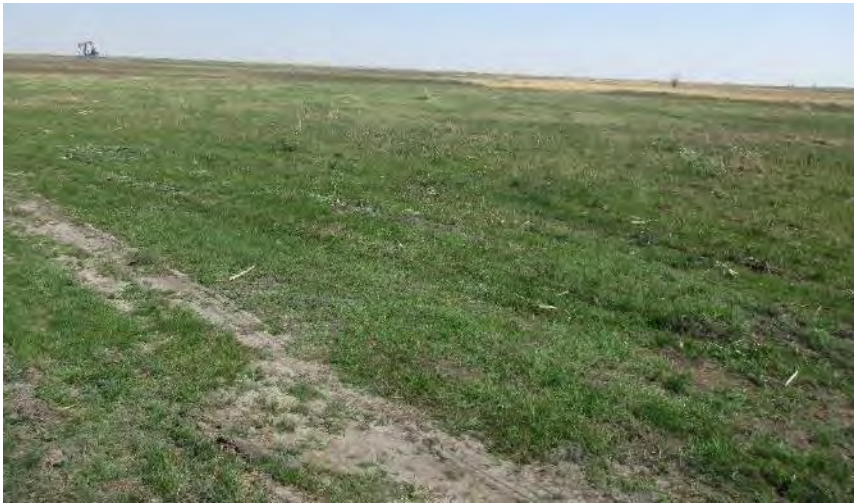
Photograph facing southeast off of an oilfield lease road showing no visual impacts. A pump jack is located approximately 1,000 feet east of site.

B1-10 was inspected on May 15th, 2018, and is located approximately 200 feet south of an oilfield lease road. The site is currently native grassland, and is surrounded by grasslands to the west, south, and east. Agricultural fields lie to the north. No visual impacts were observed at the time of the site visit. A wetland was observed to the south. The site topography is generally flat, and slopes to the north.

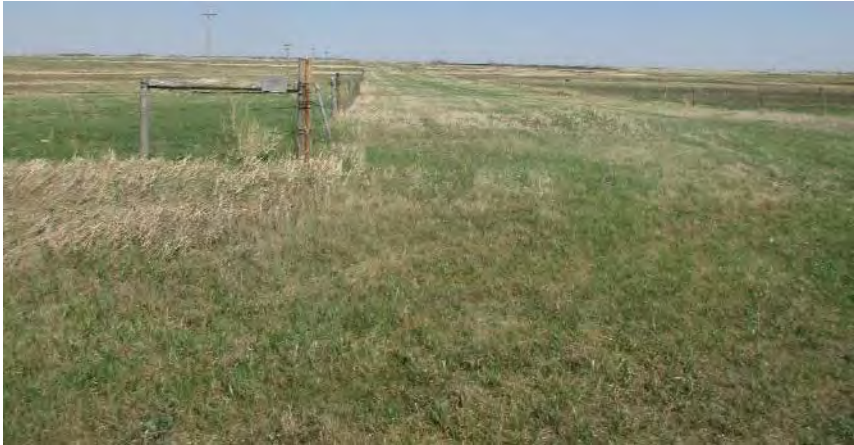
Photograph facing east off of 31st Ave NW showing native grasslands with no visual impacts. The site is located approximately 500 feet further southeast in a fenced off field.

B1-11 was inspected on May 15th, 2018, and is located approximately 500 feet south of 31st Ave NW. The site could not be accessed at the time of the site visit. The site is currently native grassland, and is surrounded by grasslands. Visual impacts were not observed from a distance at the time of the site visit. A wetland was observed to the south of the site. The site topography is generally flat and slopes to the north.

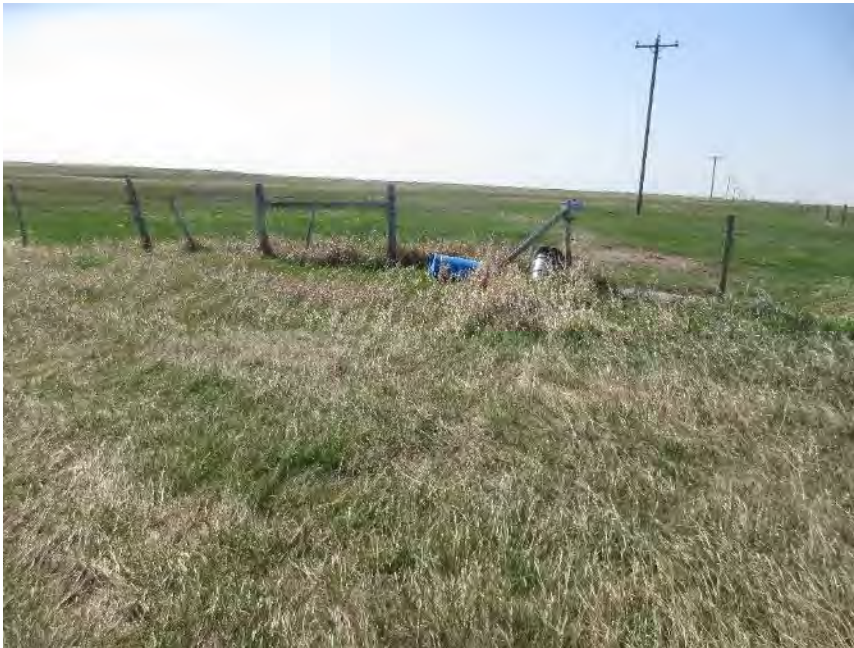
Photograph facing south off of 31st Ave NW showing native grassland. The site is approximately 1,000 feet further south in the fenced-off field. Aboveground powerlines are located approximately 500 feet west of site.

B1-12 was inspected on May 16th, 2018, and is located approximately 1,000 feet south of 31st Ave NW. The site could not be accessed at the time of the site visit. The site is currently native grassland, and is surrounded by grasslands. Visual impacts could not be observed at the time of site visit due to access limitations. A wetland was observed to the south of the site. The site topography is generally flat but a drainage direction could not be assessed due to access limitations.

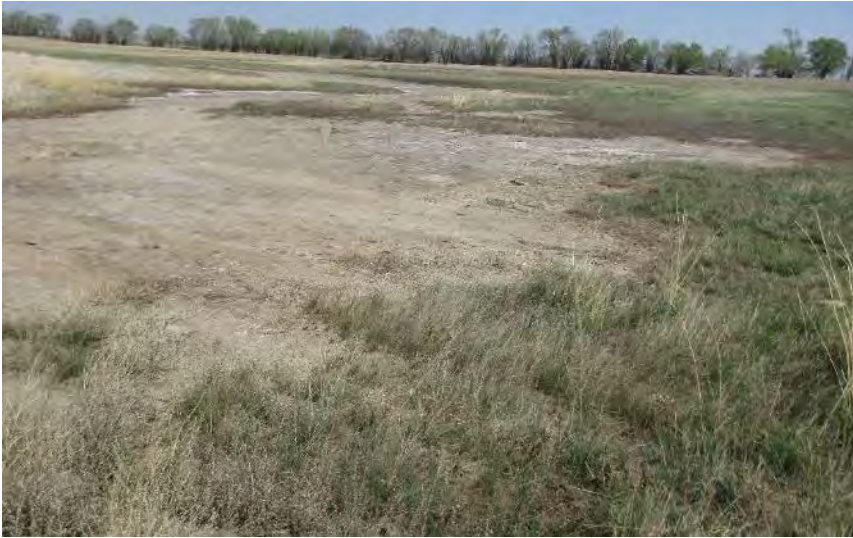
Photograph facing northeast off of an oilfield lease road showing a visually impacted area including barren areas with no vegetation. The impacted area is approximately 200 feet by 175 feet. Oil pipeline risers are located southwest of site.

B1-14 was inspected on May 15th, 2018, and is located approximately 50 feet east of an oilfield lease road. The site is currently native grassland, and is surrounded by grasslands to the east, south, and west. Oil & gas facilities lie to the northwest (consisting of one pump jack), and to the east (consisting of one pump jack). Visual impacts were observed, including an area of barren ground with little to no vegetation and salt crusting; the area of visual impacts measured approximately 200 feet by 175 feet. A wetland was observed to the north. The site topography is generally flat and slopes to the northeast. Aboveground pipeline risers were observed to the west of the site, indicating the likelihood of underground pipelines in the vicinity of the site.

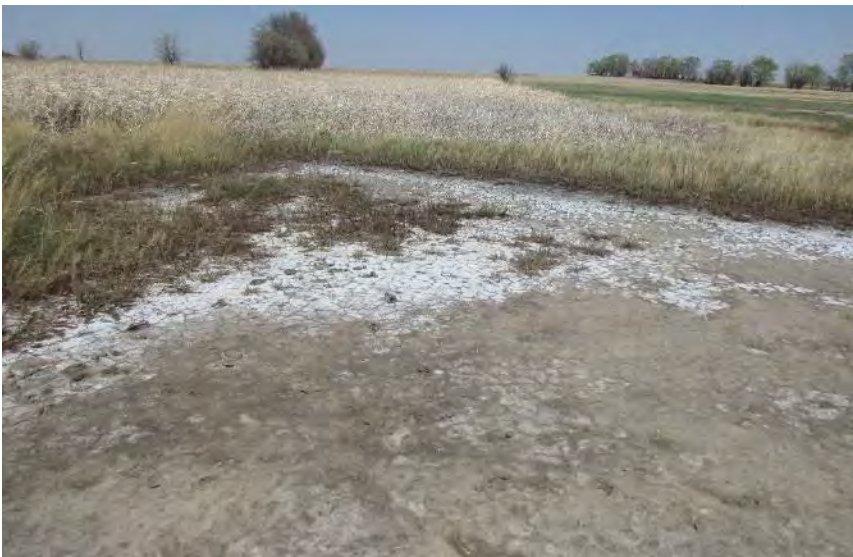
Photograph facing northeast off of oilfield lease road showing salt crusts and soil cracks on site. The site is adjacent to a wetland measuring approximately 300 feet by 100 feet.

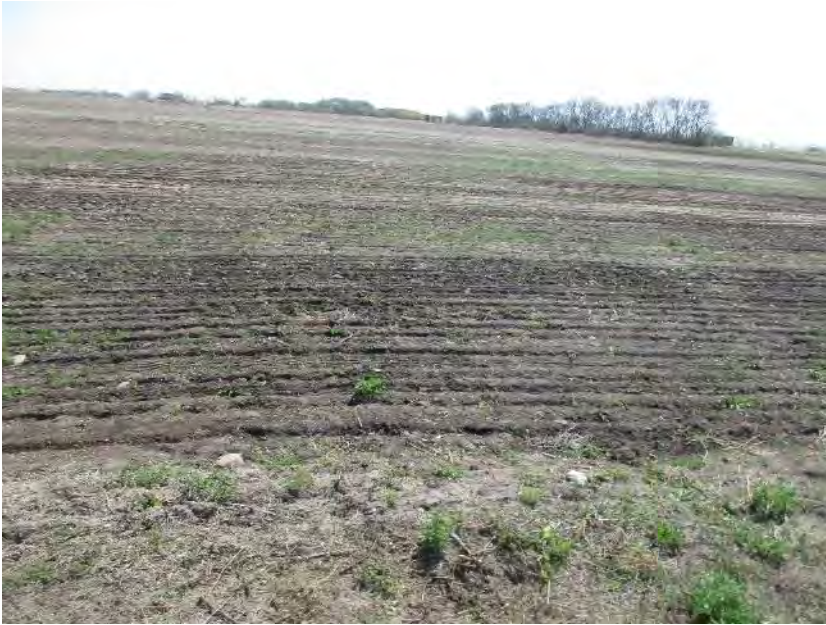
B2-1 (May 2018)

Photograph facing east of an oilfield lease road. No visual impacts were observed at the time of the May 16, 2018 site visit. The site is surrounded by agricultural fields with an oil & gas facility located to the west.

B2-1 was inspected on May 16th, 2018 and is located approximately 350 feet north of 104th St NW and 50 feet east of an oilfield lease road. The site is currently used for agricultural purposes and is surrounded by agricultural fields. An oil & gas facility consisting of two aboveground storage tanks, one heater-treater, and one pump jack was observed to the west of the site. No visual impacts were observed at the time of the site visit. A wetland was observed to the southeast of the site. The site topography is generally flat and slopes to the west and northwest. Aboveground powerlines were observed to the south of the site.

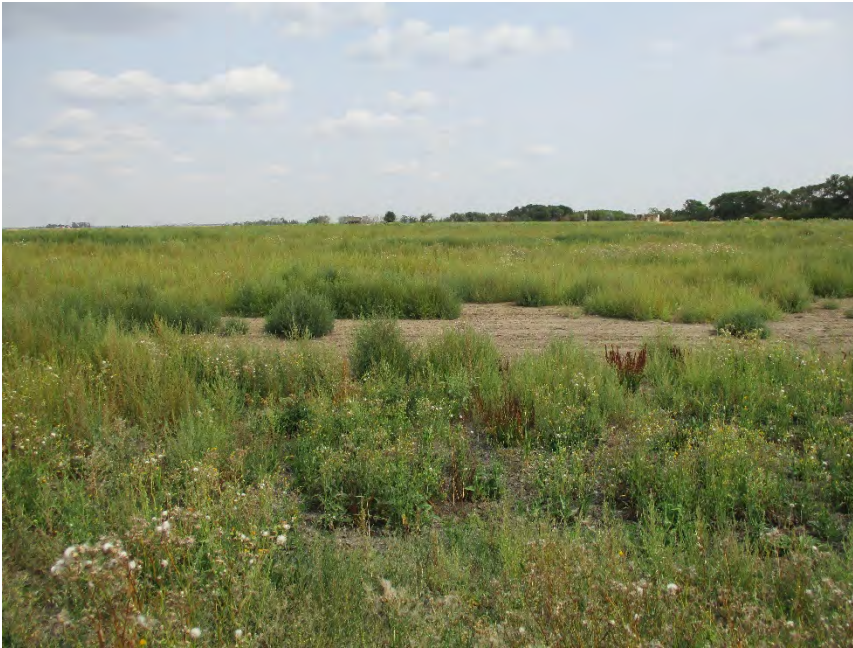
Photograph facing northeast off of an oilfield lease road showing the northern portion of the visually impacted area. Barren ground and stressed vegetation were observed in an area measuring approximately 100 feet by 20 feet.

B2-1 was revisited on August 20th, 2018. During the initial inspection, the site had recently been plowed, and no impacts could be observed. This follow-up investigation identified visual impacts consisting of barren ground and stressed vegetation in an area measuring approximately 100 feet by 20 feet.

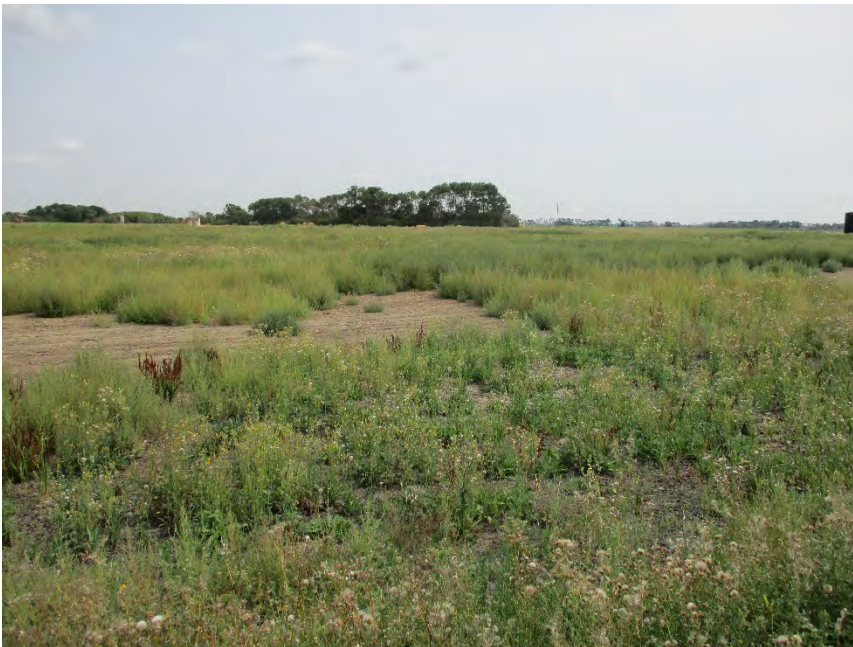
Photograph facing southeast off of an oilfield lease road showing the southern portion of the visually impacted area.

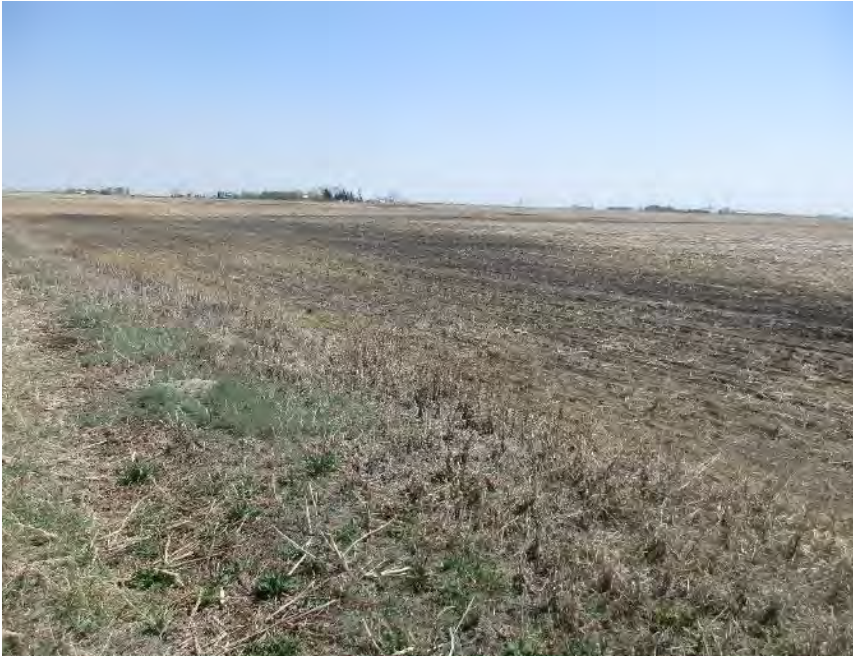
Photograph facing north of 29th Ave NW. The site is located approximately 500 feet further north from the location of the picture and could not be accessed during the time of the inspection.

B2-2 was inspected on May 16th, 2018, and is located approximately 500 feet northeast of 29th Ave NW. The site could not be accessed at the time of the site visit. The site is currently used for agricultural purposes, and is surrounded by agricultural fields. No visual impacts could be observed from a distance at the time of the site visit. A wetland was observed to the southwest of the site. The site topography is generally flat and slopes to the southwest.

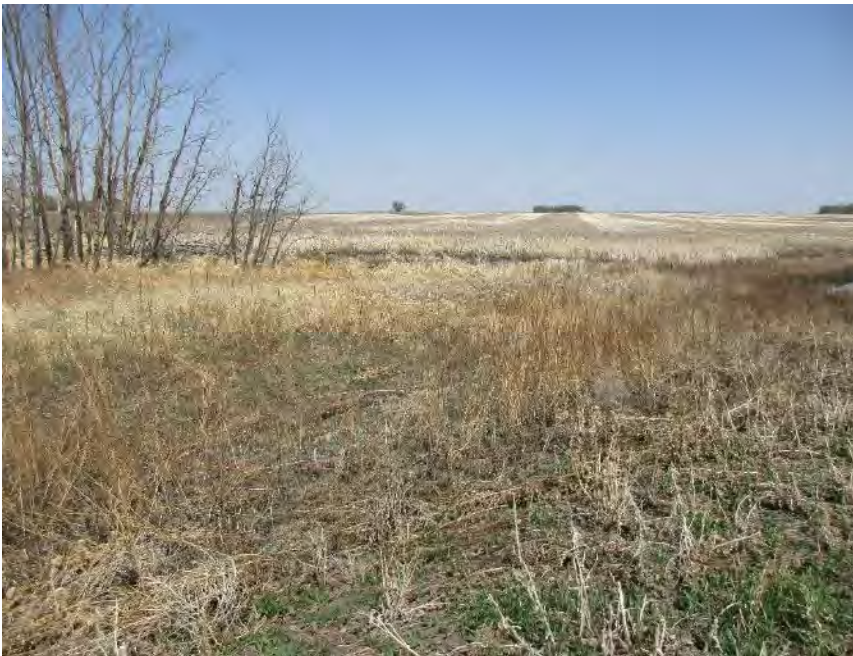
Photograph facing northwest of the wetland located to the southwest of the site. No visual impacts could be observed at the time of the visit due to access limitations.

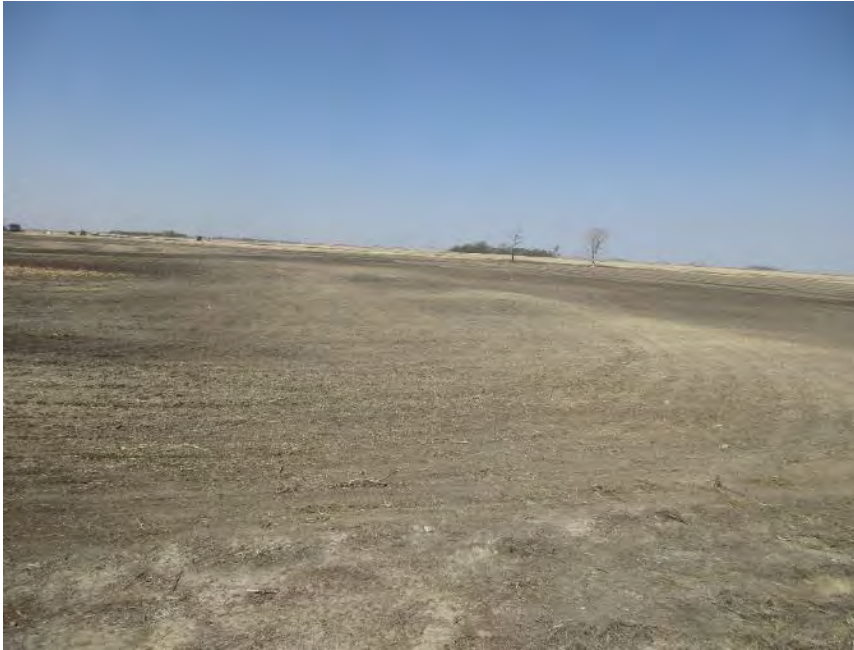
Photograph facing northwest showing site conditions. A 50 feet by 50 feet area of visual impacts can be seen in the foreground.

B2-3 was inspected on May 16th, 2018, and is located approximately 450 feet west of 28th Ave NW. The site is currently used for agricultural purposes, and is surrounded by agricultural fields to the north, west, and south. An oil & gas facility consisting of four aboveground storage tanks, one heater-treater, one wellhead, and one flare pit was observed to the east of the site. Minimal visual impacts were observed, including an area of lighter colored soils and stressed vegetation; the area of visual impacts measured approximately 50 feet by 50 feet. A wetland was observed to the southwest of the site. The site topography is generally flat and slopes to the east.

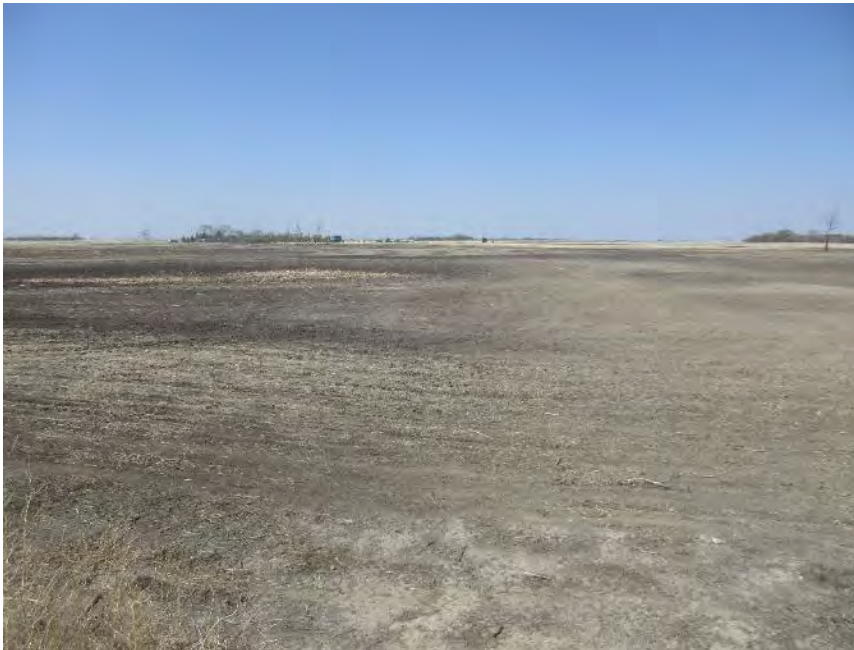
Photograph facing west showing site conditions. Minimal visual impacts were observed. The wetland observed southwest of the site can be seen in the left side of the photograph.

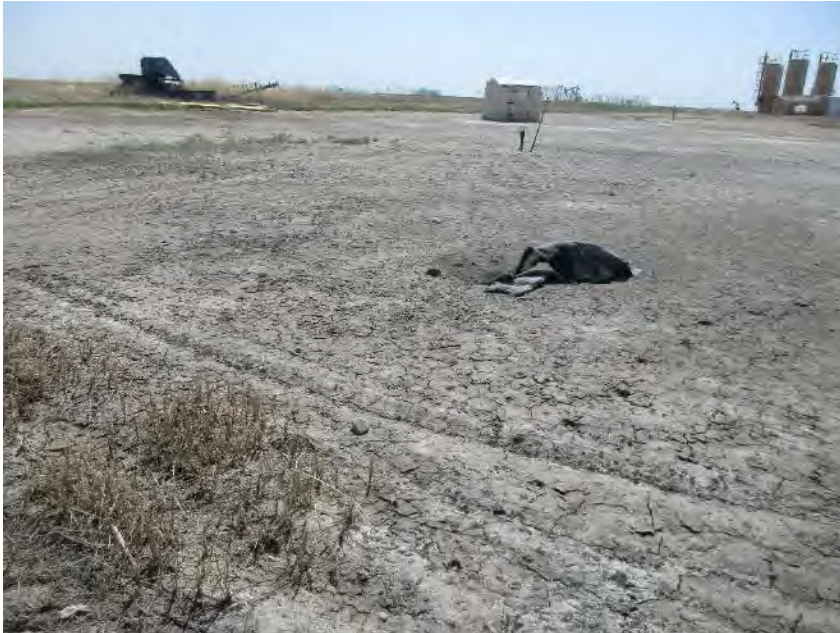
Photograph facing southwest from the northeast corner of the site, showing visual impacts, including salt residues, barren soils and stressed vegetation, within the oil & gas pad.

B3-1 was inspected on May 16th, 2018, and is located at the center of an active oil & gas facility. The site is currently used as an oil & gas facility. The facility consists of 16 aboveground storage tanks, four heater-treaters, four shacks, and one horizontal separator. Visual impacts were observed, including an area of barren soils with little to no vegetation and salt residues; the area of visual impacts measured approximately 50 feet by 50 feet. The site topography is generally flat and slopes to the northeast. An aboveground powerline was observed on the oil pad facility, running east-west.

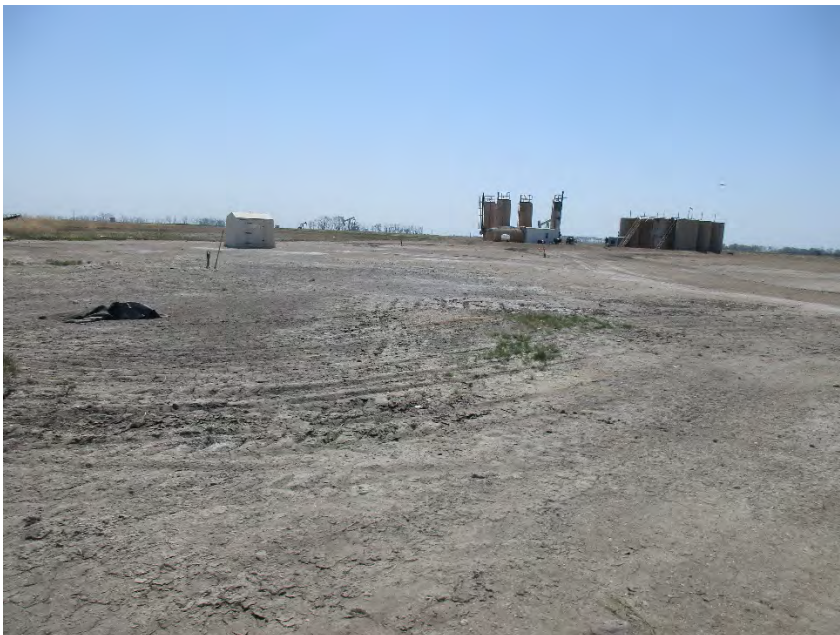
Photograph facing west from the east side of the site, showing site conditions.

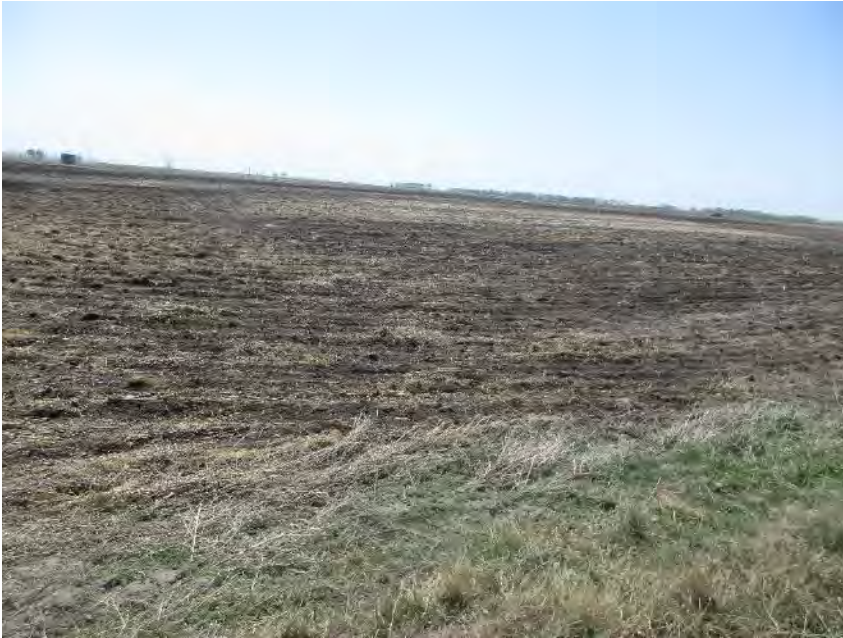
Photograph facing east off of 19th Ave NW. No visual impacts were observed at the time of the May 16, 2018 site visit.

B3-2 was inspected on May 16th, 2018 and is located approximately 500 feet east of 19th Ave NW and 50 feet north of an oilfield lease road. The site is currently used for agricultural purposes and is surrounded by agricultural fields. An oil & gas facility consisting of one wellhead was observed to the east of the site. No visual impacts were observed at the time of the site visit. The site topography is generally flat and slopes to the east.

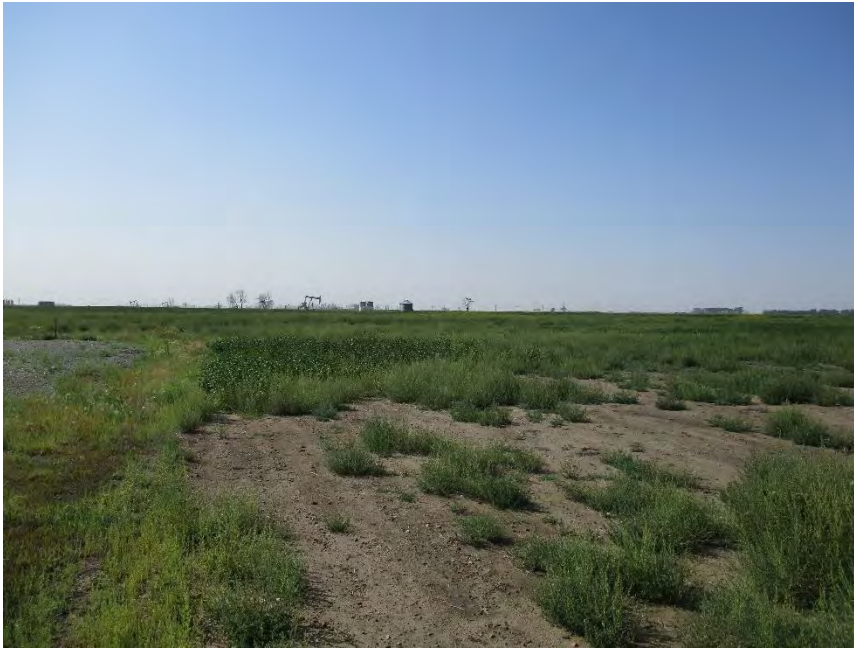
Photograph facing east off of an oilfield lease road showing a visually impacted area. Barren ground and stressed vegetation were observed in numerous areas.

B3-2 was revisited on August 20th, 2018. During the initial inspection, the site had recently been plowed, and no impacts could be observed. This follow-up investigation identified visual impacts consisting of barren ground and stressed vegetation in four distinct areas. One area measuring approximately 20 feet by 15 feet is located in the eastern portion of the site, while 3 additional areas measuring 20 feet by 10 feet, 20 feet by 20 feet, and 30 feet by 15 feet are located to the north of the lease road.

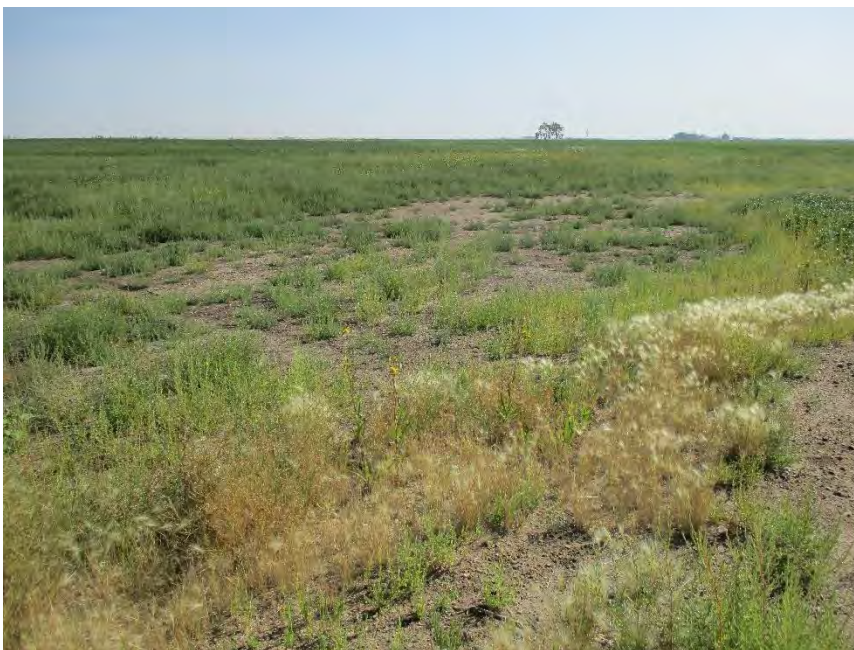
Photograph facing north off of an oilfield lease road showing a visually impacted area. Stressed vegetation was observed in numerous areas.

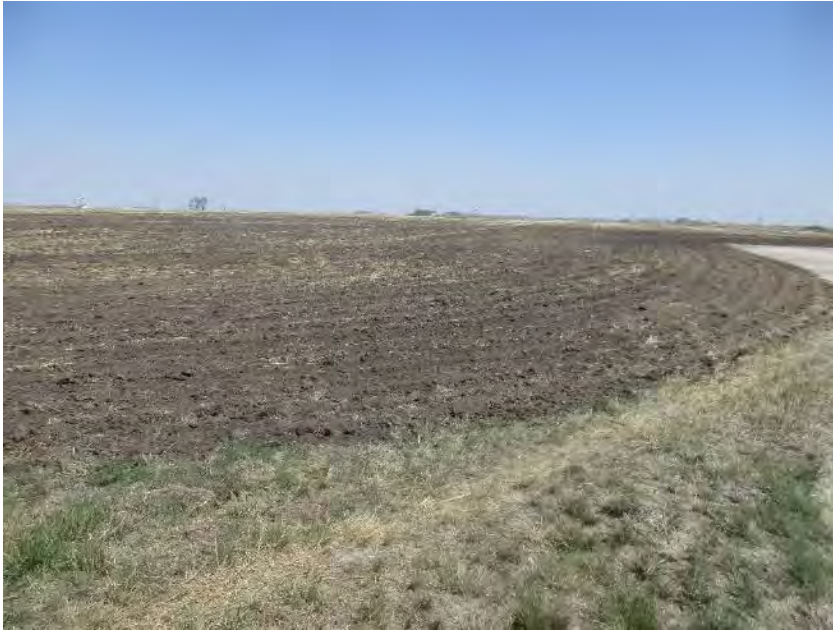
Photograph facing east off of 19th Ave NW. No visual impacts were observed at the time of the May 16, 2018 site visit.

B3-3 was inspected on May 16th, 2018 and is located approximately 450 feet east of 19th Ave NW and just north of an oilfield lease road. The site is currently used for agricultural purposes and is surrounded by agricultural fields. An oil & gas facility was observed to the south of the site, consisting of two aboveground storage tanks, one wellhead, one pump jack, and one shack. Two grain bins were also located on the site, just north of the oil & gas facility. No visual impacts were observed at the time of the site visit. The site topography is generally flat and slopes to the northwest.

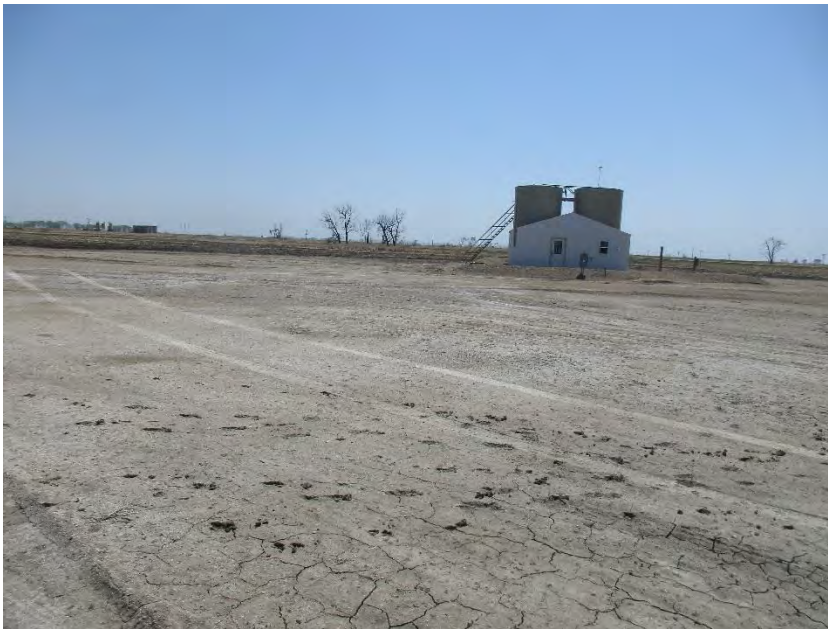
Photograph facing southwest looking onto the oil & gas facility. Soils shown in the foreground were part of the oil & gas pad, and not part of the site.

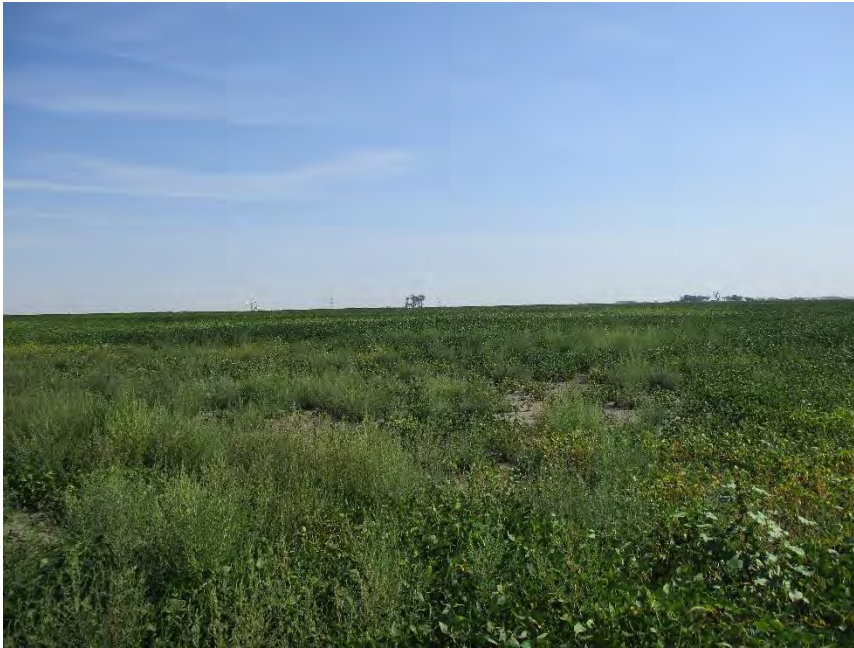
Photograph facing northeast off of an oilfield lease road showing stressed vegetation in an agricultural field. The area measured approximately 20 feet by 15 feet.

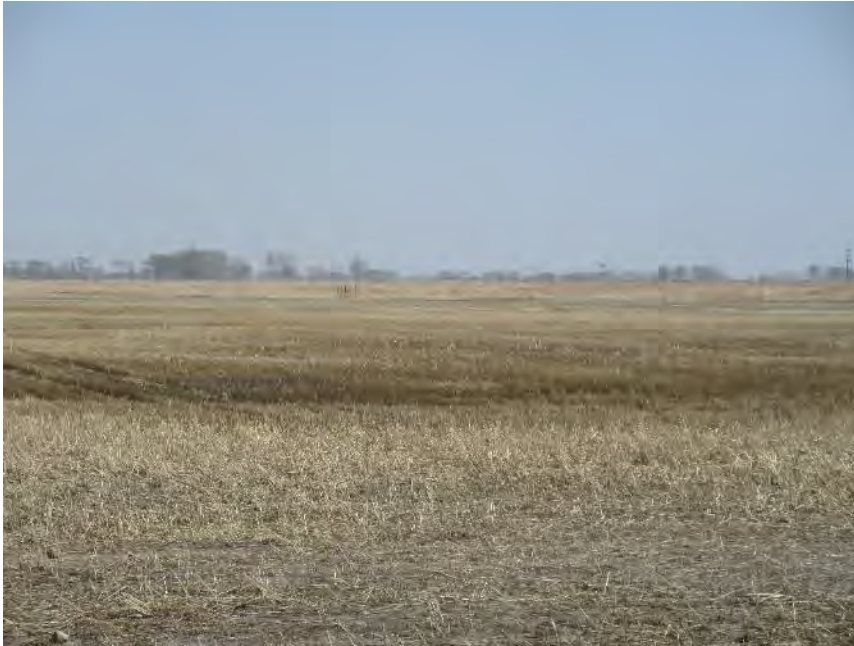
Photograph facing east off of an oilfield lease road. No visual impacts were observed at the time of the site visit.

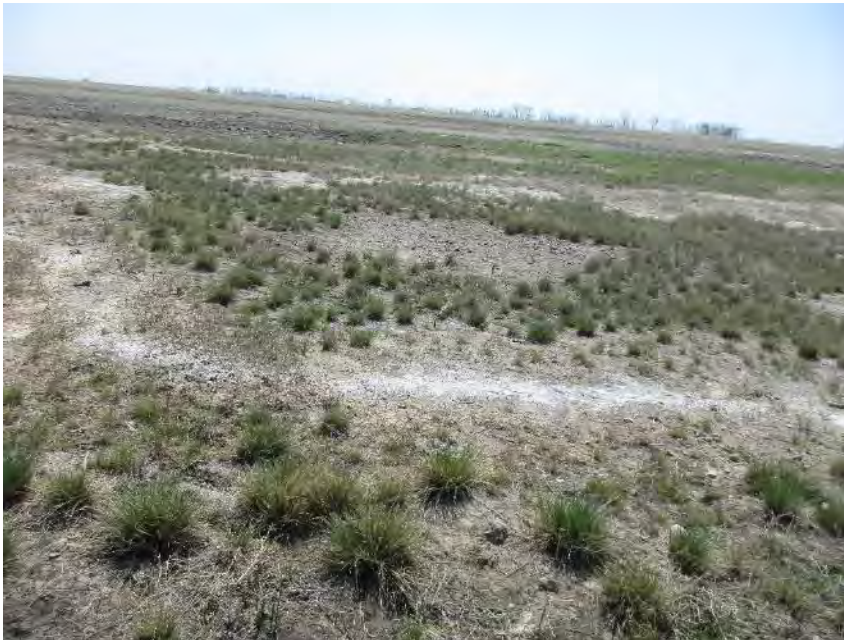
Photograph facing east of site conditions off of 19th Ave NW. Visual impacts including barren soils with little to no vegetative growth and salt crusting were observed.

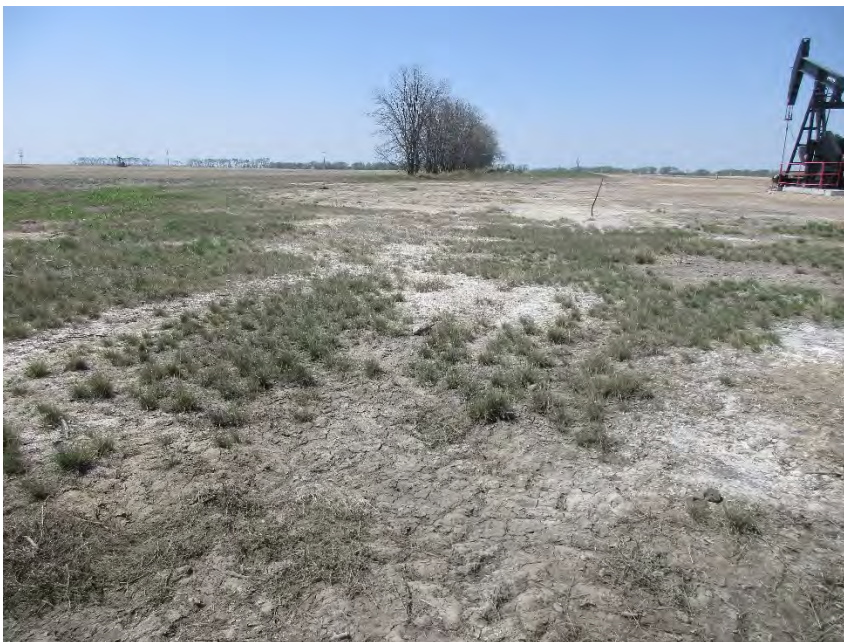
Photograph facing west from the eastern portion of the site. The oil & gas facility can be seen in the background of the photograph.

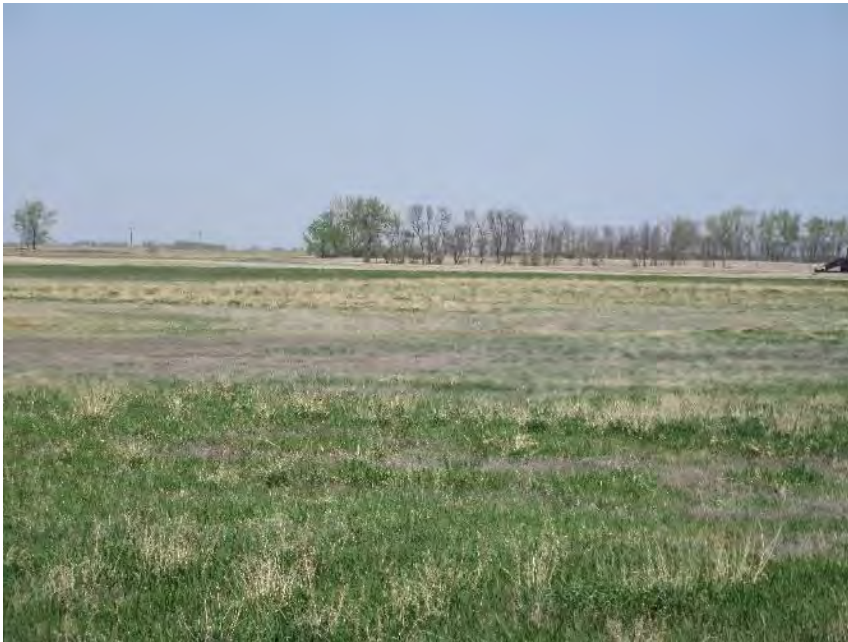
Photograph facing northwest off of an oilfield lease road. An area of stressed vegetation, measuring approximately 100 feet by 100 feet can be seen in the center of the photograph.

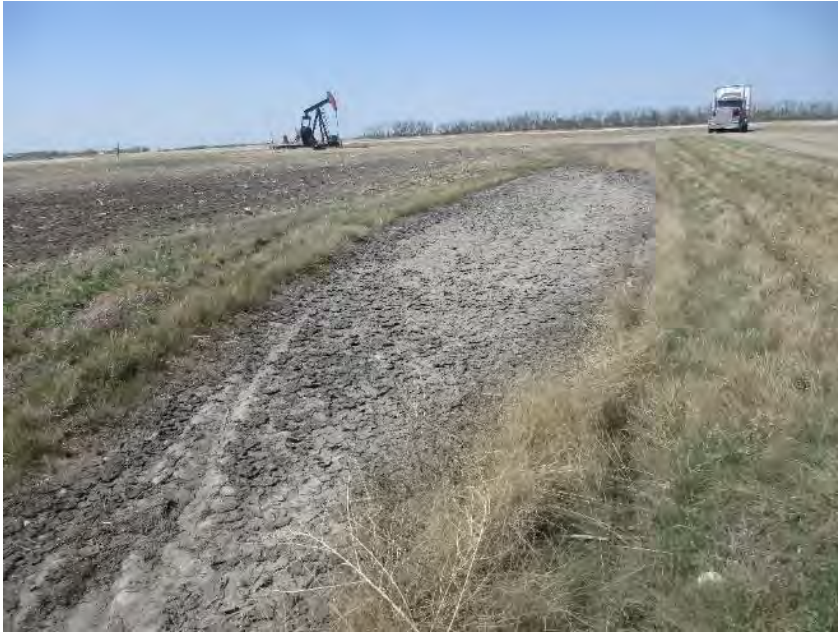
Photograph facing northwest off of an oilfield lease road. Barren soils with no vegetation and salt crusting was observed in an area approximately 75 feet by 15 feet.

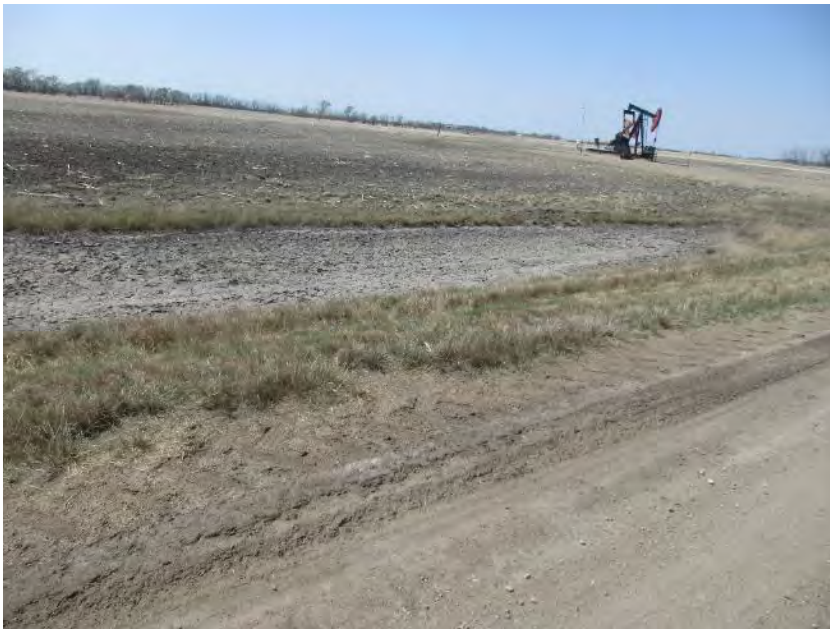
Photograph facing west/northwest off of an oilfield lease road. Visual impacts were observed within the road ditch.
