NDIC Brine Pond Study

Phase II: Site Assessments

June 25, 2018

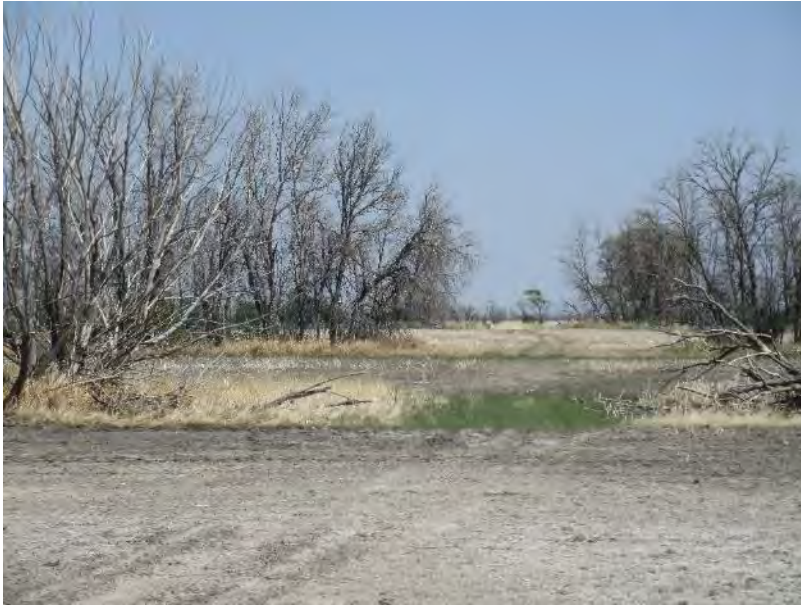
Photograph facing east off of US Highway 83. The site is located approximately 1,500 feet farther east, on private property. No visual impacts could be observed due to access limitations.

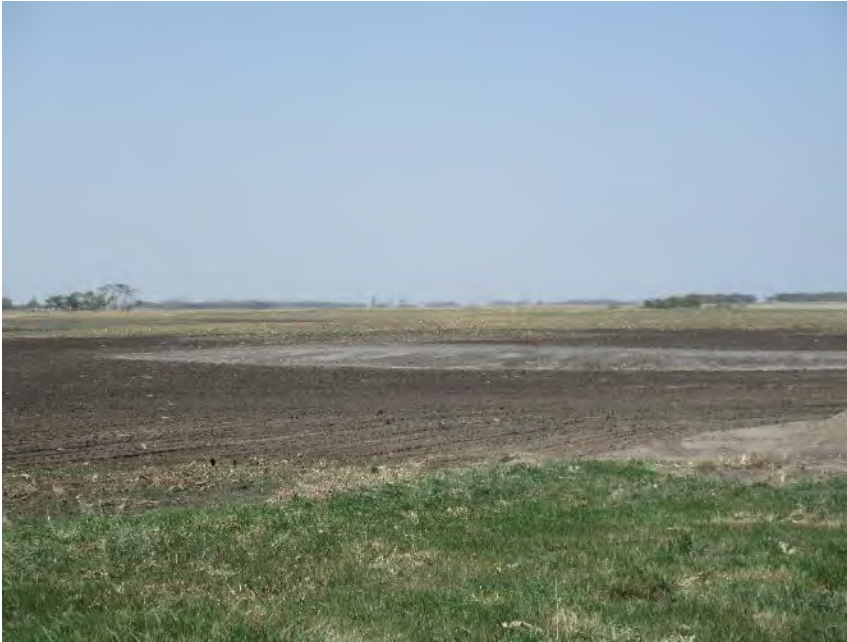
Photograph facing northwest off of an oilfield lease road. Visual impacts were observed, including barren soils and salt residues.

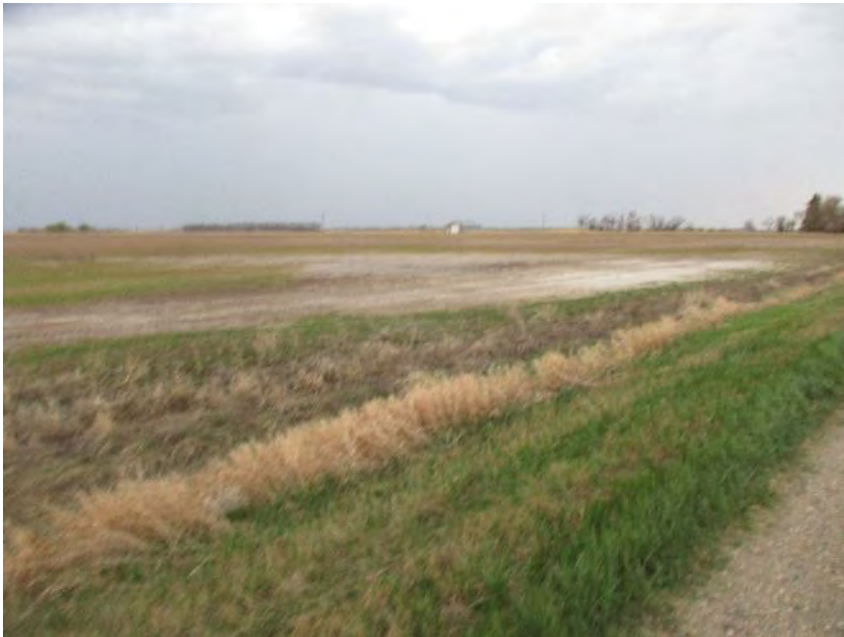
Photograph facing southwest off of 108th St NW. Barren soils with little to no vegetation and salt residues were observed.

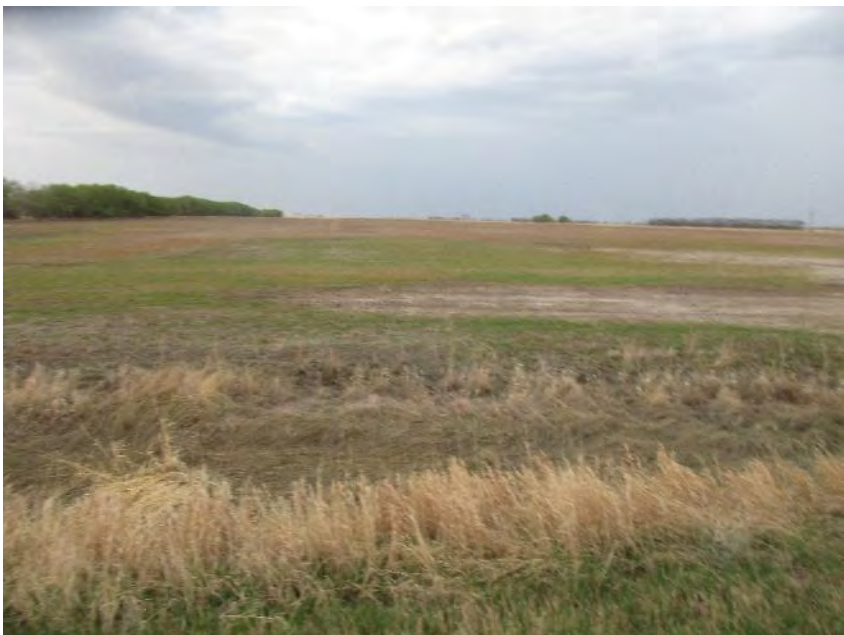
Photograph facing south off of 108th St NW, showing the eastern extent of the area of visual impacts.

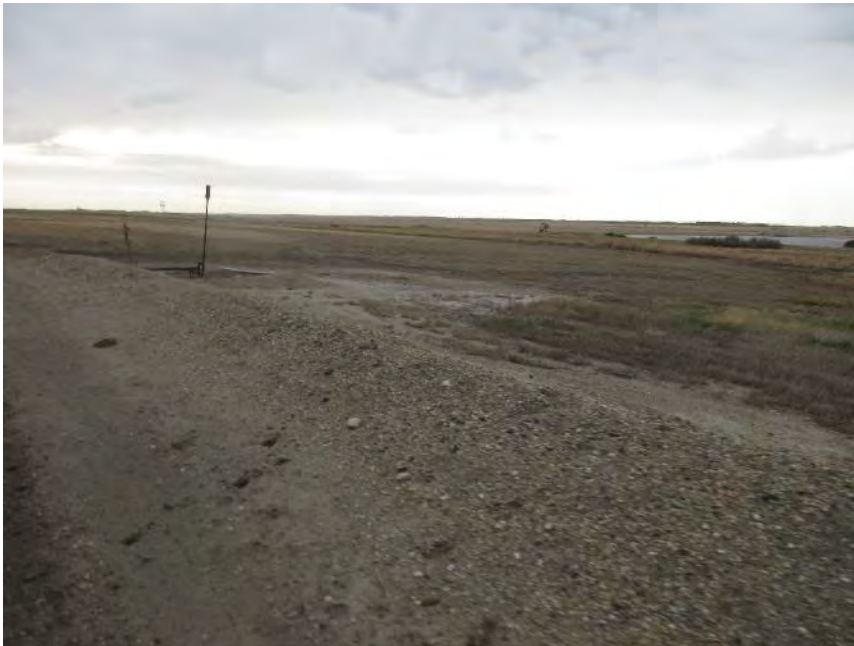
Photograph facing east off of an oilfield lease road, showing an area of stressed vegetation and salt residues.

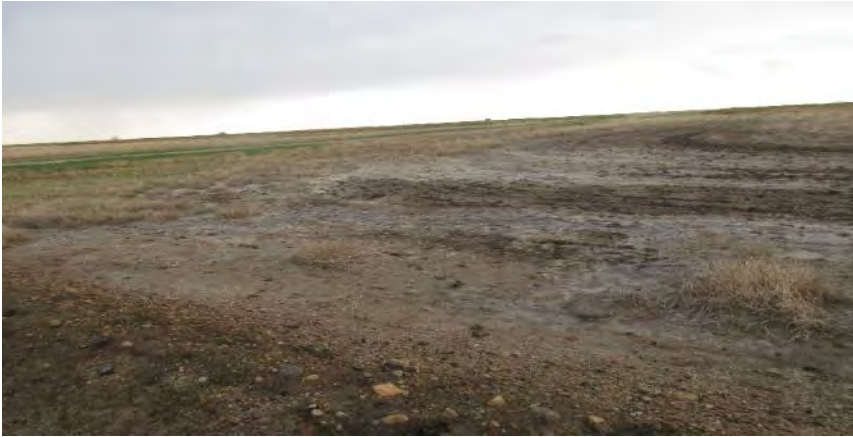
Photograph facing northwest off of an oil & gas facility showing the visually impacted area. Visual impacts follow the edge of the oil & gas facility.

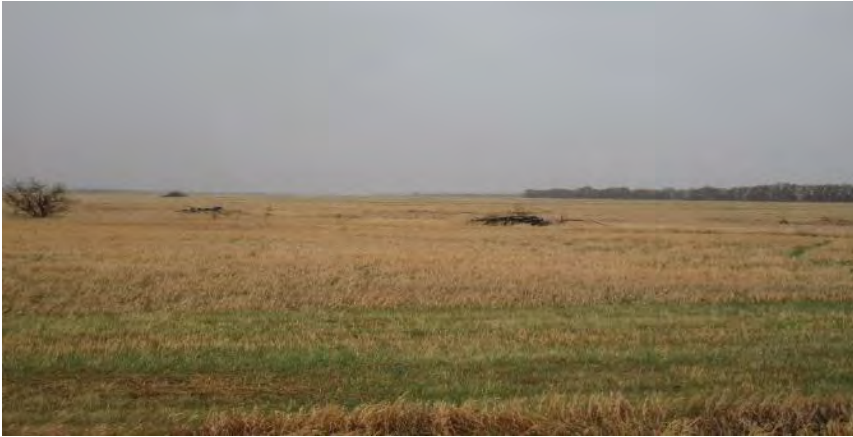
Photograph facing south off of 109th St NW showing the site. No visual impacts were observed at the time of the site visit.

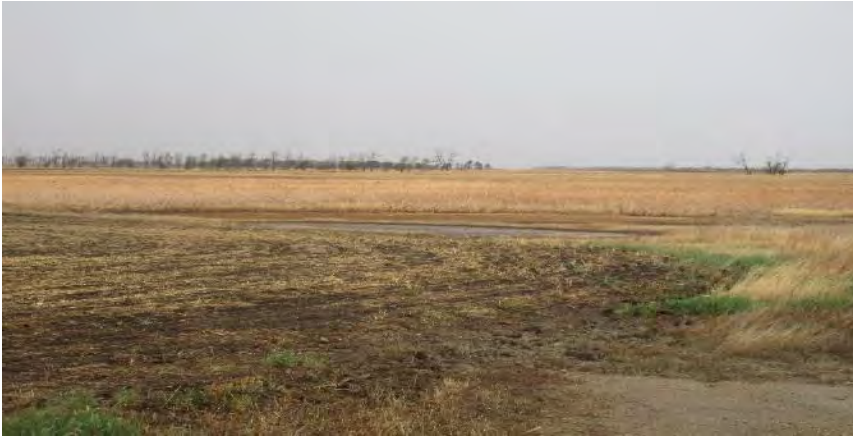
Photograph facing southwest off of an oil & gas facility showing the visually impacted area lacking vegetation.

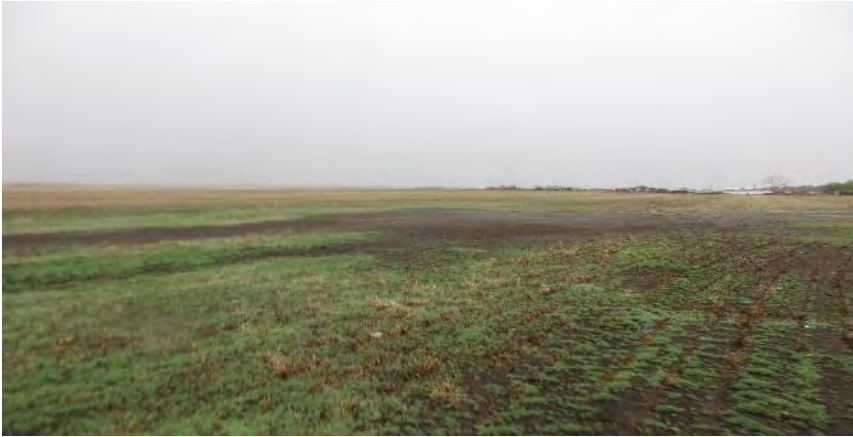
Photograph facing southeast off of an oil & gas facility. A visually impacted area lacking vegetative growth can be seen.

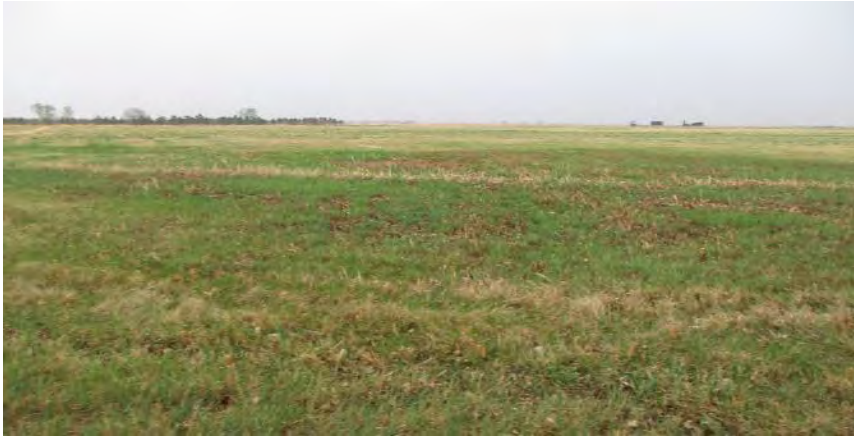
Photograph facing southeast off of an oilfield lease road showing the site. No visual impacts were observed at the time of the site visit.

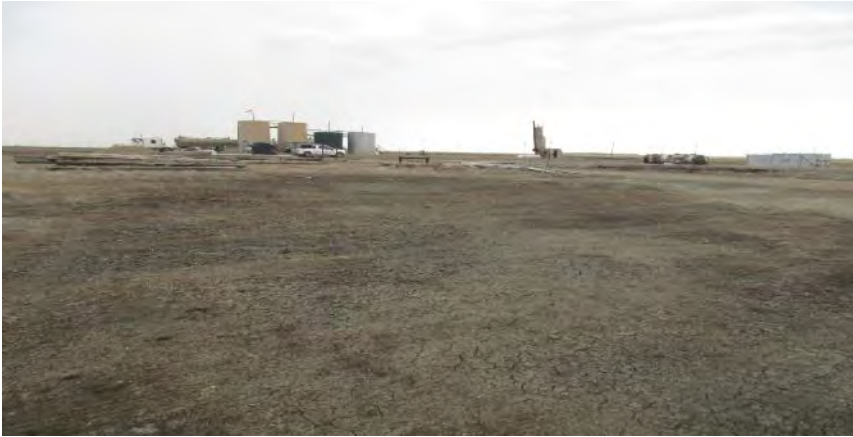
Photograph facing west off of an oil & gas facility, looking into an area of the facility used as a laydown yard. A visually impacted area with cracking soils was observed.

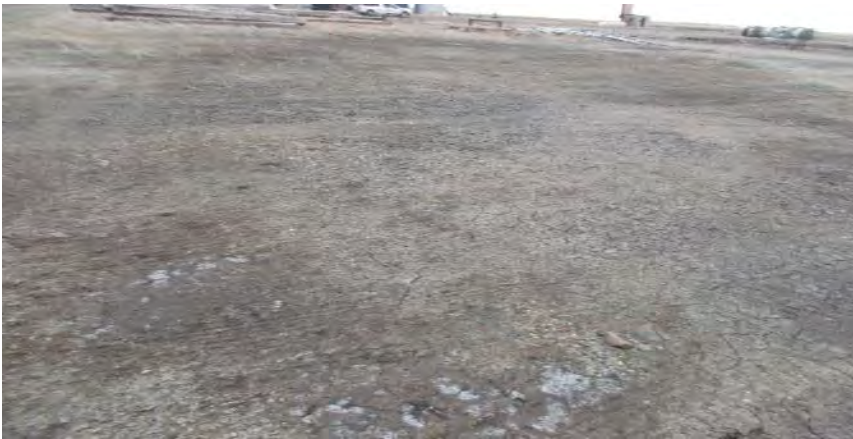
Photograph facing west showing a closer view of the cracking soils at the visually impacted area located within the laydown yard of the oil & gas facility.

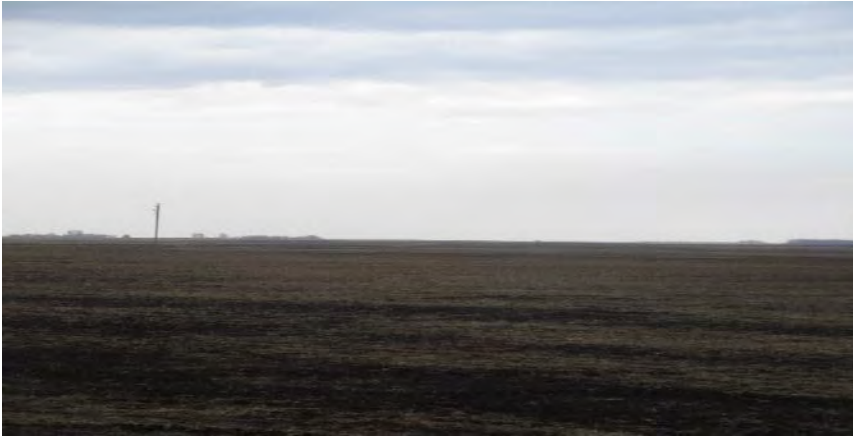
Photograph facing northwest off of an oilfield lease road showing the site. No visual impacts could be observed due to access limitations.

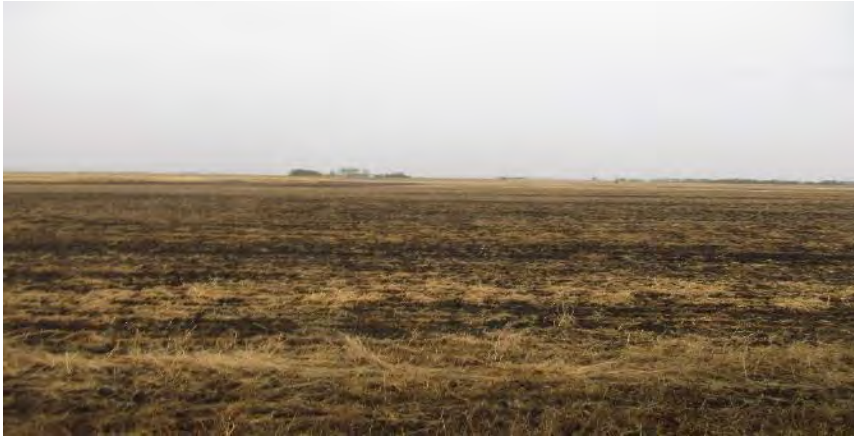
Photograph facing south off of an oilfield lease road showing the site. No visual impacts could be observed due to access limitations.

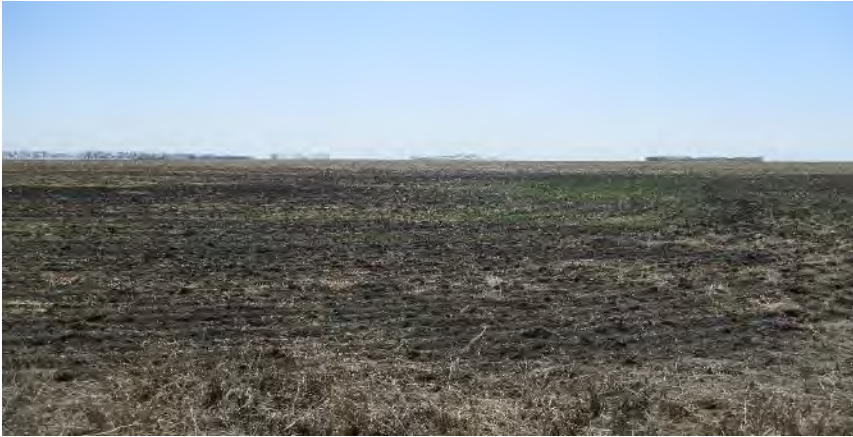
Photograph facing south off of an oilfield lease road showing the site. No visual impacts could be determined at the time of the May 17, 2018 site visit due to recent disturbance in the field.

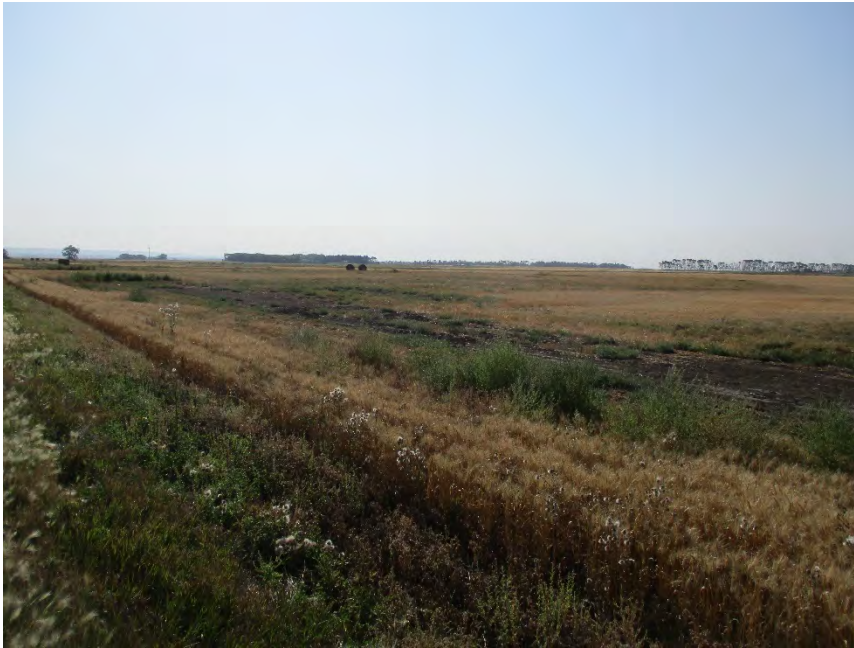
Photograph facing southeast off of an oilfield lease road showing the eastern portion of the visually impacted area. Barren ground and stressed vegetation were observed in an approximately 150 feet by 20 feet area.

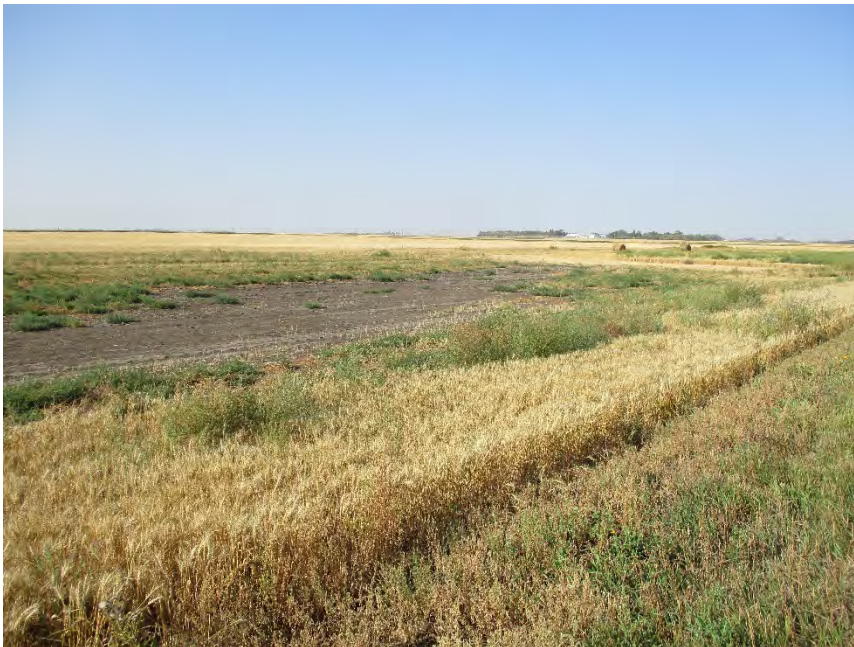
Photograph facing southwest off of an oilfield lease road showing western portion of visually impacted area.

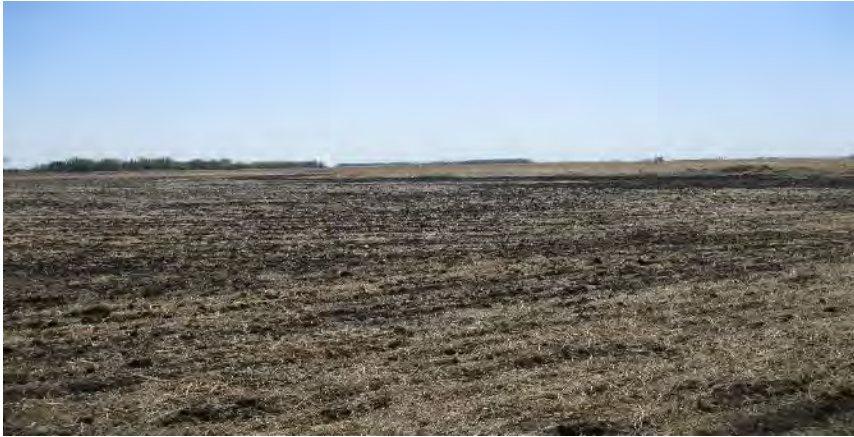
Photograph facing south off of an oilfield lease road showing the site. No visual impacts were observed at the time of the May 17, 2018 site visit.

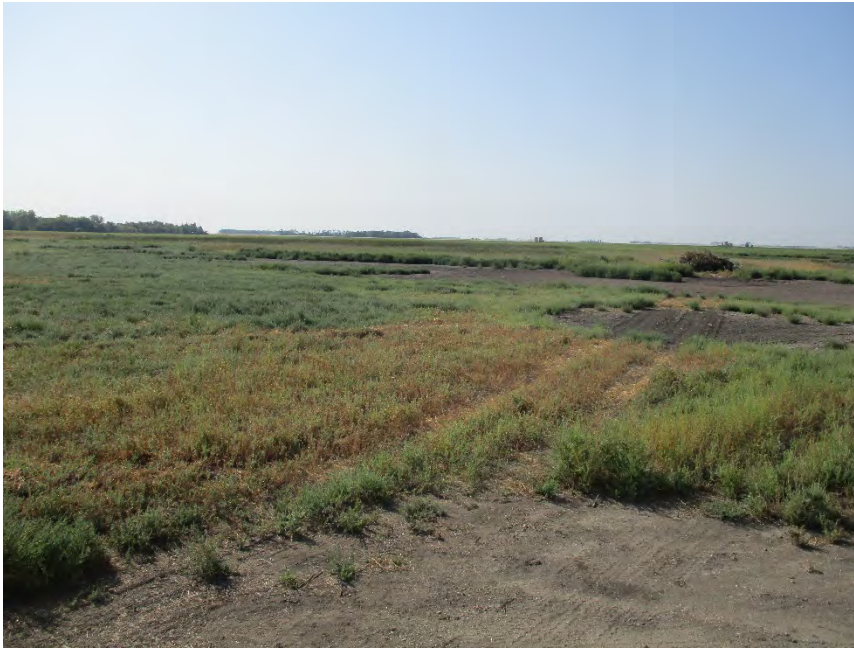
Photograph facing south off of an oilfield lease road showing a visually impacted area. Barren ground and stressed vegetation were observed in an area measuring approximately 100 feet by 50 feet.

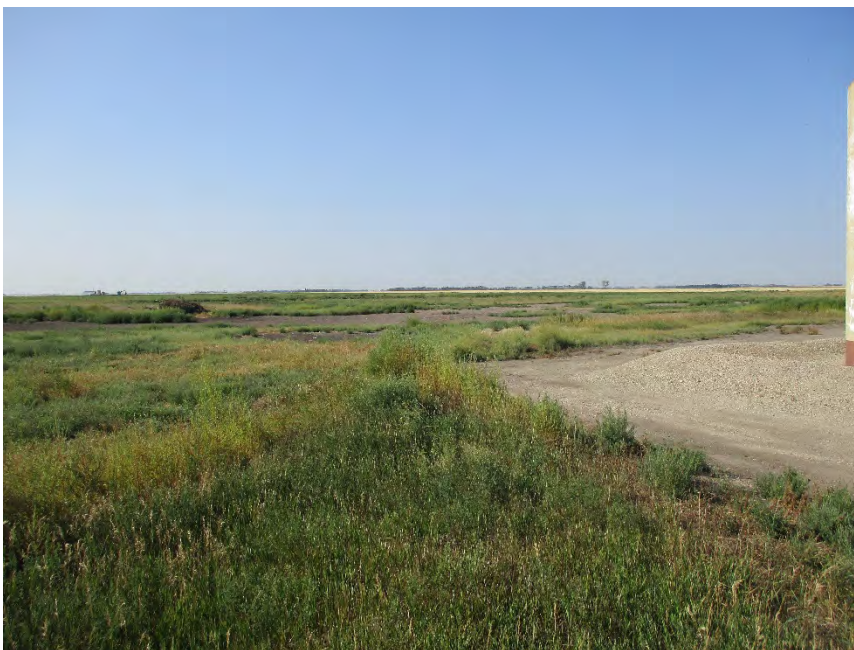
Photograph facing southeast off of an oilfield lease road showing a visually impacted area. Aboveground storage tanks are visible to the right of the picture, located north of the site.

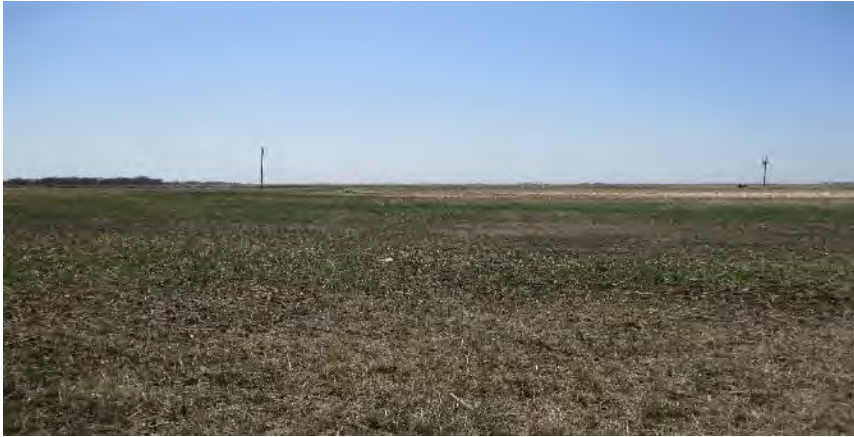
Photograph facing south off of an oilfield lease road showing the site. A wetland and aboveground powerlines can be seen in the background.

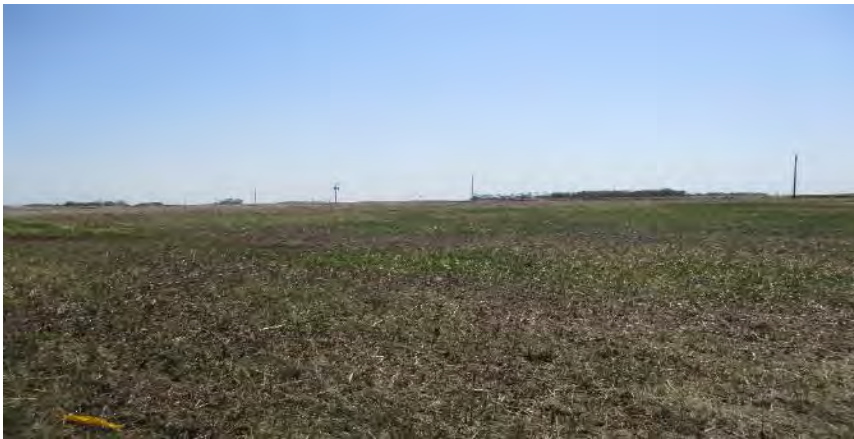
Photograph facing south off of an oilfield lease road showing the site. A small area of slightly stressed vegetation was observed at the time of the site visit.

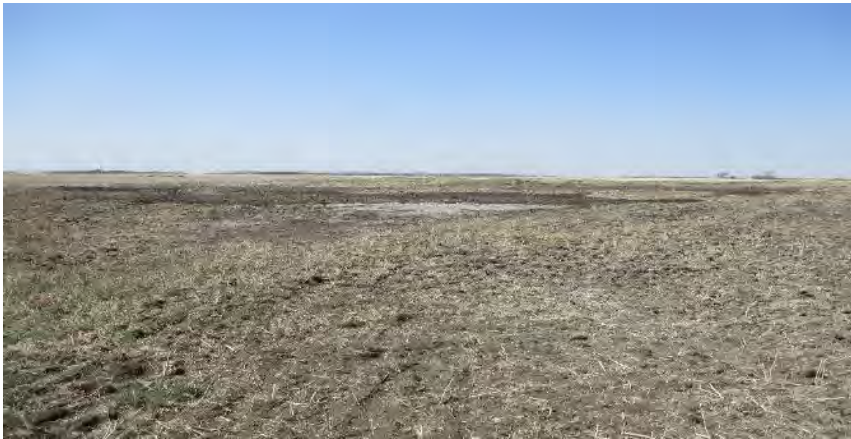
Photograph facing southwest off of 103rd St NW showing the visually impacted area lacking vegetation with salt crusting.

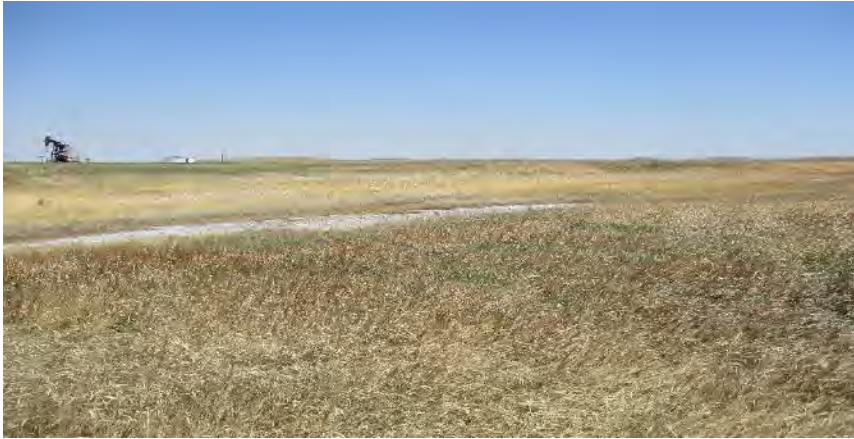
Photograph facing northeast off of an oilfield lease road showing the visually impacted area.

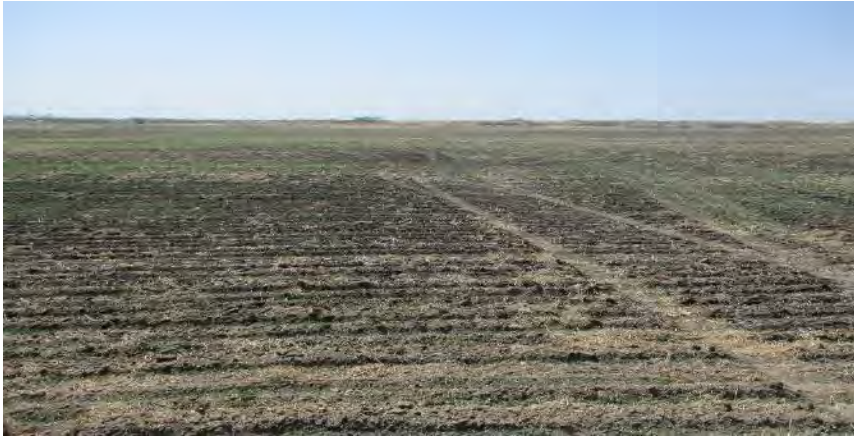
Photograph facing west/northwest off of 3rd Ave NE showing the visually impacted area. Visual impacts were minimal and included slightly stressed vegetation.

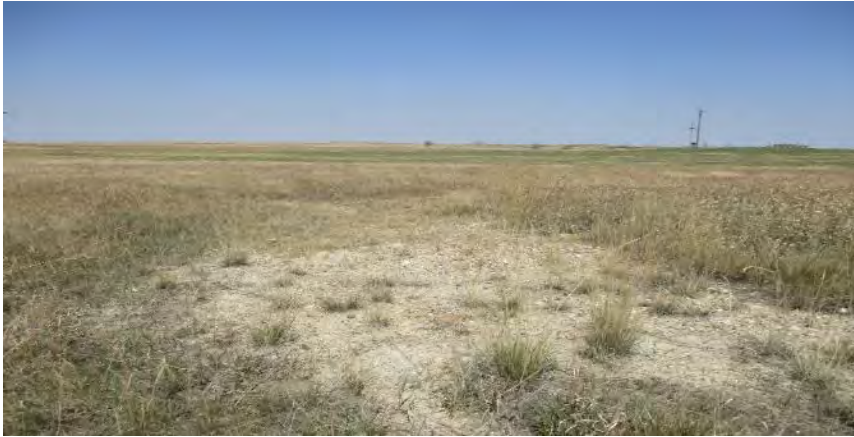
Photograph facing north off of an oilfield lease road showing the visually impacted area lacking vegetative growth.

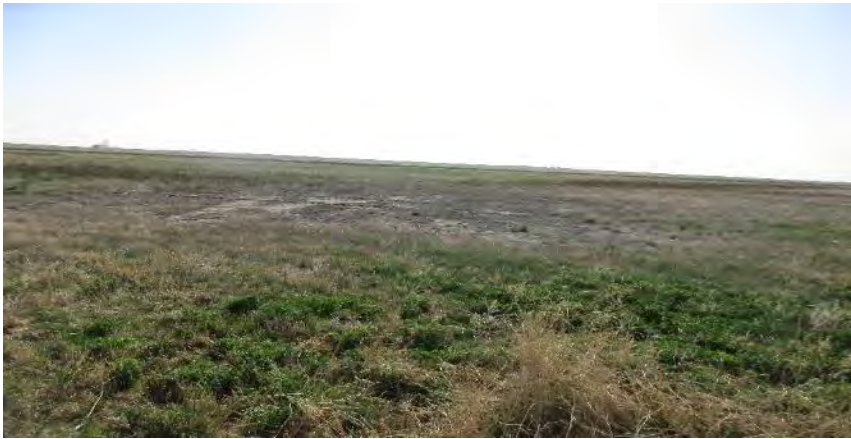
Photograph facing east off of an oilfield lease road showing the visually impacted area lacking vegetation. A wetland can be seen in the background.

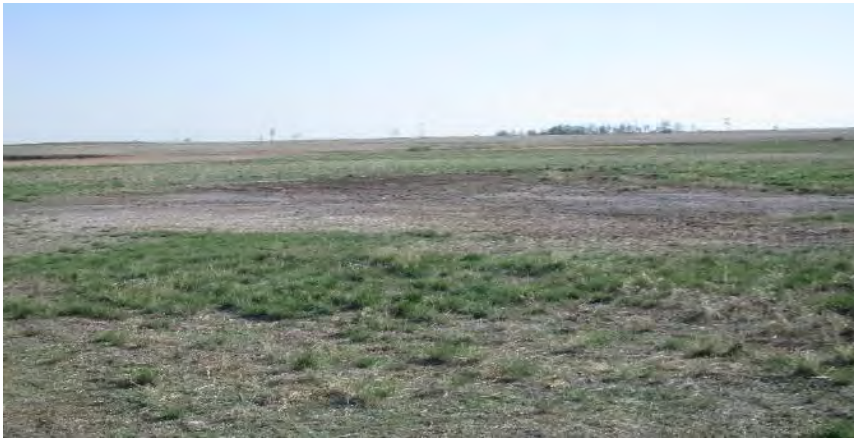
Photograph facing northeast off of an oilfield lease road showing the visually impacted area and the lack of vegetative growth. The impacted area is directly east of the oilfield lease road.

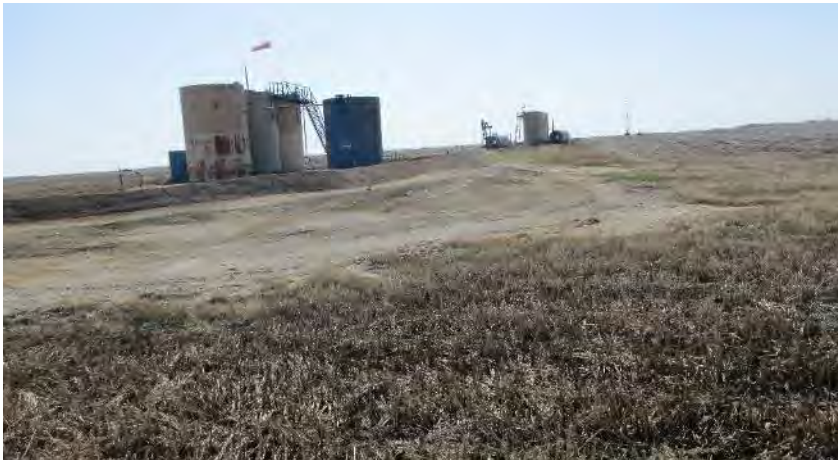
Photograph facing west/southwest off of 25th Ave NW showing the visually impacted area north/northeast of aboveground storage tanks. A wetland bordering the site was observed northeast along the road.

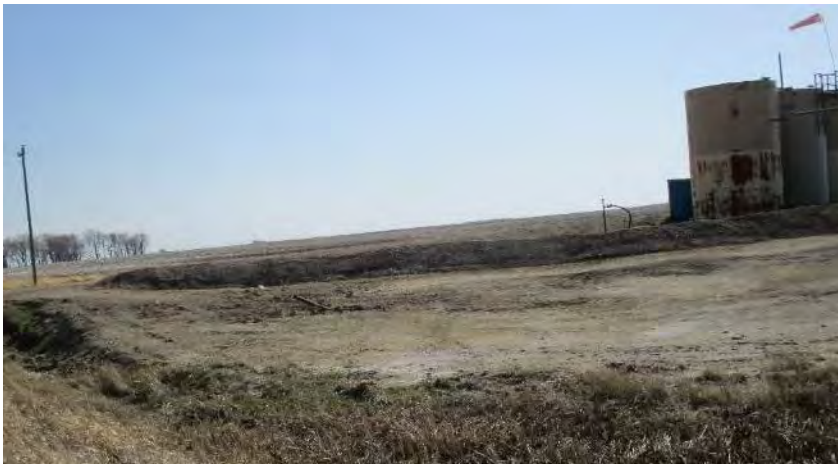
Photograph facing southwest off of 25th Ave NW showing the visually impacted area and wetland bordering the site. Aboveground powerlines were observed south of the oilfield lease road.

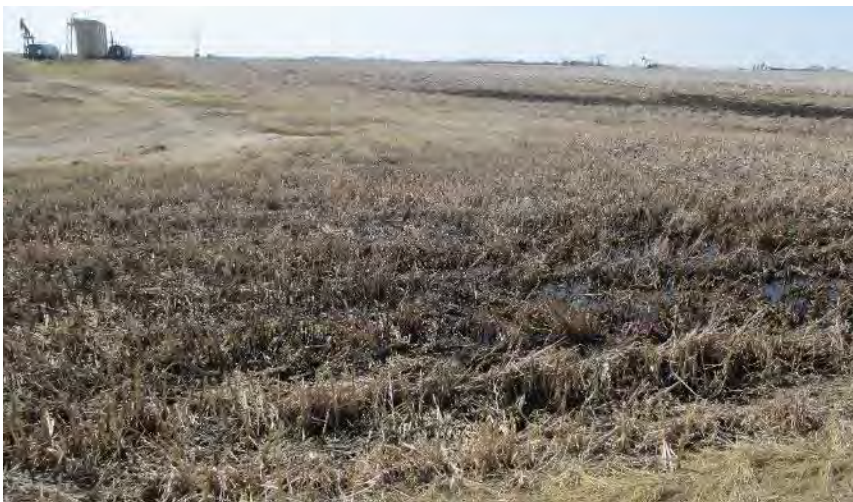
Photograph facing west off of 25th Ave NW showing the wetland adjacent to road, and agricultural land to the north.

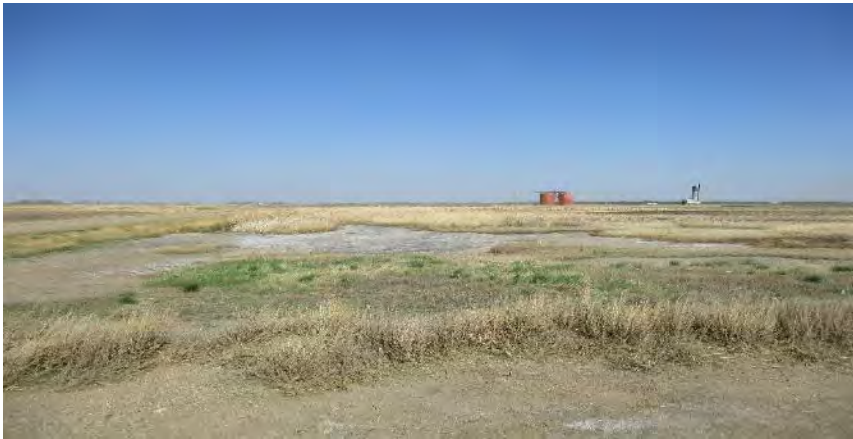
Photograph facing east off of an oil & gas facility showing the visually impacted area lacking vegetation and exhibiting salt crusting.

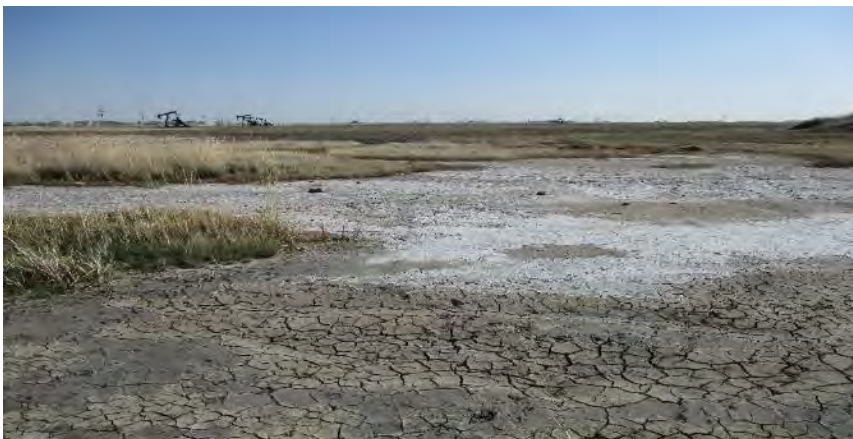
Photograph facing south off of an oilfield lease road showing visually impacted area. Soil cracking and salt crusting can be seen. A wetland is located adjacent to the site as can be seen in the background.
