# AERIAL PHOTOGRAPHY OF ILLEGALLY STORED OILFIELD WASTES

#### -- SALTED LANDS COUNCIL --

# ISSUE #1: OILFIELD WASTE AT UNAUTHORIZED SITES

#### LOCATION: MOHALL

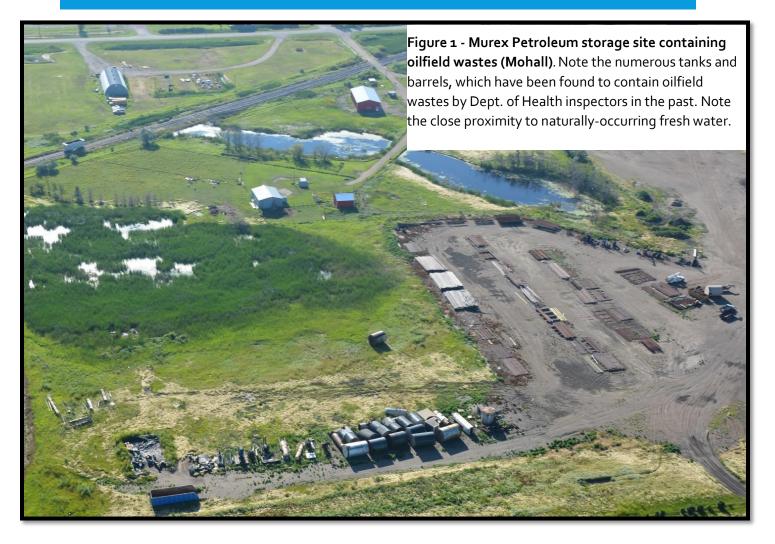
- 1. Department of Health staff inspected this site on June 9<sup>th</sup>, 2015.
- 2. The inspectors found hazardous oilfield wastes improperly stored at this site which is not an authorized hazardous waste facility.
- 3. Bill Jansky Environmental Health and Safety Coordinator for Murex Petroleum was also present.

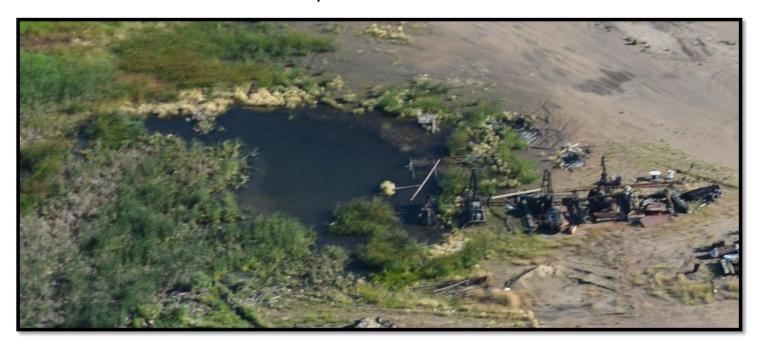
- a. The barrels contain "oil, rags, diapers, and other waste from well sites."
- b. The barrels..." are collected and contained in a containment basin."
- c. "The basin walls are approximately 3 feet in height."
- d. "The basin is **lined with plastic liner**."

Note that there is no perimeter berm or diking around this storage site - which is illegally doubling as an oilfield waste storage site. There is nothing preventing contaminated runoff from spreading off-site.

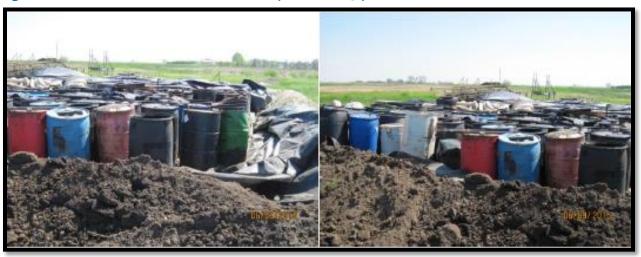
Figure 2 - "Containment Basin" - DoH inspector 2015 photo - Mohall

"The basin walls are approximately 3 feet in height."

The barrels in this pit are among those the inspector reported as containing "oil, rags, diapers, and other waste from well sites" in June 2015. The inspector referred to this pit as a "containment basin," despite its structural deficiencies and lack of impermeable material. We question the basin's ability to contain fluids.

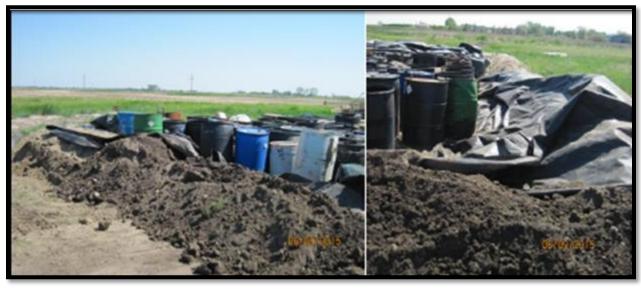
Figure 3 - "Containment Basin" – photo by DoH inspector in 2015 – Mohall

**Dept. of Health inspector written statement in 2015:** "The basin is lined with plastic liner."

A plastic liner is only effective if it is installed and maintained properly. This lining was not installed properly, and thus the inspector's statement, "The basin is lined with plastic liner" is misleading.

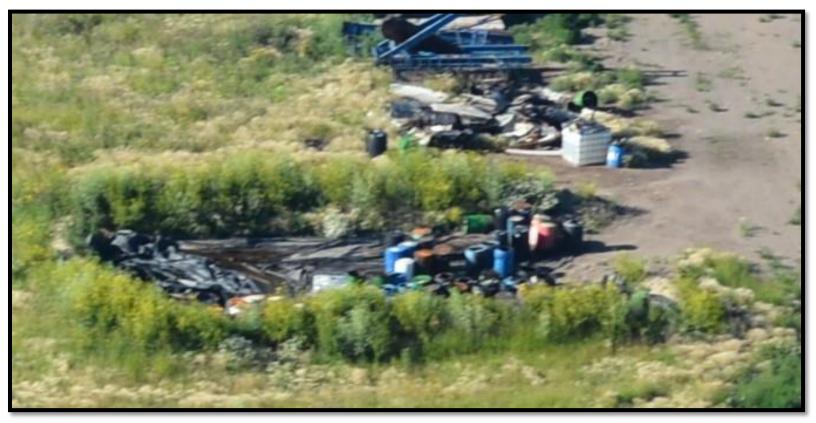
Basin containing liquid and tanks of oilfield waste more than a year after inspection.

As shown above, there is liquid and barrels in this basin as of July 18, 2016 - more than a year after Murex Petroleum was told to remove liquid from this basin containing and properly dispose of the potentially hazardous oilfield wastes. It appears that not all of the barrels were "mixed on site with fly ash in a roll off" and taken to Clean Harbors, as stated in the Department of Health inspector's June 2015 memo. Not only was Murex Petroleum asked to do so, it's the law:

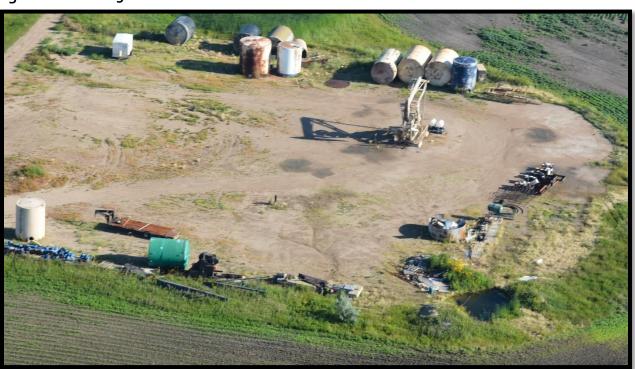
Figure 6 - Well #15106 Site - 2016

The tanks at this site appear to be in poor condition (note the rust) and may not be "resistant to the effects of produced fluids or chemicals that may be contained therein" – as required by rule 43-02-03-49.

As rule 43-02-03-49 states, "unused tanks and production equipment" are not allowed to be stored for more than "one year" – which has passed.

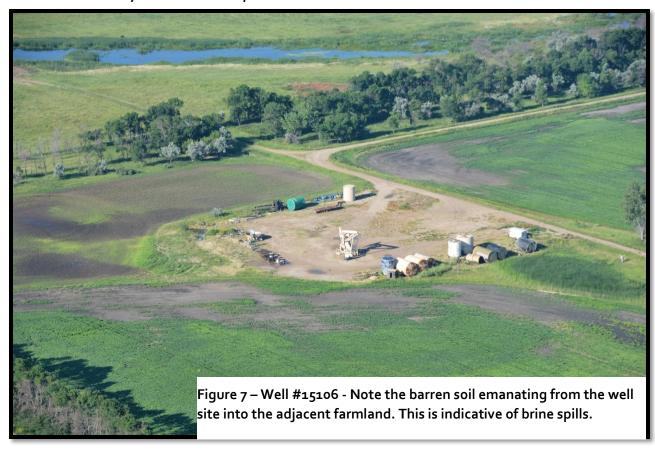
If these tanks still contain waste, then this site is in violation of the **ND Administrative Code rule 43-02-03-19.2** instead. As stated previously, this rule requires that **all waste material recovered from spills**, leaks, and other such events must immediately be disposed of in an authorized facility.

The barren soil at the site shown above (Figure 7) is likely a sign of salt from brine spills - such as the reported uncontained brine spill caused by a pipeline leak at this location in 2010. The spill was estimated at **200 barrels** (8,400 gallons).

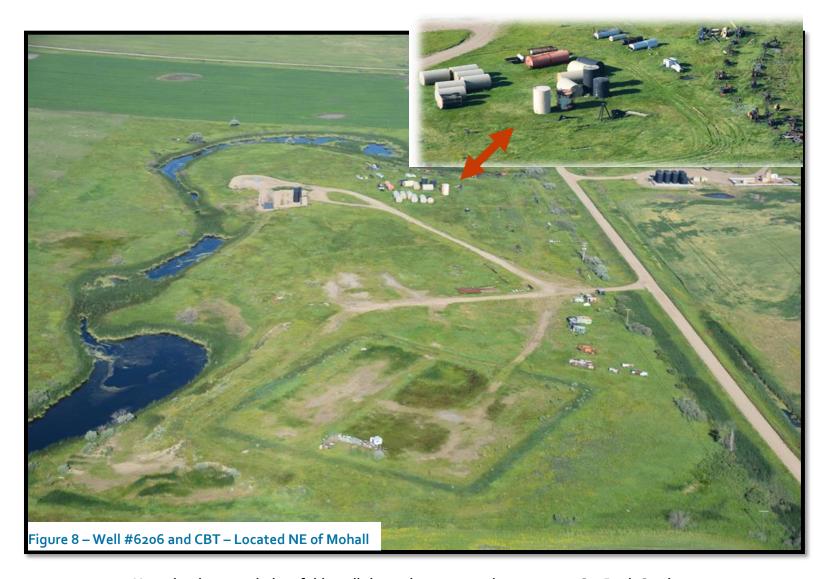
Note the close proximity of this well site and storage yard to a stream, Cut Bank Creek.

It is unknown what the square outlined area was used for.

In 2014, there was a reported brine spill from a pipeline leak at the well site above (Figure 9).

The brine spilled off of the well site and entered into **West Cut Bank Creek** (shown in photograph). This creek flows into the main Cut Bank Creek, which is a tributary of the **Mouse River** (aka Souris River) – which ultimately flows in Lake Winnipeg.

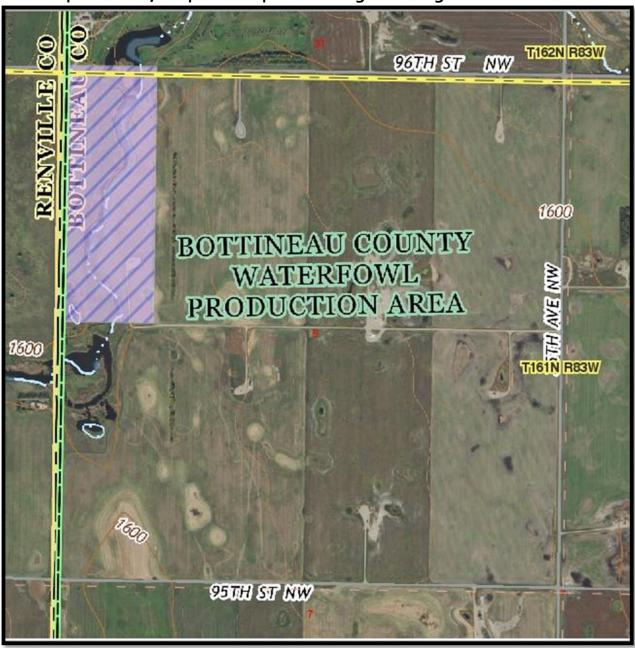
In 2013, there was a reported brine spill in the neighboring section (Sect. 6) in the **Bottineau County Waterfowl Production Area** (shown below). It was estimated at **54 barrels** – which is **2,268 gallons** – according to the well operator's spill report. Two barrels of oil were also reported spilled.

This spill was not inspected by Dept. of Health staff, nor was the Game and Fish Dept. alerted, despite the spill occurring in a designated nature area.

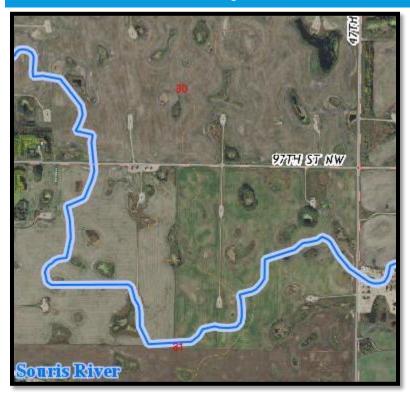
Figure 10 – Area Surrounding Well #7748

When the Dept. of Health inspector visited the site he discovered an old, unreported oil spill.

This old oil spill would likely have never been discovered had the inspector not happened upon it while visiting the brine spill site.

The site was inspected solely because it was reported as a **not contained** spill – meaning the spill leaked "off location" of the well site.

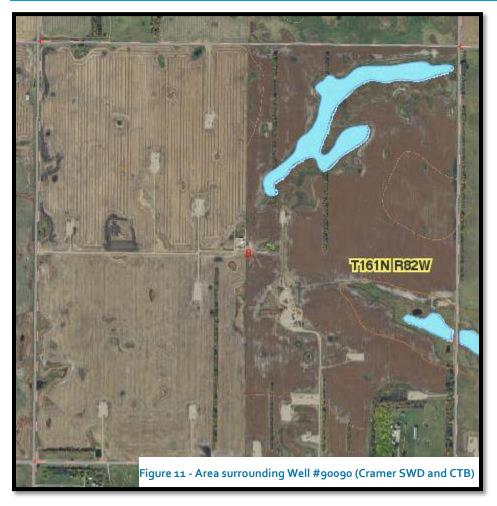
#### LOCATION: SENW SECTION 8 TOWNSHIP 161 RANGE 82

The spill occurred at the Cramer CTB (central tank battery). The spill report states the wrong county. The spill occurred in Bottineau County, not Renville County as the report states.

The total spill volume for this August 22<sup>nd</sup> oil and brine spill was estimated by the well operator at **2,100 gallons**.

This well site has had 6 other reported brine spills since 2004.

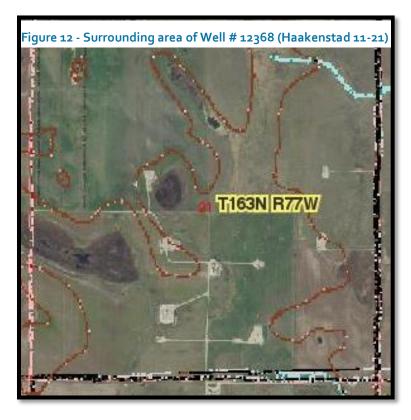
# LOCATION: SECTION 21 TOWNSHIP 163 RANGE 77

Earlier this month on August 16<sup>th</sup> a fire occurred at Well # 12368 (Haaakenstad 11-21), and an "unknown" of oil and brine spilled was burned off in the fire.
