AERIAL PHOTOGRAPHY OF OILFIELD SITES IMPACTED BY BRINE SPILLS AND OILFIELD WASTES

-- SALTED LANDS COUNCIL --

UNAUTHORIZED HAZARDOUS WASTE SITE

LOCATION: NWSE SECTION 14 TOWNSHIP 161, RANGE 84

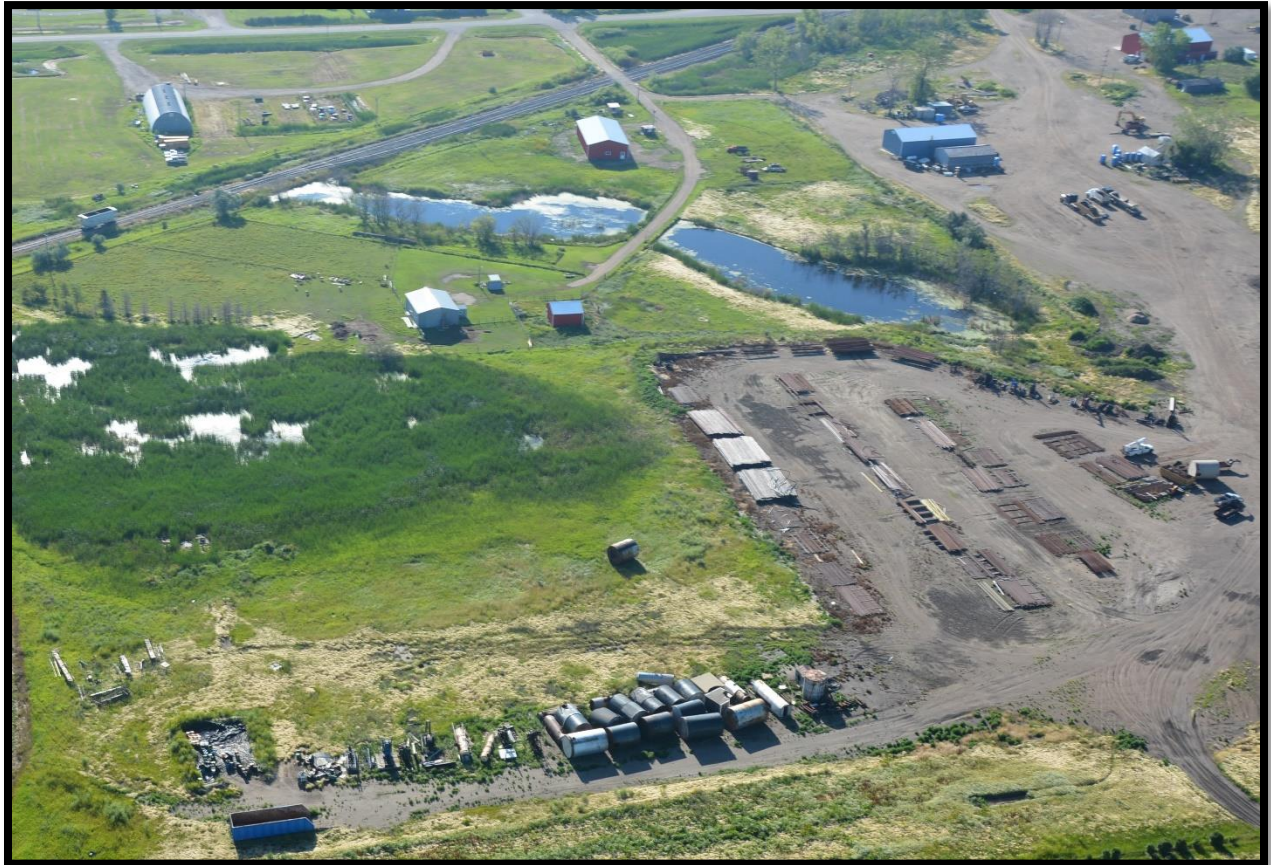
Figure 1 – Murex Petroleum *Unauthorized* Waste Storage Site Near Mohall.

1. Department of Health (Environmental Section) staff inspected this site on June 9th, 2015.
2. They found hazardous oilfield wastes improperly stored at this site – which is not an authorized oilfield waste facility.
3. Bill Jansky - the Environmental Health and Safety Coordinator of Murex Petroleum - was also present.

- a. The barrels at the site contain *“oil, rags, diapers, and other waste from well sites.”*
- b. The barrels...*“are collected and contained in a **containment basin.**”*
- c. *“The **basin walls** are approximately **3 feet** in height.”*
- d. *“The basin is **lined with plastic liner.**”*

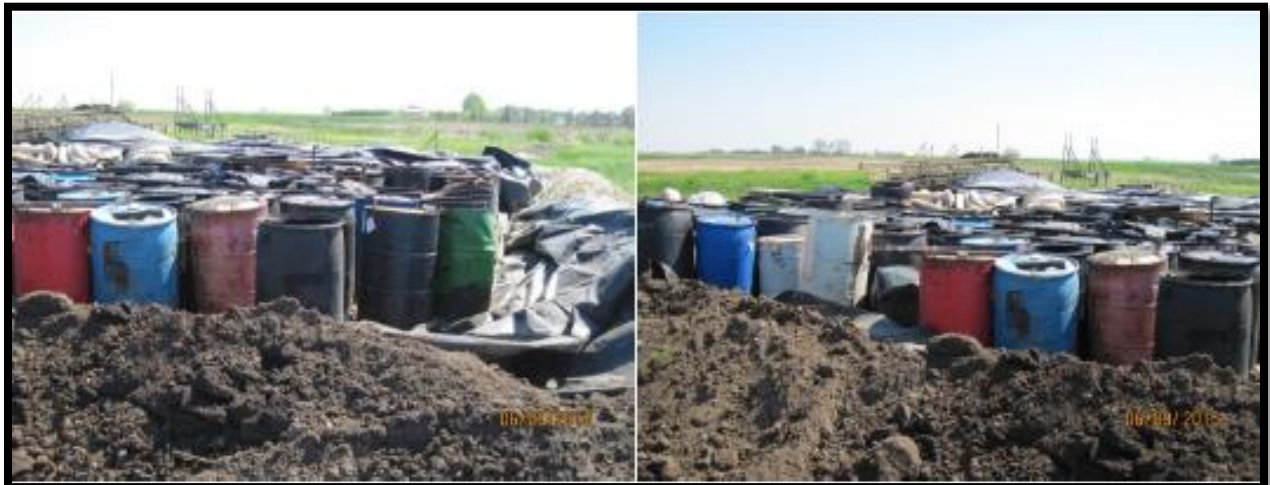
Figure 2 - ND DoH inspector’s 2015 photograph of the “Containment Basin”

ND DoH inspector statement in 2015: *“The basin walls are approximately 3 feet in height.”*

The barrels in this pit are among those the inspector reported as containing “oil, rags, diapers, and other waste from well sites” in June 2015. The inspector referred to this pit as a “containment basin” despite its structural deficiencies. As shown in the aerial photograph taken in July of 2016 shown below (Figure 3), the dike’s walls are not 3 ft. around the entirety of this so-called “containment basin.” A dike is only as effective as its wall’s lowest point. There appears to be no wall around portions of this basin, even a year after the Dept. of Health’s meeting with Murex Petroleum.

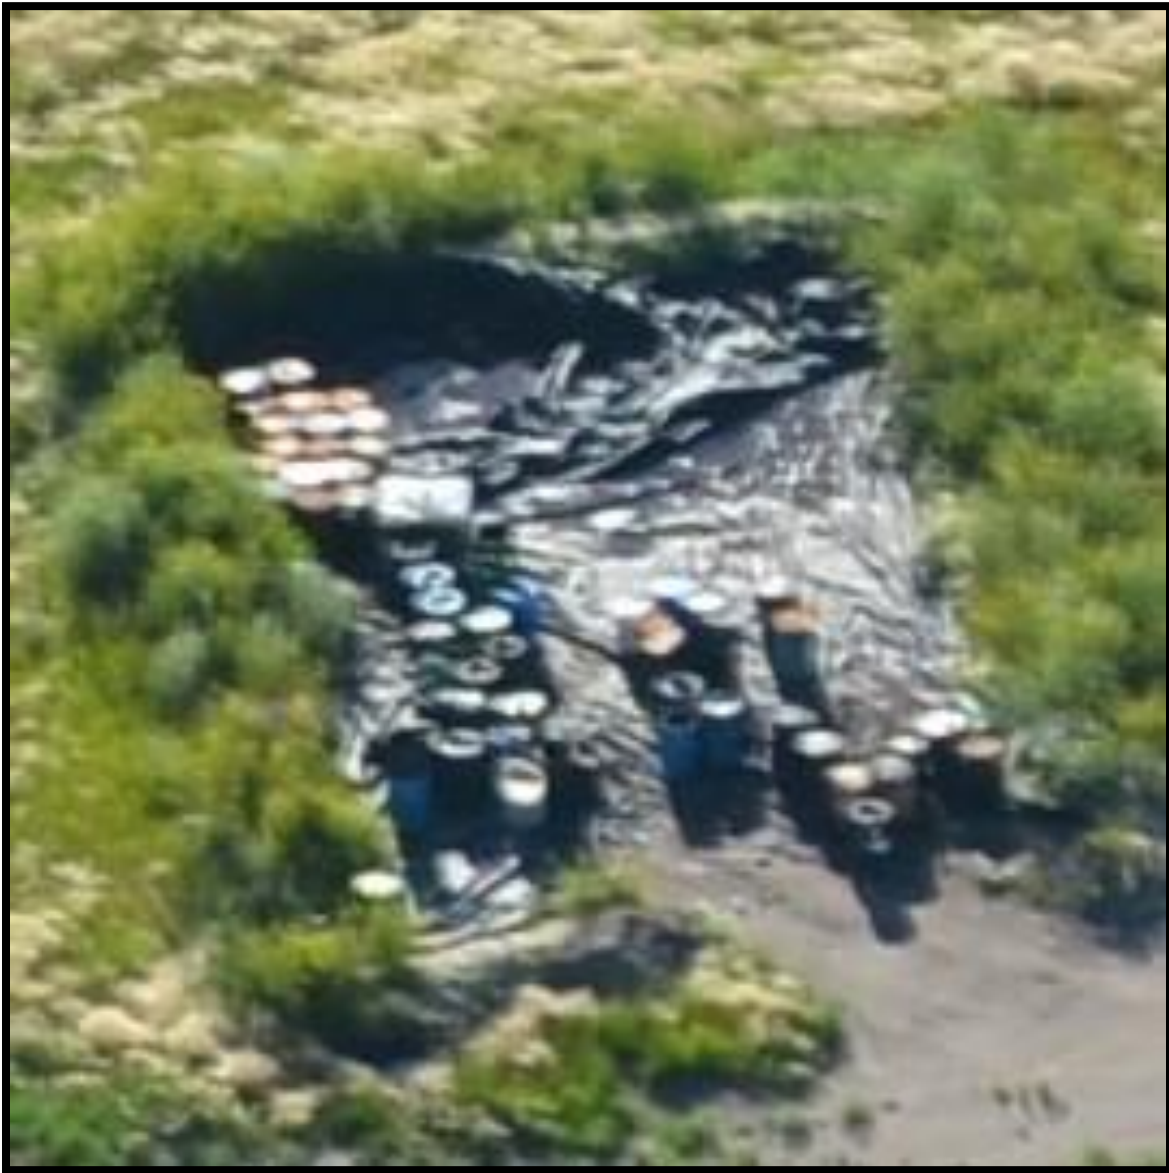
Figure 3 – “Containment Basin” with defective dike - 2016

This photo was taken more than a year after the 2015 inspection. Note that the “dike” does not extend all the way around this unauthorized hazardous waste storage pit. The dike appears to have collapsed in the upper right corner, and there is no wall where the basin connects to the rest of the unlined storage site. As stated above, the inspector found “oil, rags, diapers, and other waste from wells,” in these barrels; so it is possible that such hazardous oilfield wastes are still being improperly and illegally stored at this Murex Petroleum storage site.

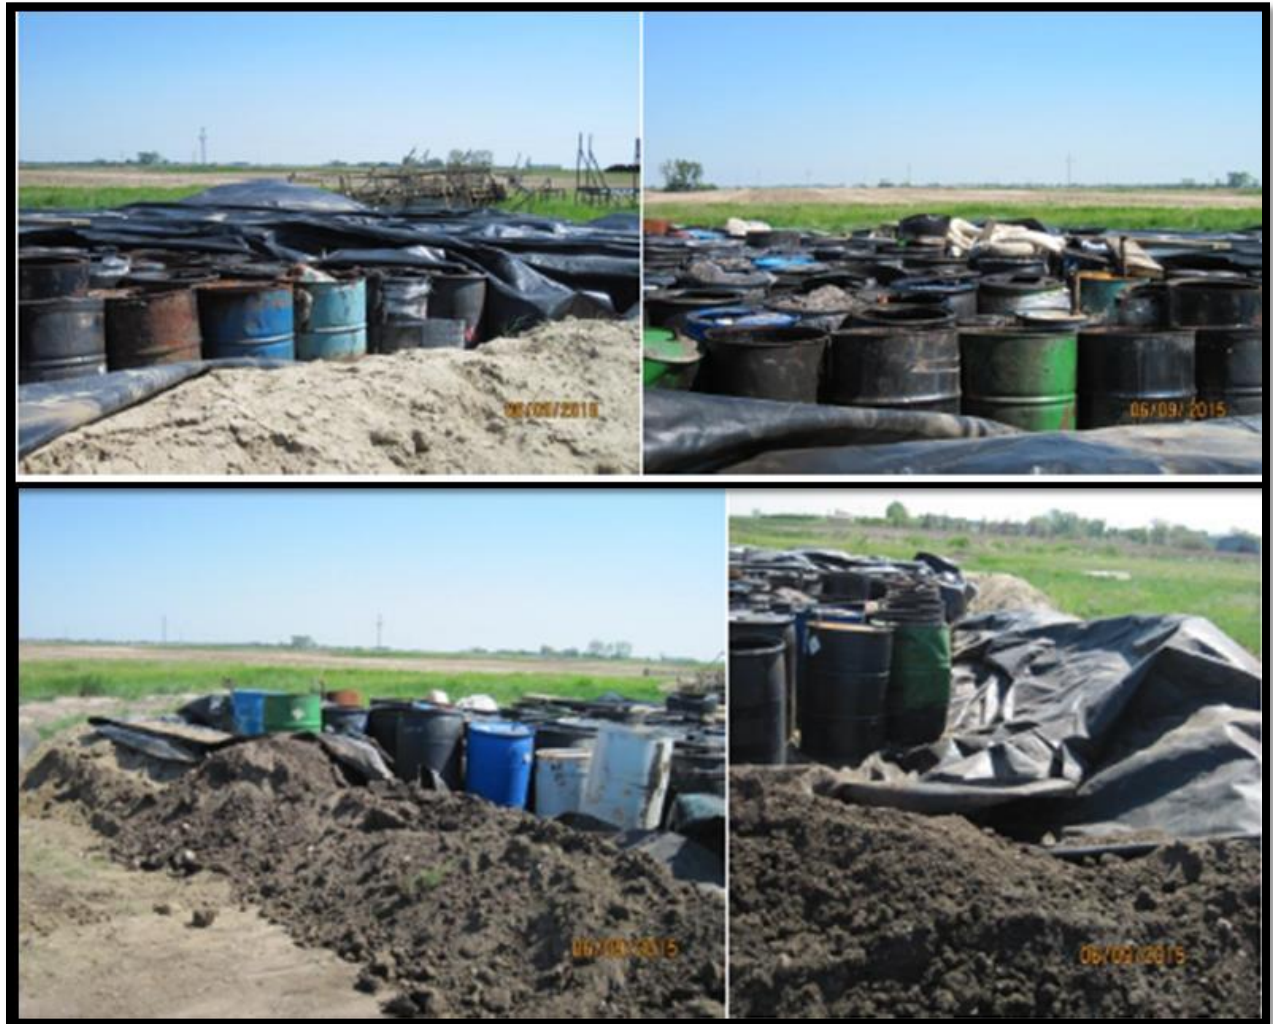
Figure 4 - DoH inspector’s 2015 photographs of basin’s plastic “lining” -2015 photo

ND DoH inspector statement in 2015: *“The basin is lined with plastic liner.”*

A plastic liner is only effective if it is installed and maintained properly. An effective plastic lining would be tightly secured throughout the entire area in which hazardous wastes are stored. The lining should also cover the basin walls completely – to both prevent erosion of the dike’s dirt walls and to prevent contamination of that soil by the materials stored within the dike in the event of a leak or spill.

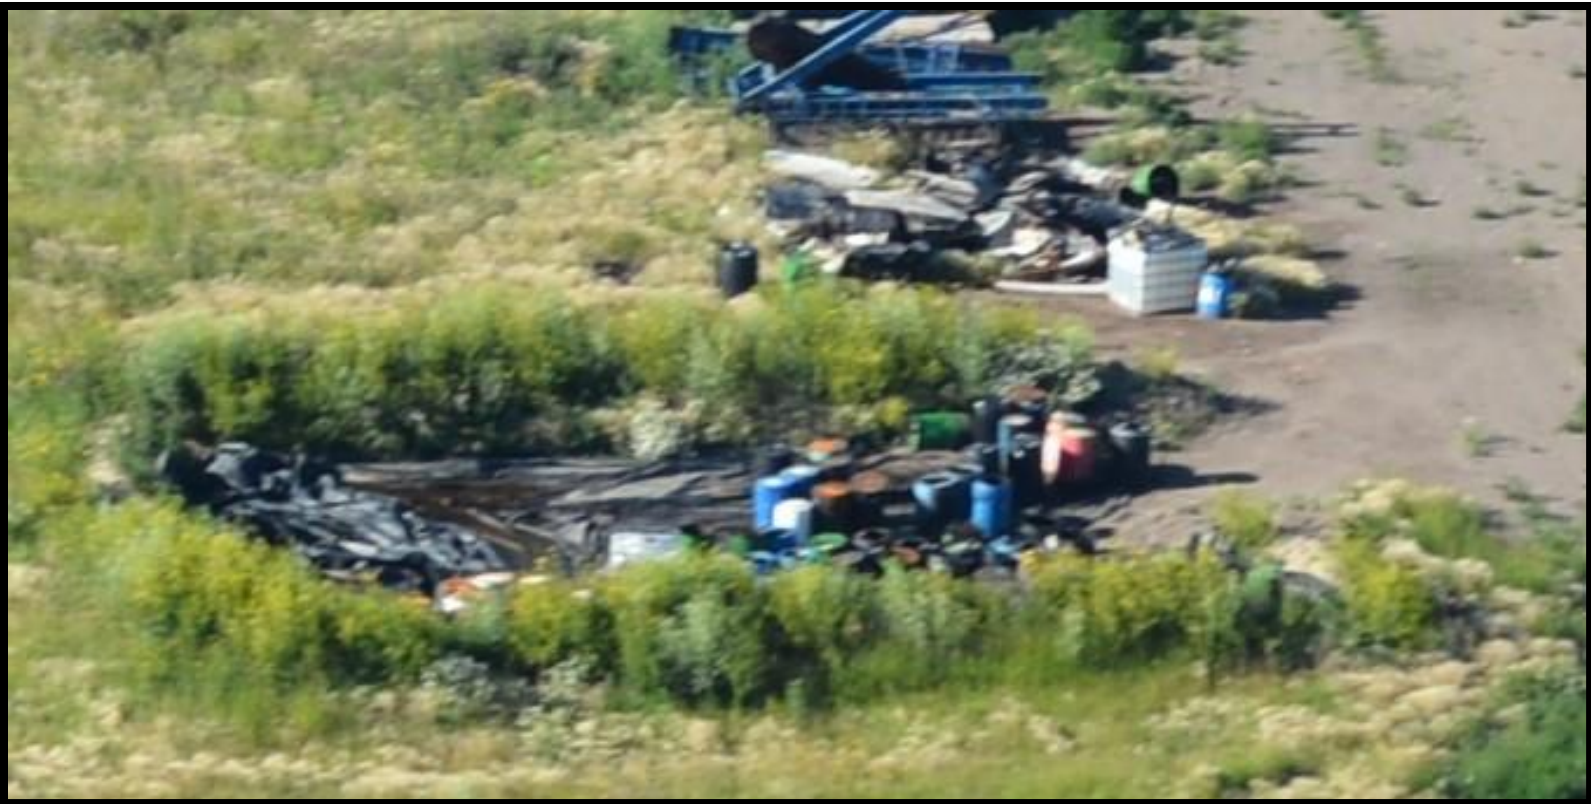
Figure 5 – Basin containing liquid and tanks of oilfield waste materials - 2016

As shown above, there is liquid and barrels in this basin as of July 18, 2016 - more than a year after Murex Petroleum was told to remove liquid from this basin containing hazardous oilfield wastes. It is unknown whether Murex did *“suck out all of the liquid from the basin”* and take it to Clean Harbors, as promised. Regardless, more liquid has accumulated, and barrels are still there. It appears that not all of the barrels were *“mixed on site with fly ash in a roll off”* and taken to Clean Harbors, as promised in the inspector’s June 2015 memo.

All waste generated from oil exploration and production is to be disposed of immediately at an **authorized facility**, as required by **Administrative Code rule 43-02-03-19.2**, and storage of wastes can only be stored in earthen pits or receptacles like this one in an **emergency**.

This site is in violation of the above rules since this is not an authorized waste disposal facility, and wastes are being stored there in an open receptacle in a non-emergency.

“Murex...will suck out all of the liquid from the basin.”

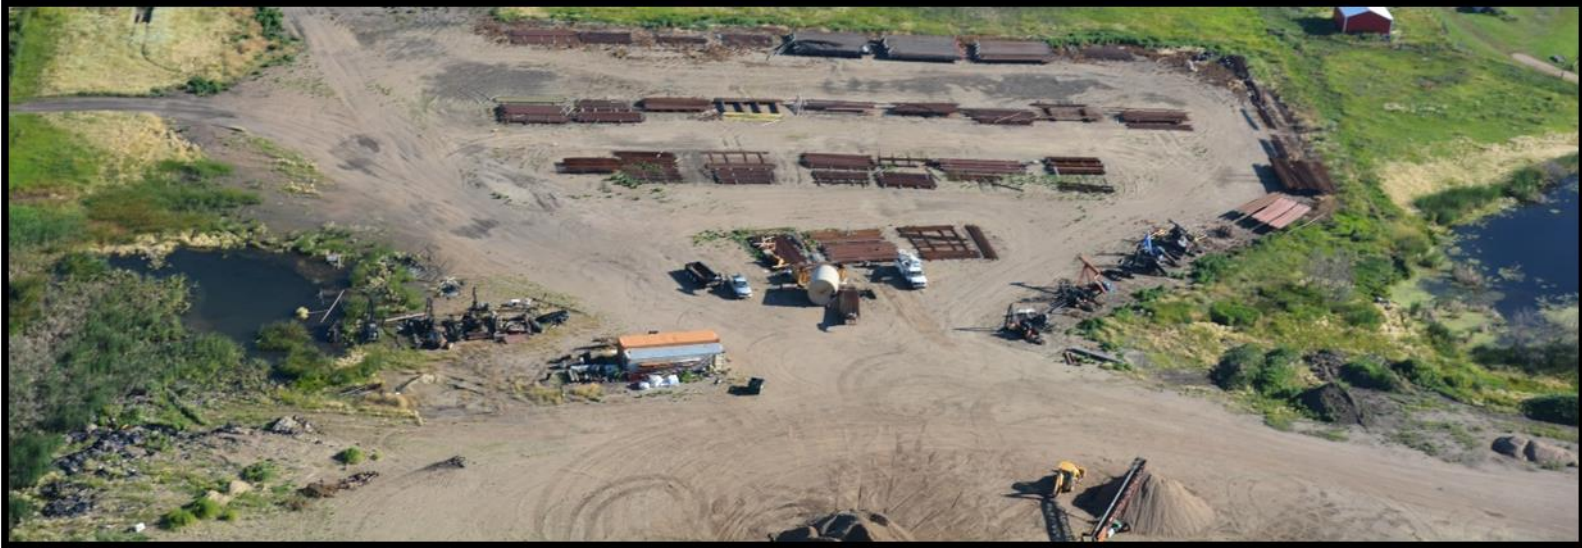
Figure 6 – Murex Petroleum Storage Site near Mohall – 2016 photographs

Note that there is no perimeter berm around this storage site, which is doubling as a hazardous waste site as previously shown. Thus, there is nothing preventing contaminated runoff from spreading off-site, as the standing water shows.

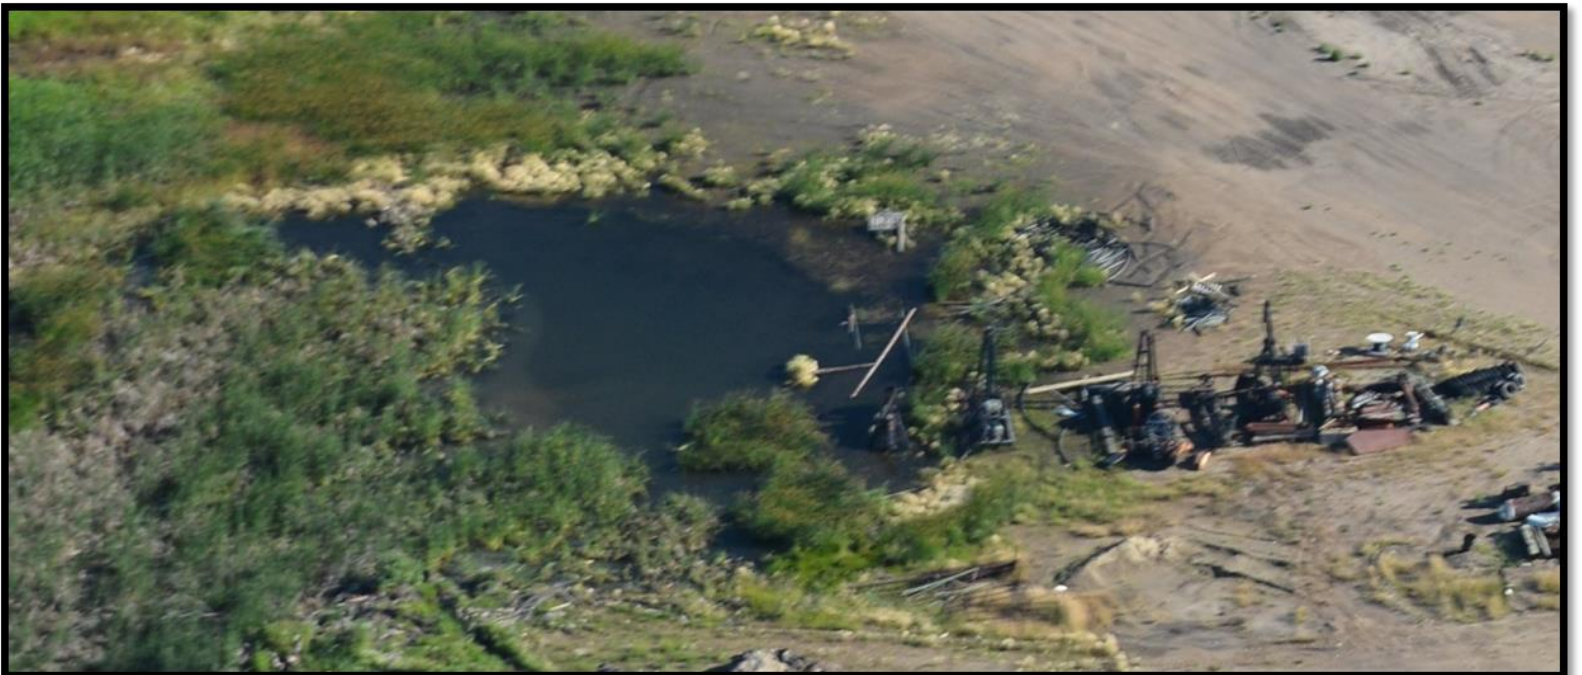
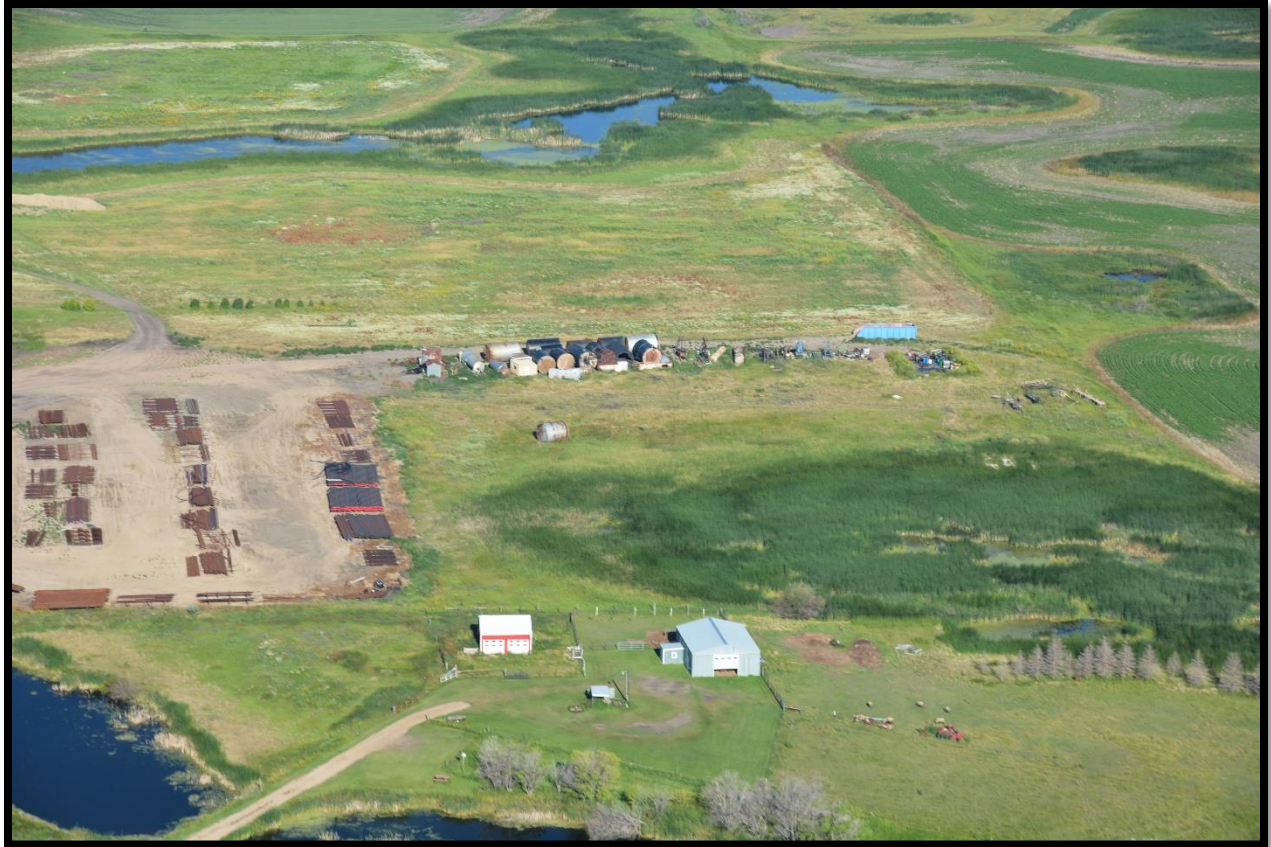
Note the numerous tanks and barrels, whose contents have been hazardous - according to the Dept. of Health inspector. Note the close proximity to naturally-occurring fresh water (the wetland to the lower right and the creek in the upper left). These bodies of water are at risk of contamination via runoff from this storage-turned-waste disposal site.

The lack of a perimeter berm around this site or any effective containment infrastructure within the site allows for hazardous waste fluids and consequentially contaminated runoff to spread offsite, which could potentially contaminate the surrounding soil and water.

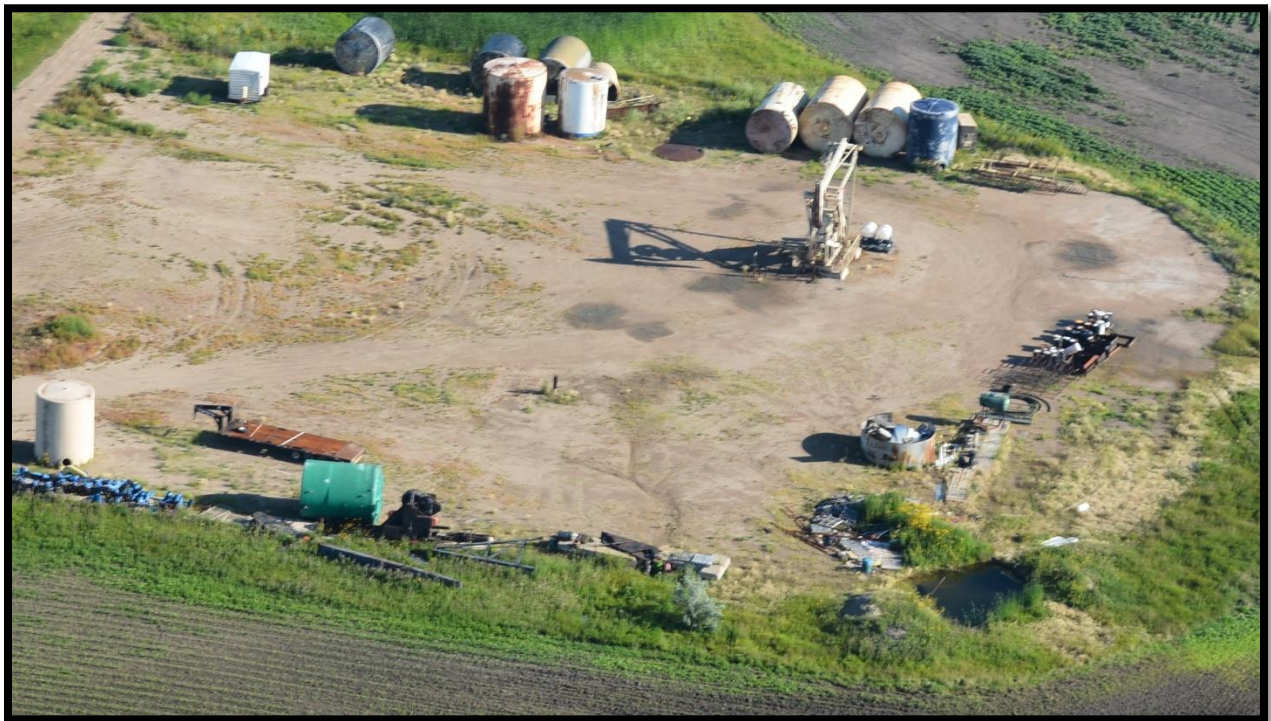
Figure 7 - Tanks at Well #15106 site -2016 photo

The Director of the Environmental Section of the ND Department of Health visited this well site in 2014. He said then that the department would follow-up and require the operator of the site to clean it up. These photos, taken July 18th 2016, show that this site has still not been cleaned up more than a year later and remains out of compliance with administrative code rules.

This site is out of compliance for the following rules:

The tanks at this site appear to be in poor condition (note the rust) and may not be “**resistant to the effects of produced fluids or chemicals that may be contained therein**” – as required by rule 43-02-03-49.

As rule 43-02-03-49 states, “**unused tanks and production equipment**” are not allowed to be **stored for more than one year**.

If these tanks are being used and do contain waste, then this site is in violation of rule 43-02-03-19.2, which requires that all waste material recovered from spills, leaks, and other such events must immediately be disposed of in an authorized facility:

This is not an authorized waste disposal facility. Therefore storage of the tanks and any waste contents at this site is not legal.

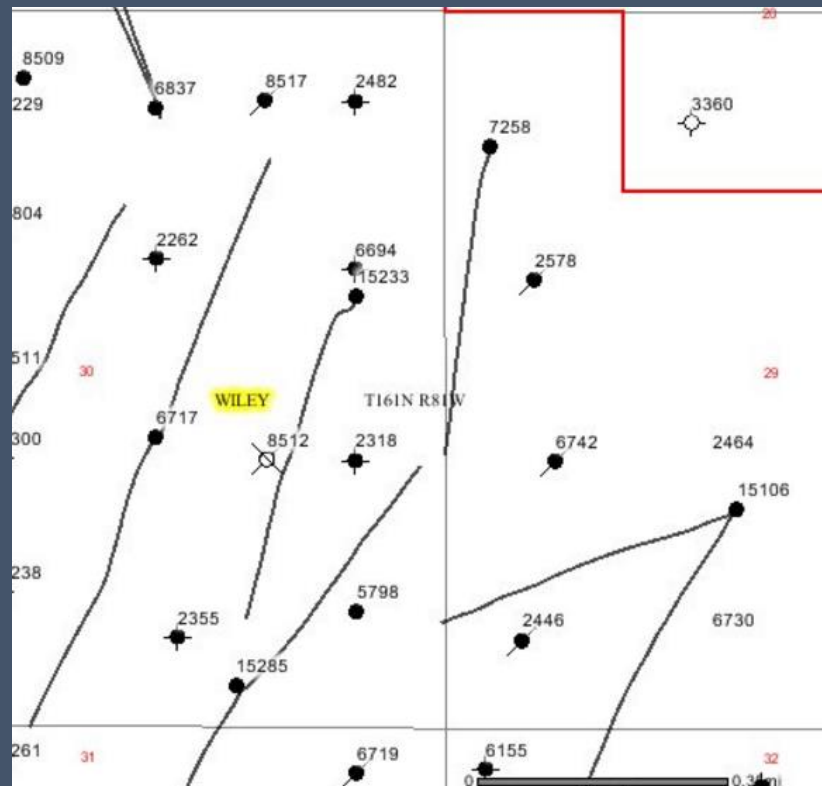
Figure 8 - Well #15106 within NESW Section 29, Township 161 Range 81 – Wiley Field

LOCATION: NESW SECTION 29, TOWNSHIP 161 RANGE 81 – WILEY FIELD

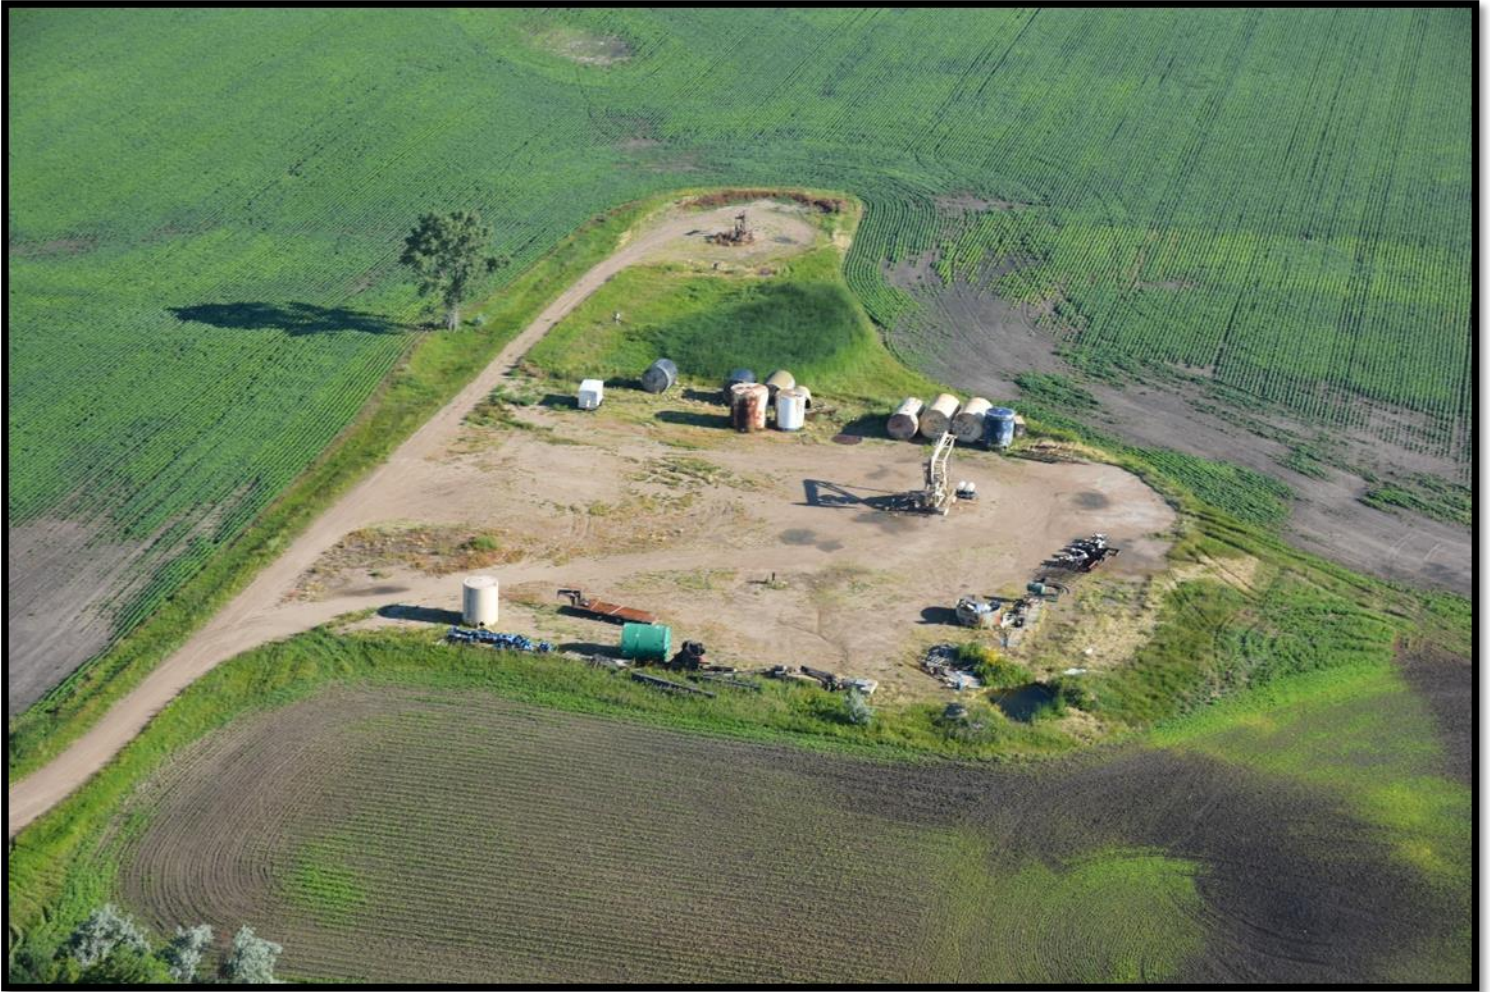
SPILL DATE: **7/6/2010**

VOLUME: **200 barrels (8,400 gallons)**

TYPE OF SPILL: **Pipeline leak**

CONTAINED TO WELL SITE: **No**

SPILL AREAL EXTENT REPORTED: **40 X 200 yards**

The report for this spill states that **all 200 barrels** of brine spilled were “vacuumed up,” yet the barren land around the well site is indicative of salt contamination.

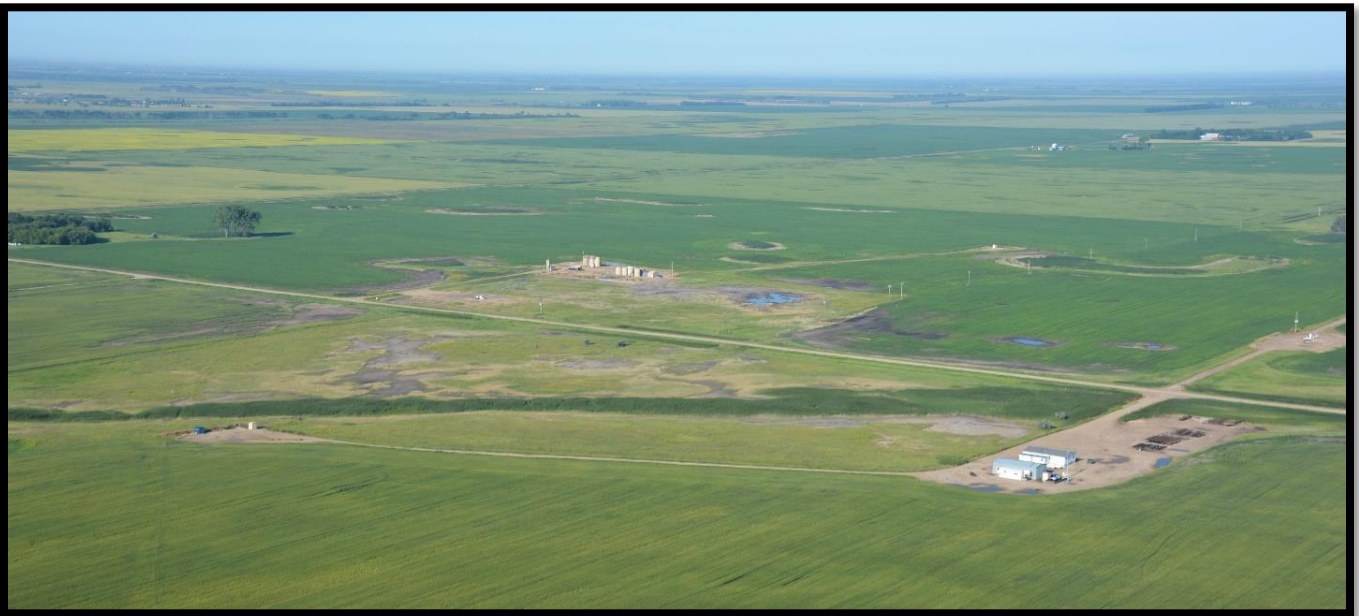
Figure 9 - Oil wells #8513 (lower left) #15288 (center) and Denbury company headquarters (lower right)

Note the barren soil emanating from well sites, in contrast to the farmland at a distance from the sites, which support robust vegetation.

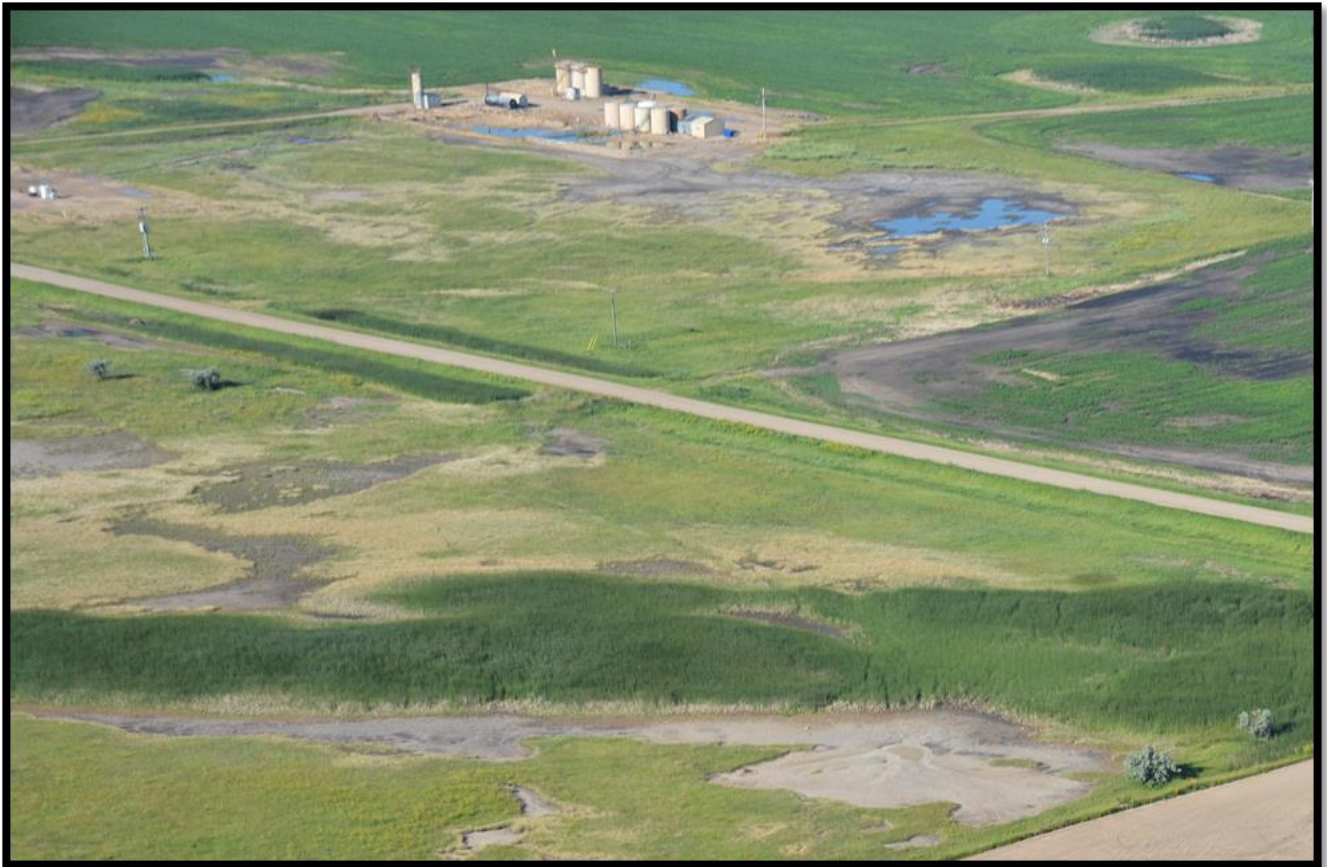
This is what 100% spill clean-up looks like?

Quickly? Sites like the one pictured above have had damage from brine spills for years. There are legacy spills at this location that Department of Mineral Resources and the Department of Health are well aware of, but are unwilling to address.

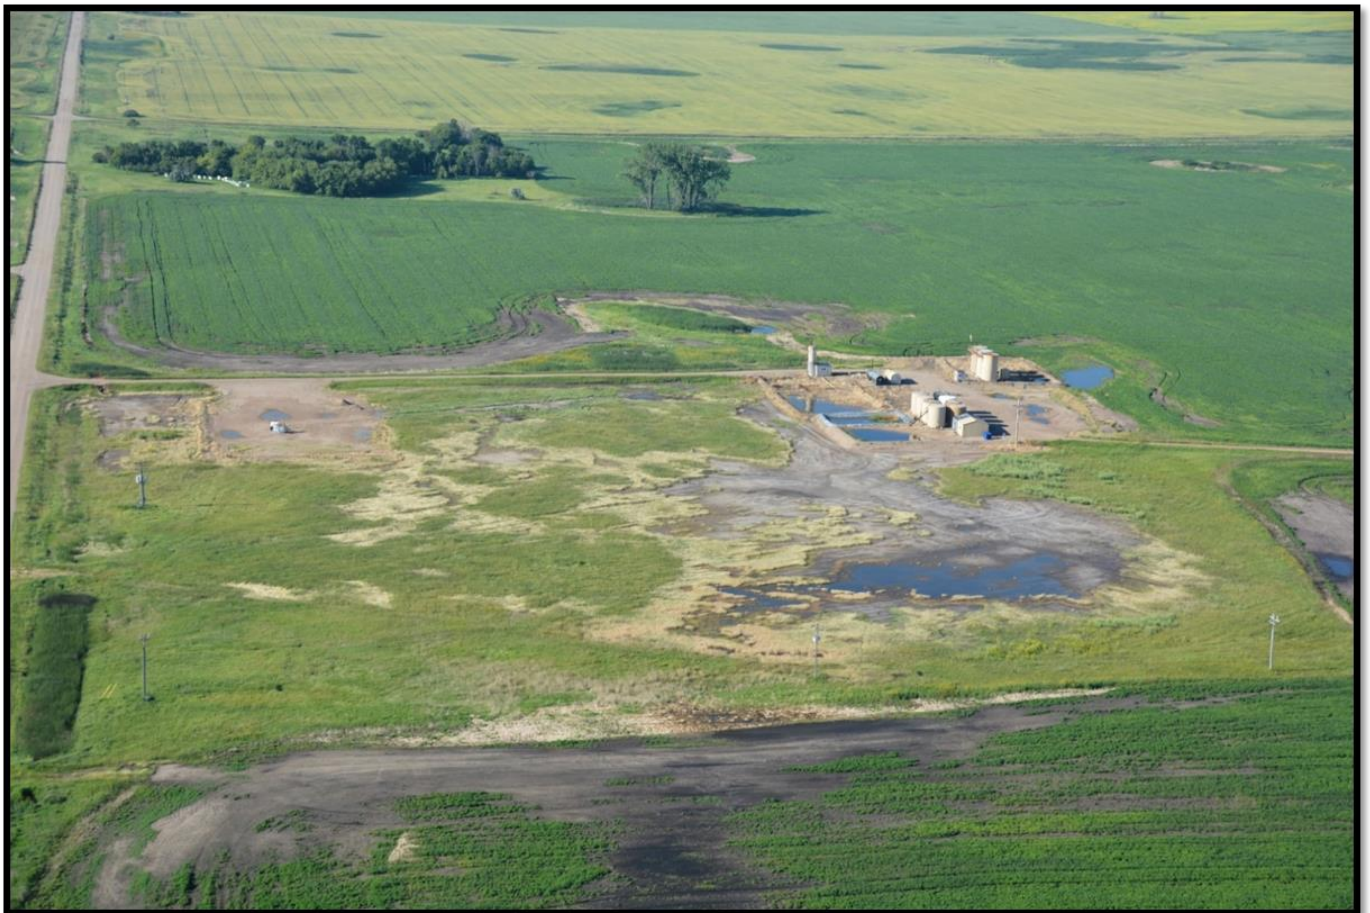
Well #15288 - Note the barren soil emanating from the well site. Duke University took water samples from standing water in the road ditch (far left hand side).

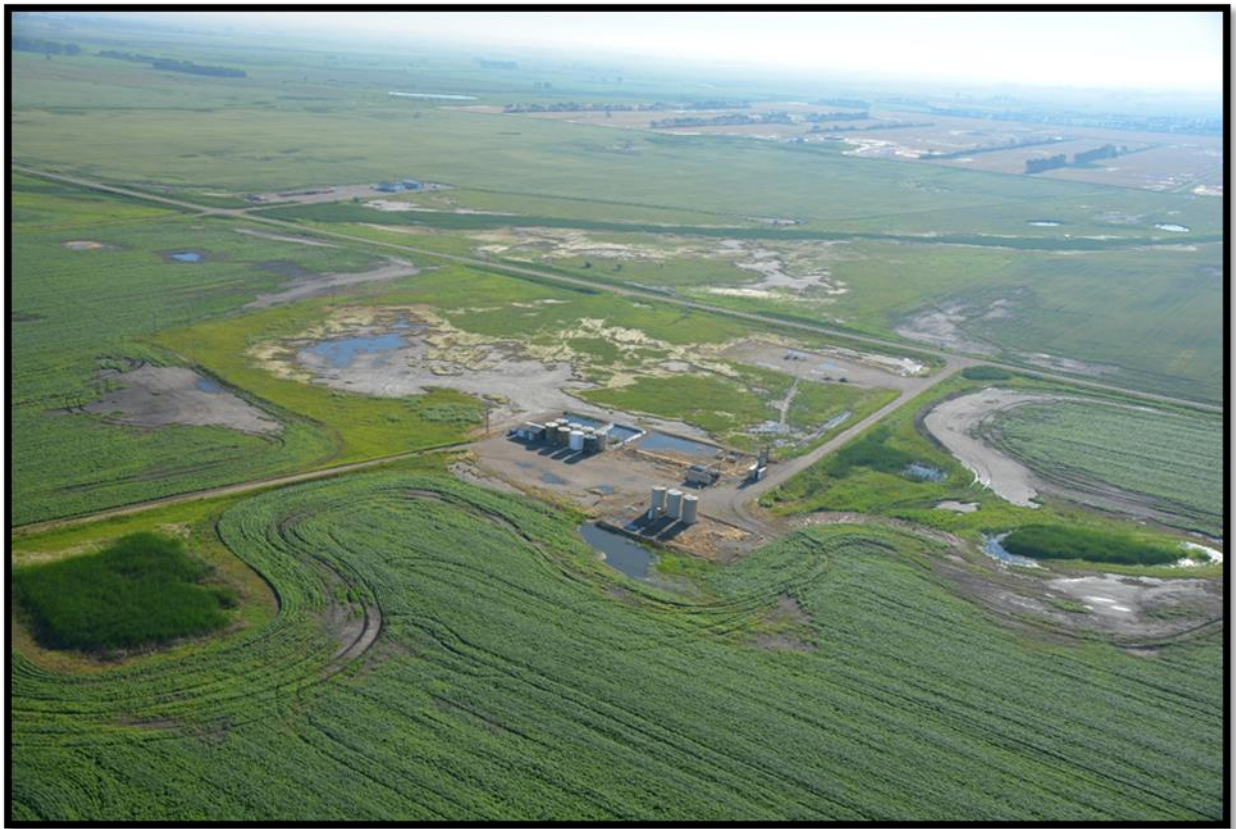
Figure 11 – Well # 15288

Note the barren soil encroaching on the edge of the adjacent farmland. Note the standing water on location in the open pits. It is unknown whether those pits contain hazardous waste.

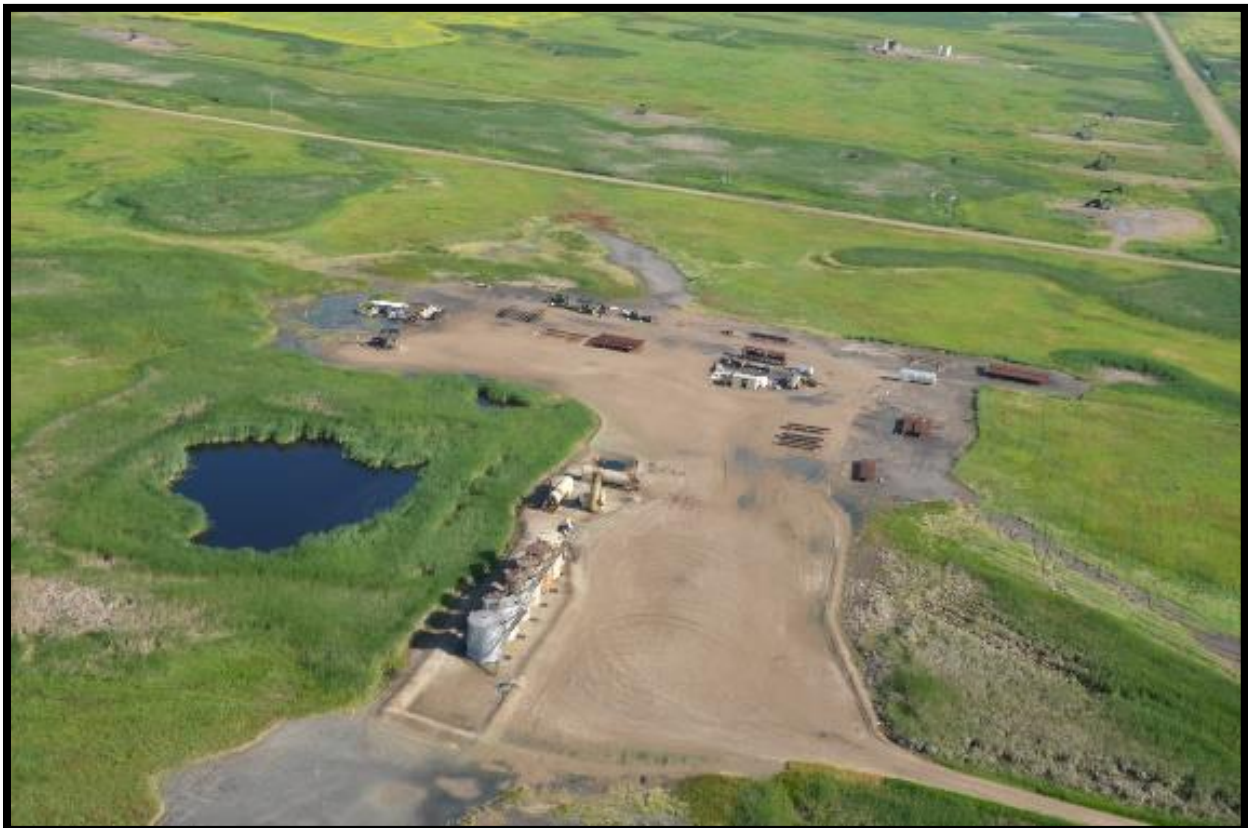
Figure 12 – Oil Well #1431 and plugged SWD Well #90035 - 2015 Photograph

Barrels at this location contain oil and other contaminated oilfield waste (soil, gravel).

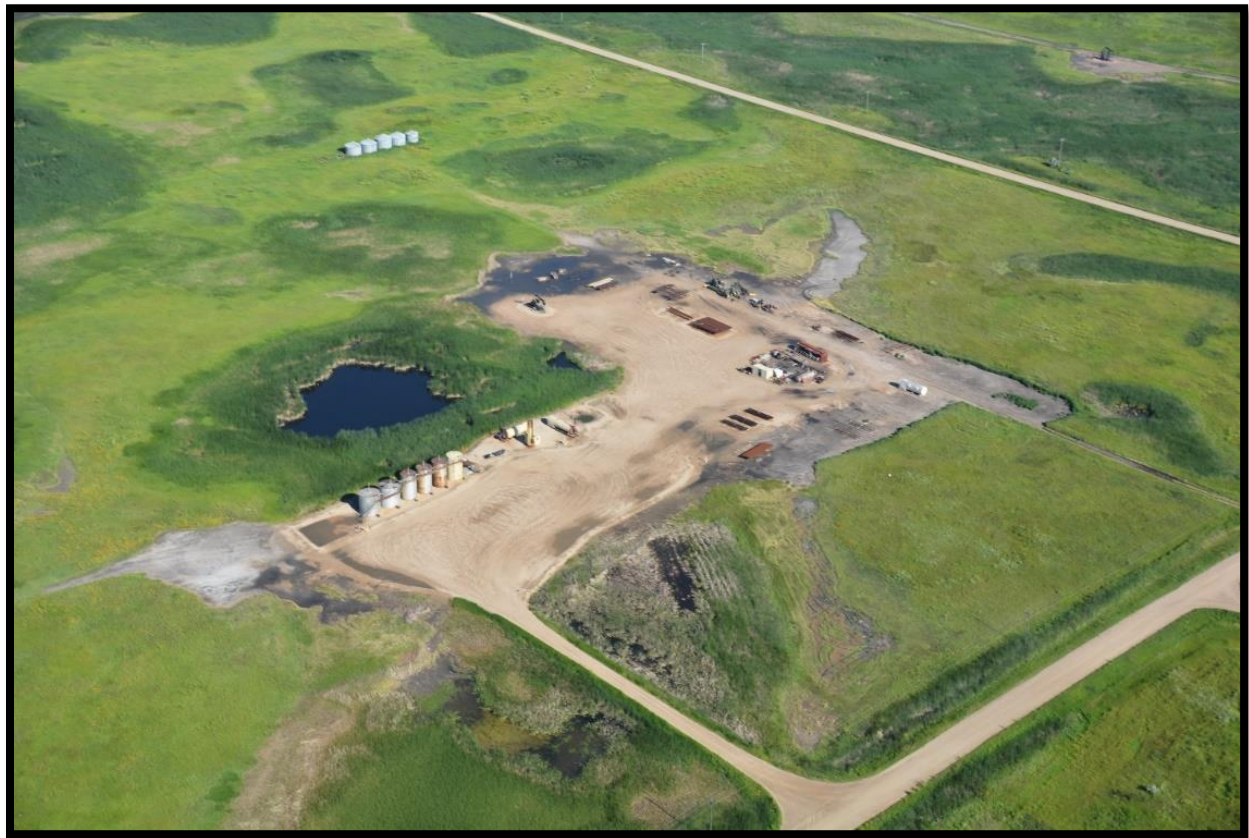
Figure 13 – Oil Well #1431 and SWD Well #90035 – 2016 photograph

Note the barren soil and white crust, both signs of high concentrations of salt in the soil, emanating from the well site.

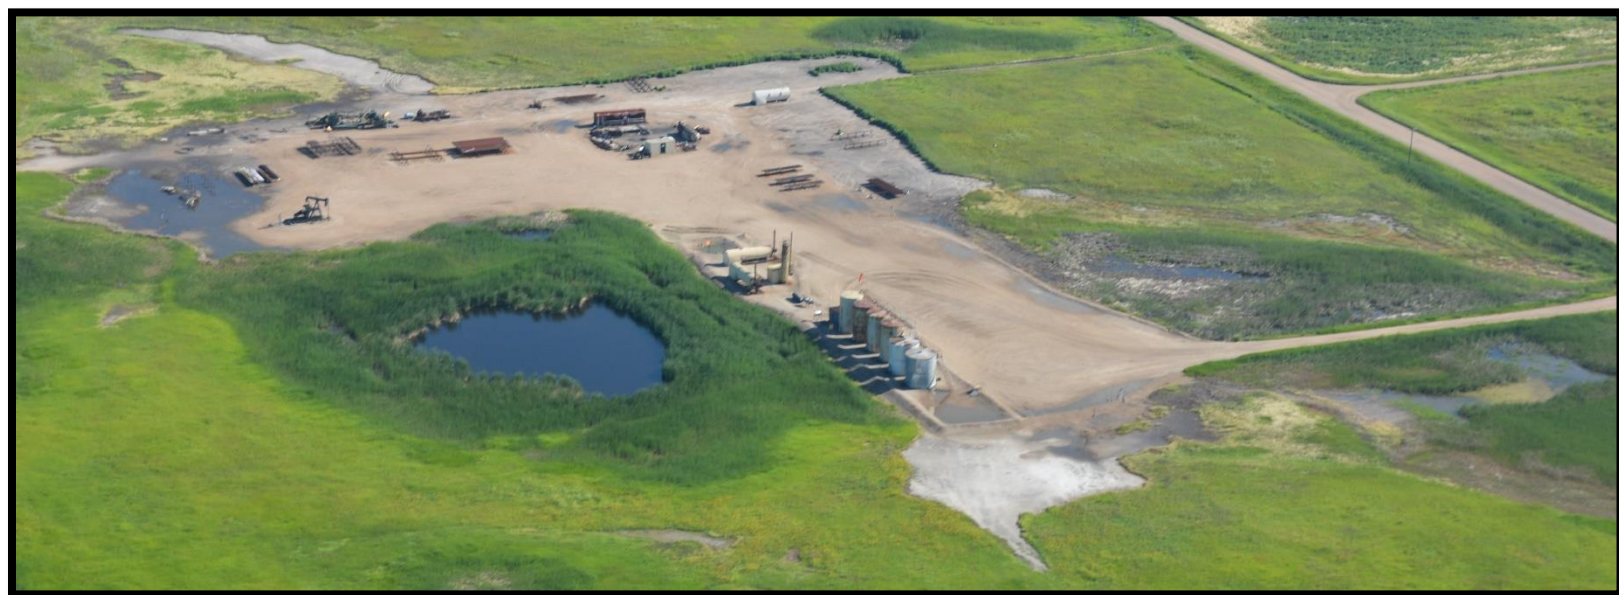
Note this site's lack of infrastructure to prevent runoff from contaminating surrounding soil and water, despite the site's close proximity to a pothole wetland.
