# Impacts of Brine on Soil and Vegetation in the Bakken Region of Western North Dakota Hannah Tomlinson, Aaron Klaustermeier, Ryan Limb, Aaron Daigh, & Kevin Sedivec

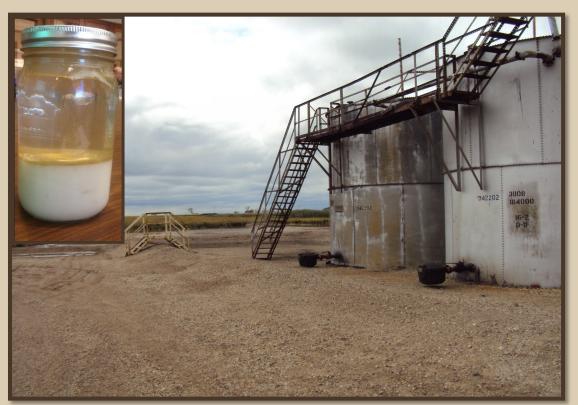
Fig. 3a: Non-reclaimed brine spill site near Bentinck, ND, jar of brine after five years in left-hand corner

- Sampled seven non-reclaimed brine spill sites in Bottineau and Burke County, ND, 2014 (Fig. 3a)
- Collected soil and vegetation data along transects originating from center of spill, moving outward toward the spill boundary using a 1x1 m frame (Fig. 3b)
- Collected composite soil samples at three depths (0-15,15-30, and 30-60 cm)
- Analyze soil samples for EC 1:1, EC 1:5, and Saturated Paste Extract EC (EC<sub>SE</sub>)
- Collected bulk density samples at the 0-15 cm depth
- Estimated plant cover using a modified Daubenmire (1959) cover class method
- Statistical analyses SAS 9.3

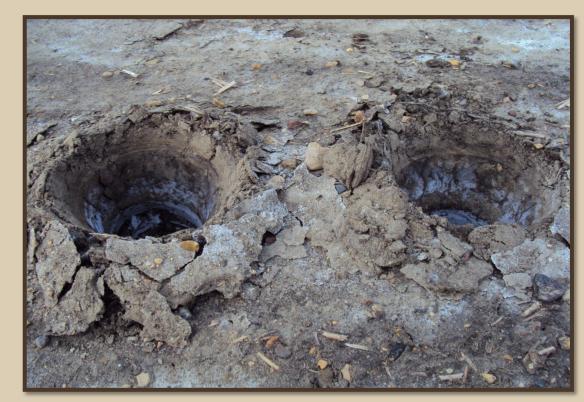
Fig. 6: BD holes on brine spill site in western ND

- EC 1:1, EC 1:5, and EC<sub>SE</sub> were highly correlated ( $R^2 \ge 0.90$ ; p<0.05) • EC<sub>SE</sub> decline paralleled the increase in
- vegetation (p<0.05) (Fig. 4)
- EC<sub>SE</sub> were highest in the 0-15 cm depth • Age of spill was not a contributing factor for EC<sub>SE</sub>
- Bulk density (BD) decreased with relative distance (p<0.05) (Figs. 5 & 6) Soil compaction reduces water infiltration and restricts root growth  $(BD > 1.6 \text{ g/cm}^3)$

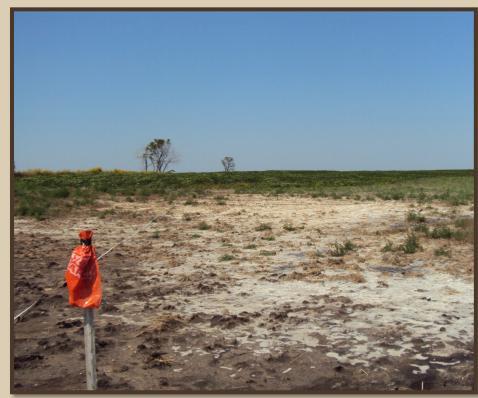
Fig. 8: Visible salt crust from brine spill in western ND

- Plant diversity and evenness were positively correlated with a decrease in  $EC_{SE}$  (p<0.05) (Fig. 7)
- Inflation of plant diversity and evenness occurred due to weedy halophytic species
- Salts decrease soil water potential energy resulting in plant root desiccation
- Salts near the soil surface reduce the number of available "safesites" for seed germination and establishment<sup>4</sup> (Fig. 8)

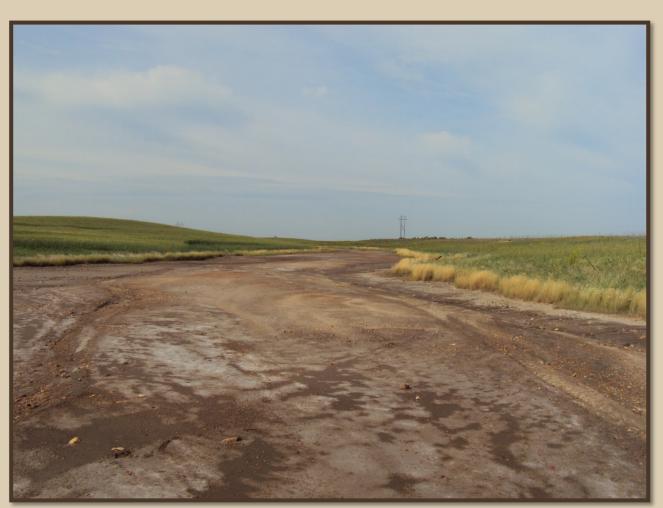
Fig. 9: 2014 photo of a 50+ year old non-reclaimed brine spill site in western ND

- successional processes (Fig. 9)
- conditions on a practical time scale
