Collection and Development Of Actionable Reclamation Data Using Aerial Remote Sensing

Contract No. G-037-73

Final Report

Mark Jackson
Hell Creek Environmental LLC
15399 Cranes Mill Rd.
Canyon Lake, TX 78133

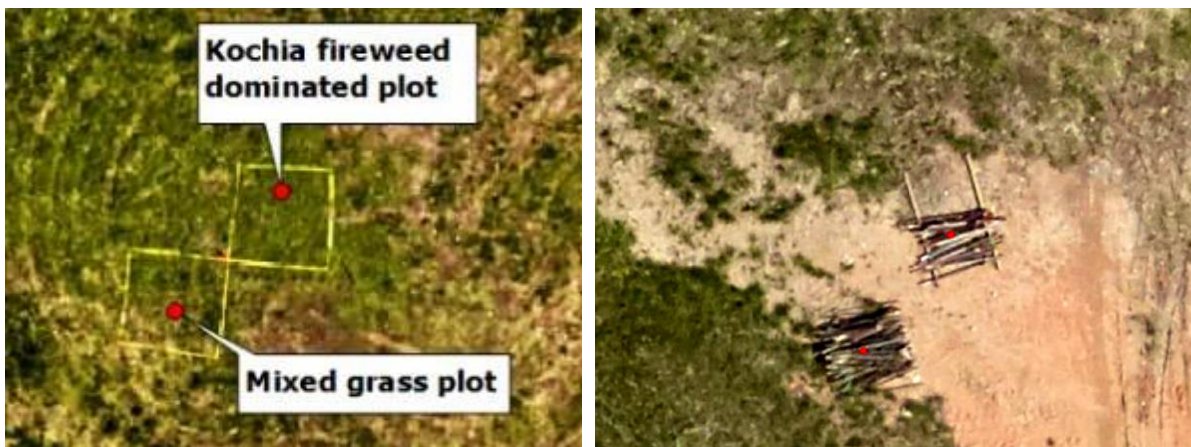
Figure 5(a): shows control plots delineating forbs from grasses before aerial survey. 5(b): shows infrastructure which was included in the sites inventory during ground truthing.

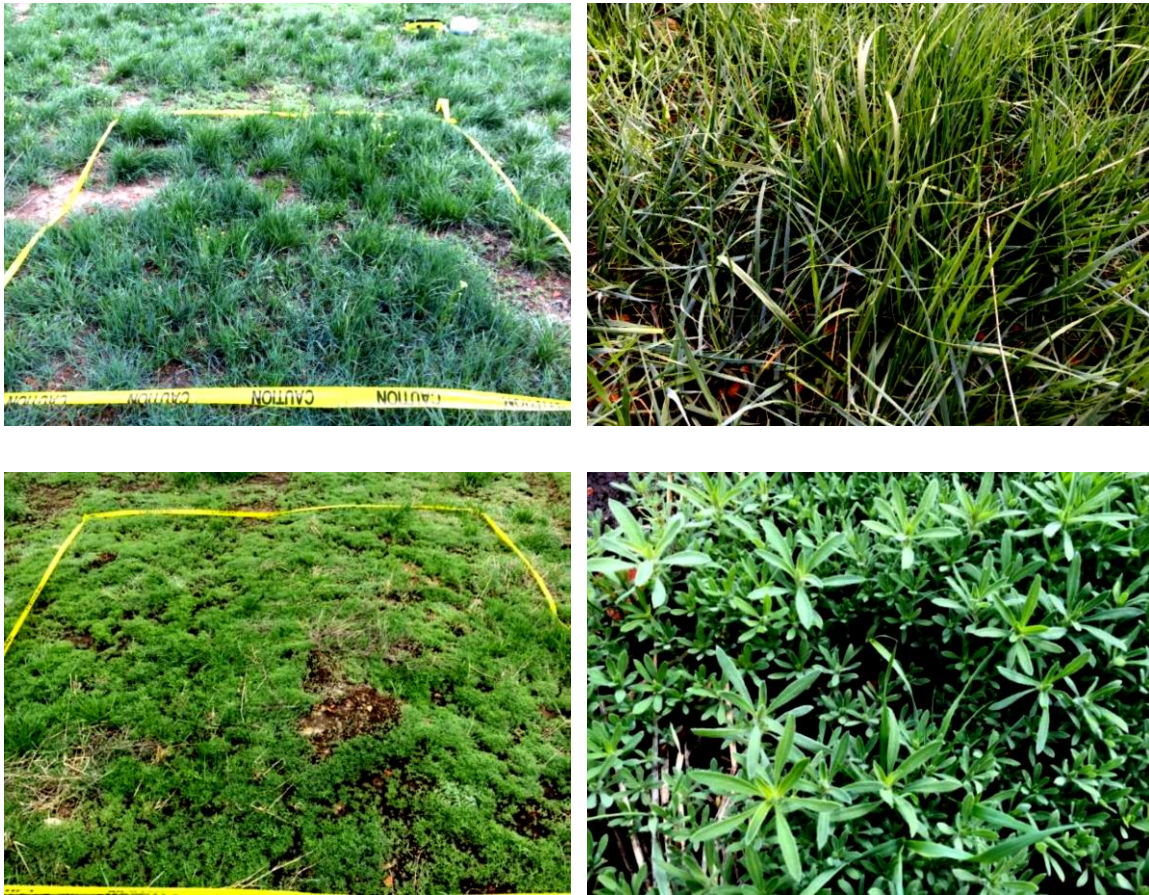
Figure 6: Needle and Wheatgrass dominated plot (top) and Kochia fireweed dominated plot (bottom).

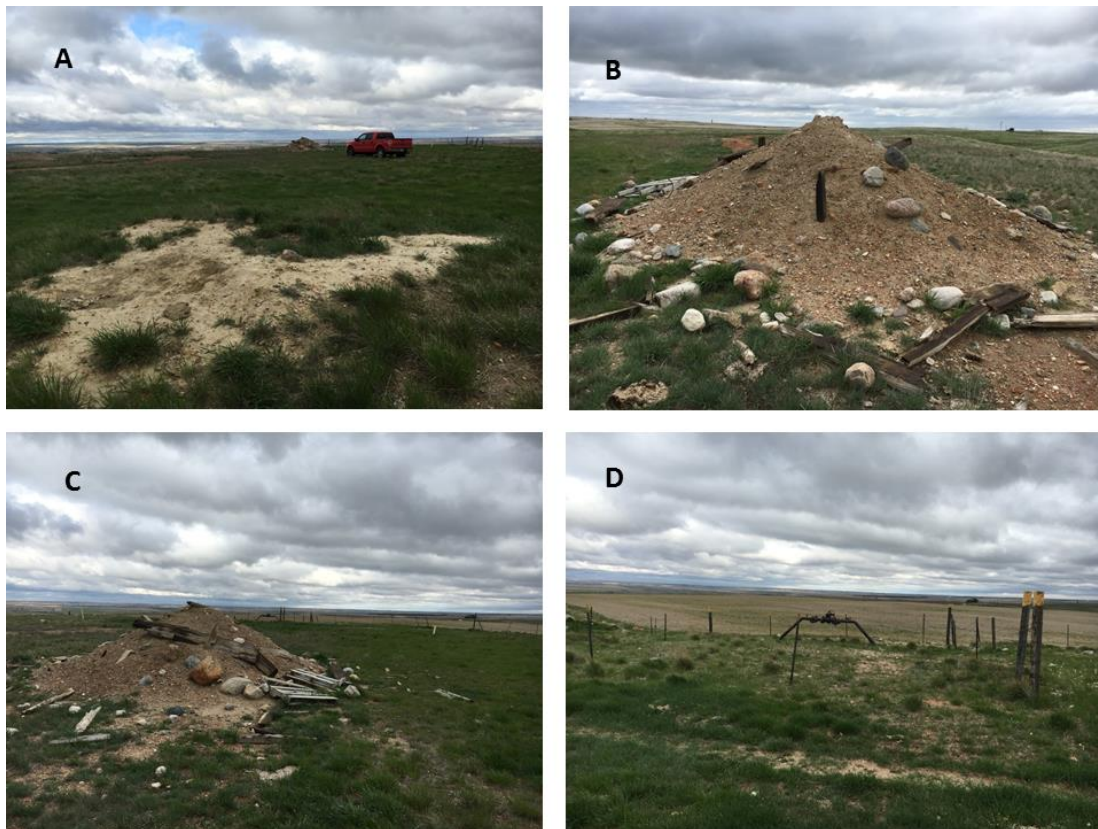
Figure 7: Persisting bare ground areas and debris refuse piles. Operational infrastructure was also inventoried at the D-306 Site for comparison with the aerial imagery.

The D-306 site scored poor in each of the three site selection grading categories. The site visit conducted before the spring 2016 flights identified the “junk” and the degraded state of the ground cover which indicates the lack of any reclamation. Bare spots (A) were present throughout both the pad area inside and outside the site boundary. These areas contained scoria base cover and fine silts with a white hue. The debris pile (B/C) contained large stones, wood debris, a pallet, and a variety of sands and gravel. The pipeline riser (D) is active infrastructure but was inventoried to be used for an imagery inspection point of reference. The access road was still present and was likely being used to access the pipeline infrastructure.

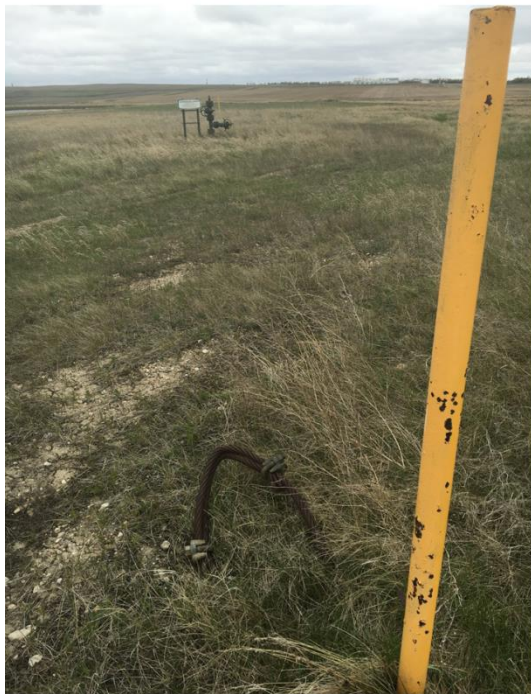
which provided infrastructure of known dimensions. Ground truthing further identified other infrastructure such as the rig anchors and associated markers. Three of the four rig anchors were still installed at the site. Cones were placed at the three anchor and measurements were taken between each to ground truth the accuracy of the aerial imagery. The measurements between the actual distance and the distance measured in the geospatial platform were within three inches. The rig anchors and cable were 6 to 10 inches across and served as a reference for the actual 3 cm imagery and the ability to see sub 10 cm objects. The vegetation was well established but the actual base cover was greater than 30 percent residual scoria and gravel. This photo, taken during the site visit, shows these features as well as the vegetative state of the pad.

Figure 8: Wellhead and above grade infrastructure, including the cable, rig anchors, and postings.

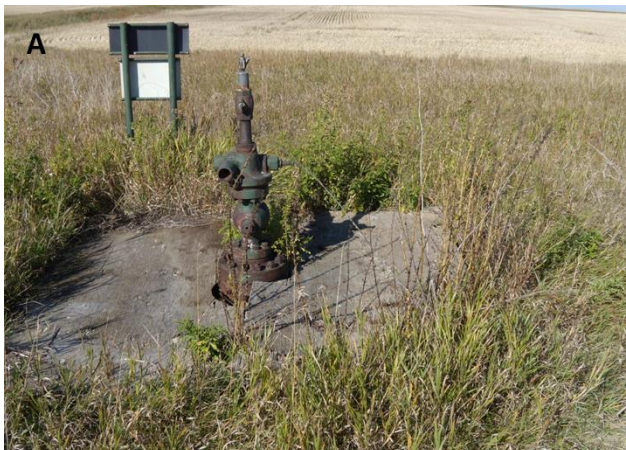
Figure 10: TMU F-144 residual infrastructure ranging from the wellhead to rig anchors. Overall the site was in good vegetative state and surrounding land was being used for production.

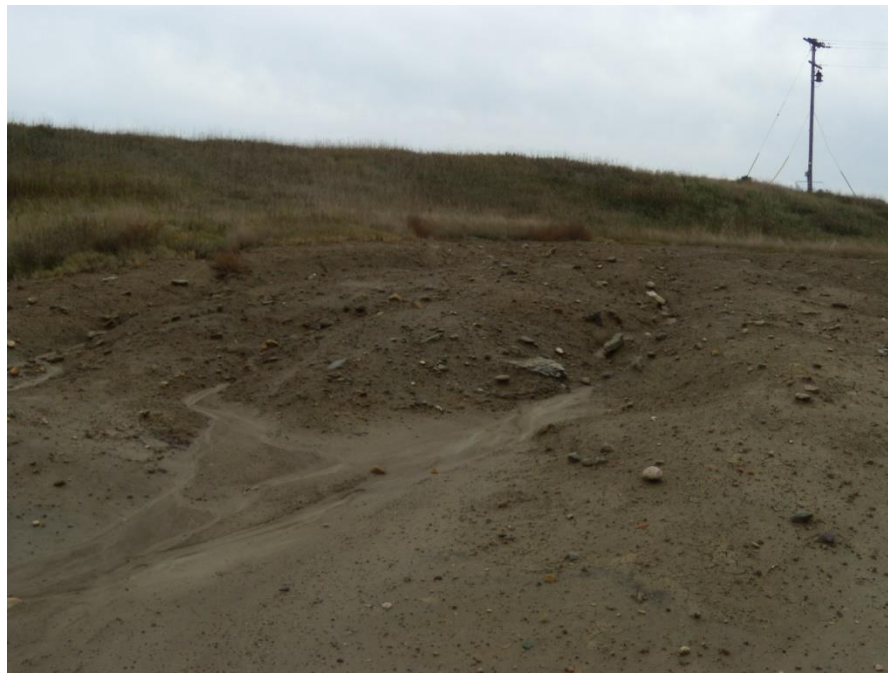
Figure 11: F-220 showing a washout feature and debris down-slope of the previous well pad.

The Blue Buttes-Madison F-220 well pad was not discernable from the surrounding terrain. A slope just off site exists but was not known if it was an engineered feature. A large washout area existed down slope to the west where vegetation was not able to be established. Debris was found in the washout of the slope indicating that there may have been a buried pit at one time which is now being exposed by erosion.

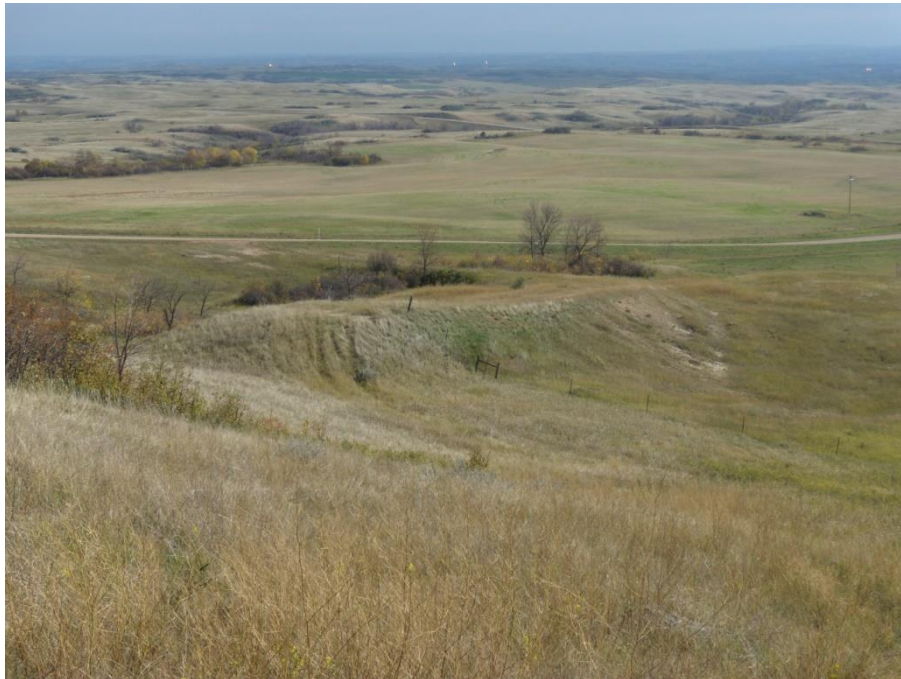
Figure 12: F-429 was considered a candidate for release from bond due to the recovery of the site in ecological terms. The remaining access road feature was the last consideration in terms of reclamation.

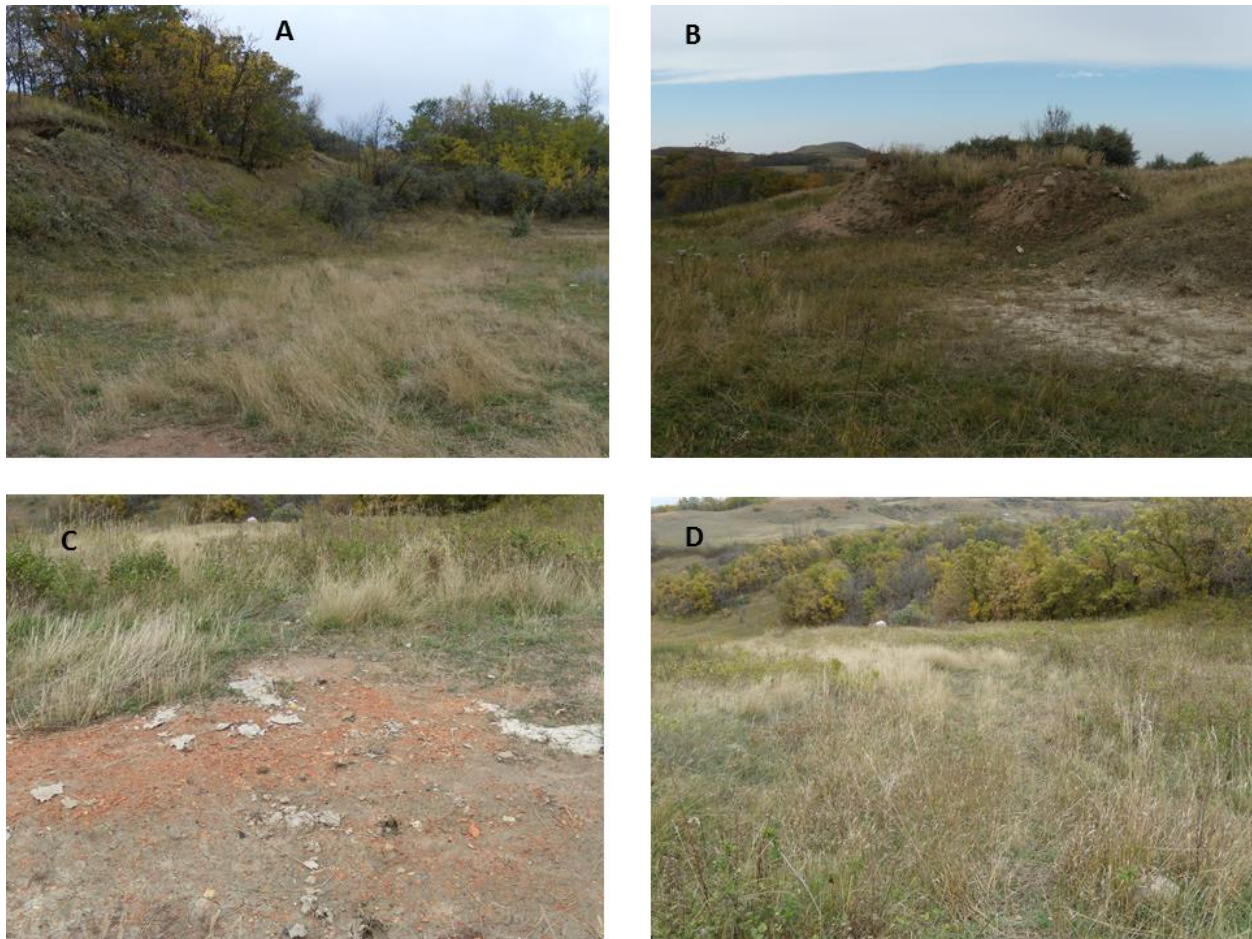
Figure 13: G-316 shows excavation features and residual scoria and gravel base. The slope was clearly altered and not returned to the native contouring.

The Blue Buttes-Madison G-316 site represents a common situation where reclamation activity has not been conducted but the surrounding ecology has encroached into the pad boundary over time. Reestablishment of vegetation is progressing on surface soils dominated by residual scoria and gravel pad and road base (Figure 13-C). The access road to the former pad location was very unstable, rutted due to running water, and degraded (Figure 13-D).

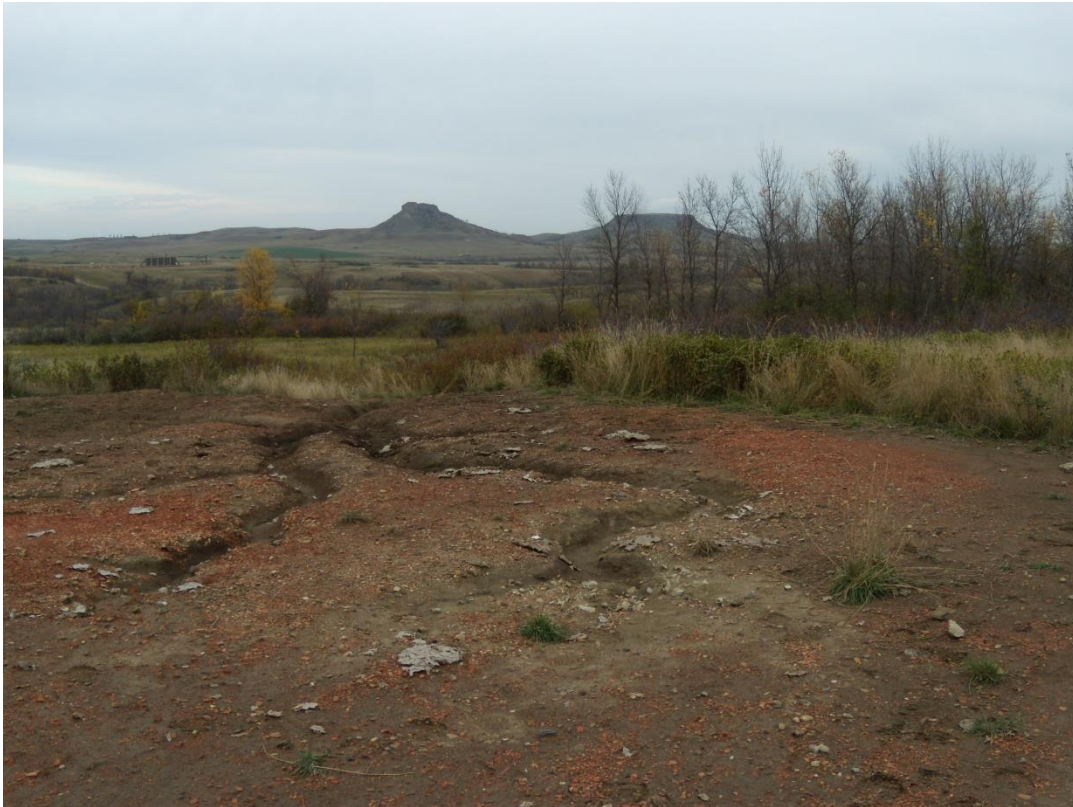
Figure 14: The H-408 is essentially without reclamation with the original scoria pad remaining.

The H-408 site was plugged and abandoned but the scoria pad and contouring still remain. The level pad is causing pooling on the site and eventual spill-over and runoff is eroding the northeastern edge of the pad. This site is a good example of how if an operating pad or a bare spot left after a pipeline is installed can have erosion that incises the landscape and headward erosion moving up slope can eventually expose infrastructure to be left to the elements and or damage by cattle and range animals. This photo shows the erosion features as a preferential path for cattle migration due to the presence of excrement and hove marks traversing the rills.

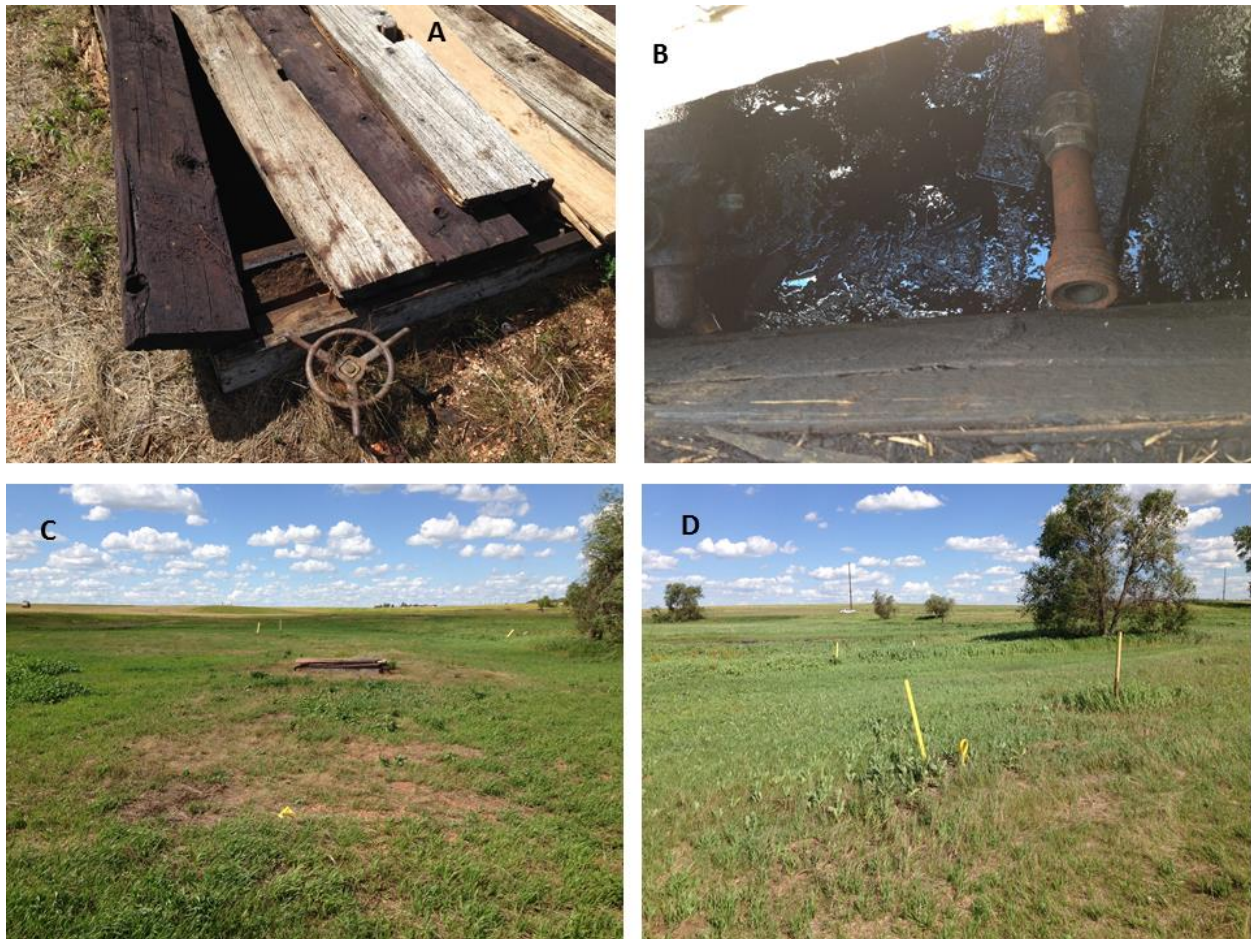
Figure 15: The N-130 with the existing well before being plugged and abandoned.

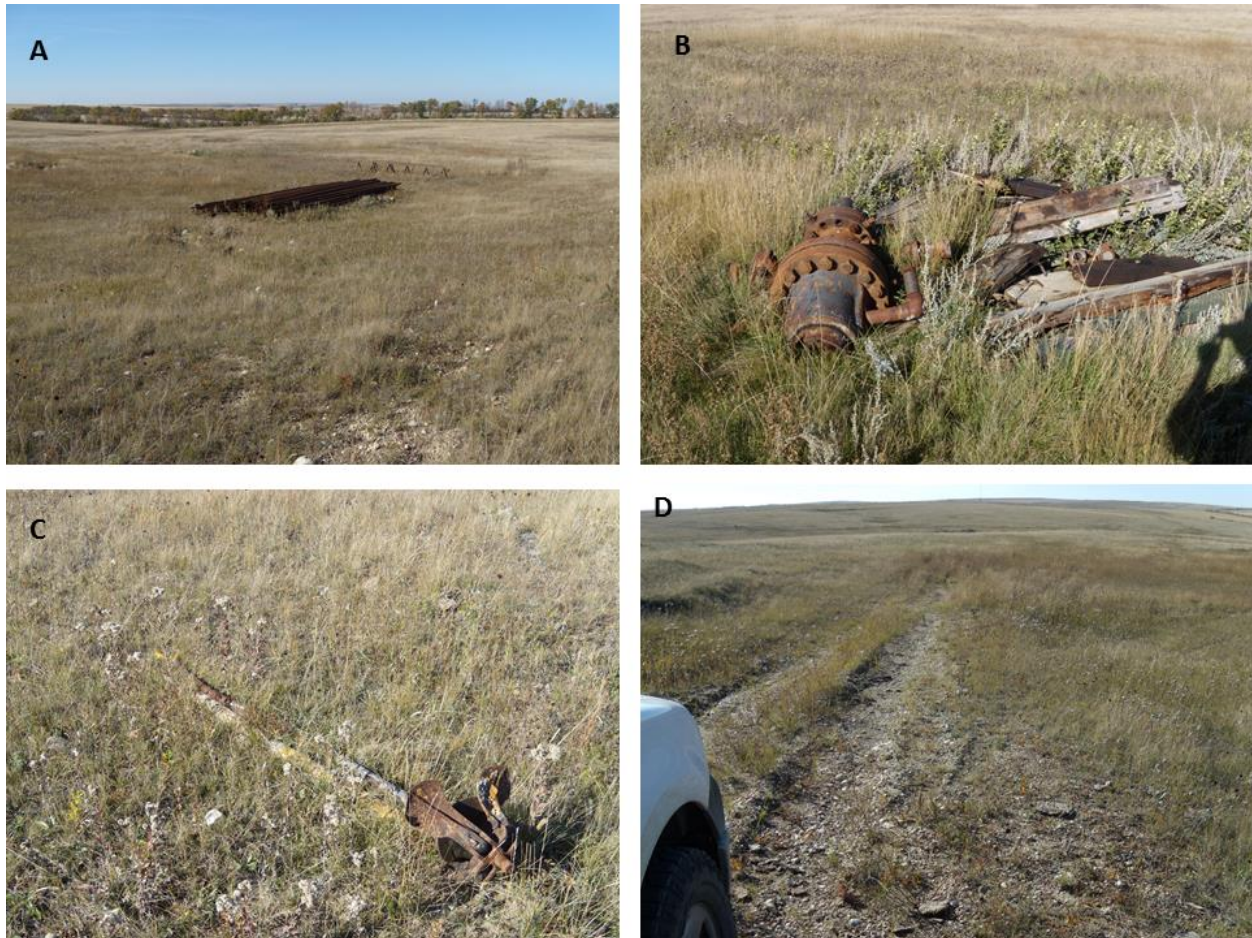
Figure 16: The N-152 showing residual infrastructure including the access road and debris piles. Vegetation was well established over most of the site and matched the ecology of the land adjacent to the former pad.

The Tioga-Madison Unit N-152 site includes the access road and old scoria/gravel base near the wellhead. Infrastructure includes multiple rig anchors which had been removed from the ground and are still laying onsite, pipe rack and pipe stands being stored on location, and the BOP and other valve tree components mingled in with debris pile. Vegetation has begun to recover but residual access road features are still present showing channeling of surface water runoff. Contouring work would need to be done to return the surface water runoff back to a native state.

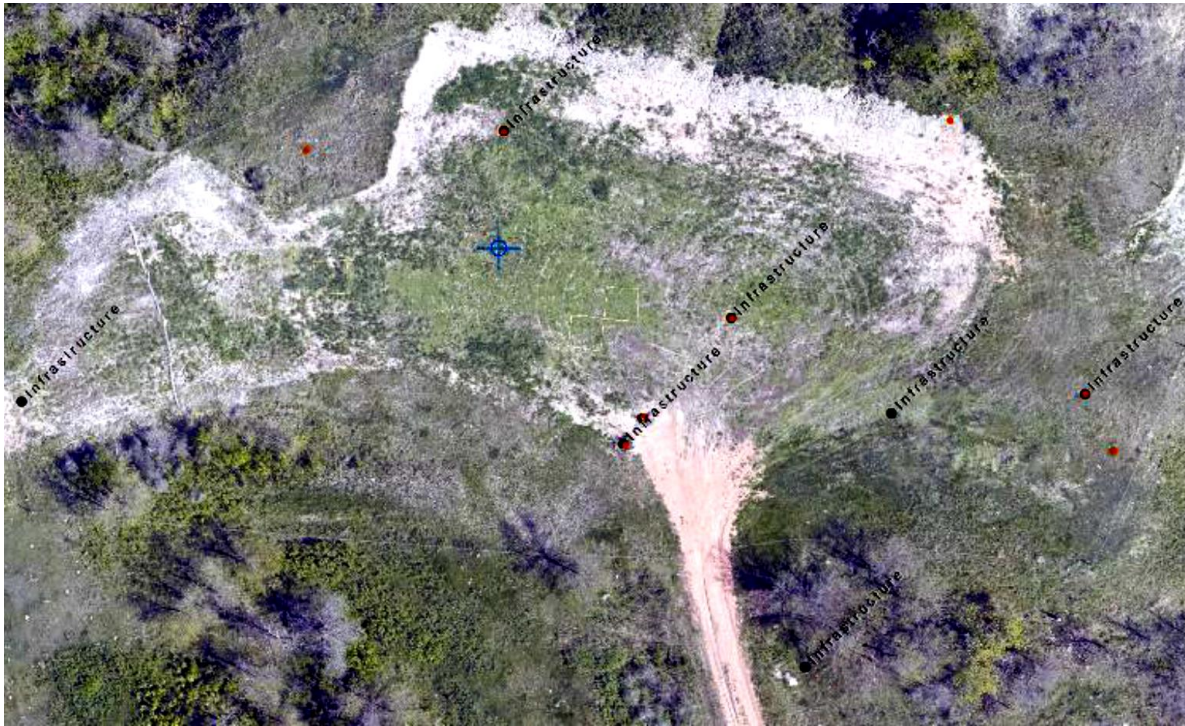
Figure 19 Comparison of results between analyst 1 (orange dots) and analyst 2 (black dots) at Blue Buttes Madison Unit E-331.

Similarly, infrastructure was identified using 3-cm, 6-cm and 10-cm resolution data. The specific features included pipes, posts, barrels, and trash. Unlike vegetation, infrastructure identification results among analysts were quite similar. Figure 7 below shows the results of infrastructure identification using 3-cm resolution imagery. As can be seen in Figure 7, most infrastructure features are accurately identified by both experienced and less experienced analysts; only a few locations are different.

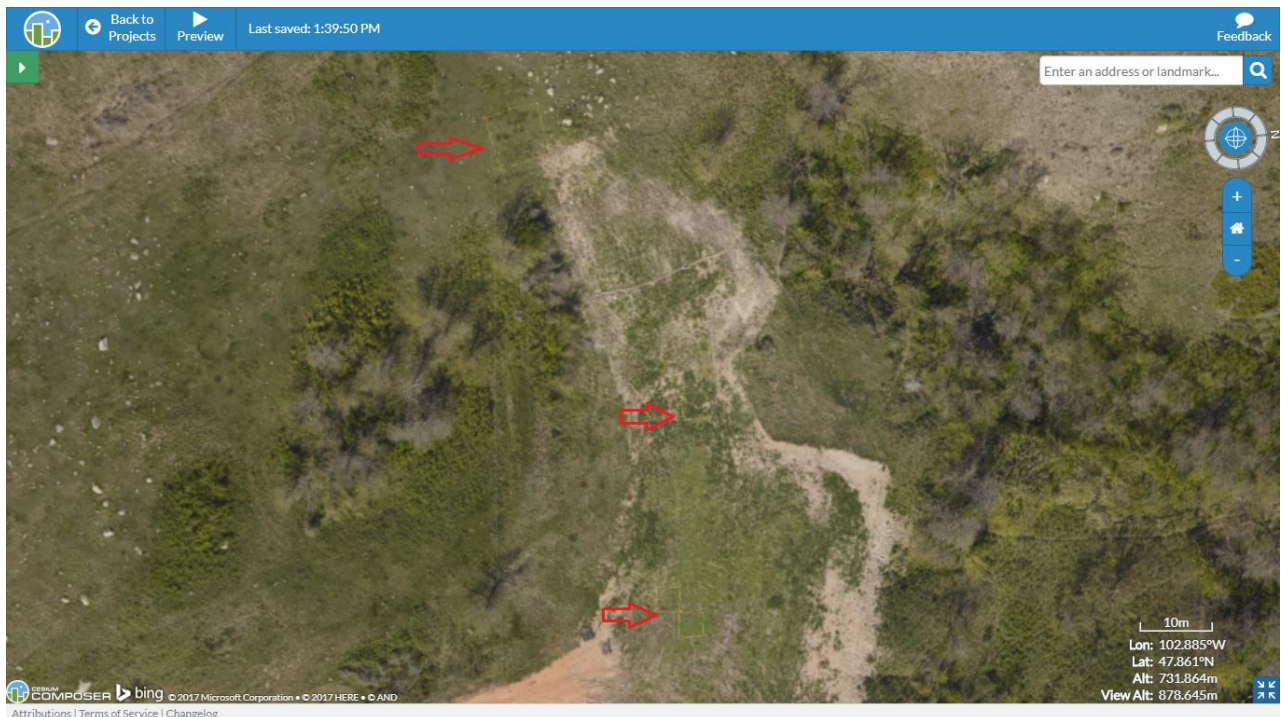
Figure 21: The E-331 Site control vegetation plots (red arrows identifying yellow plot boxes).

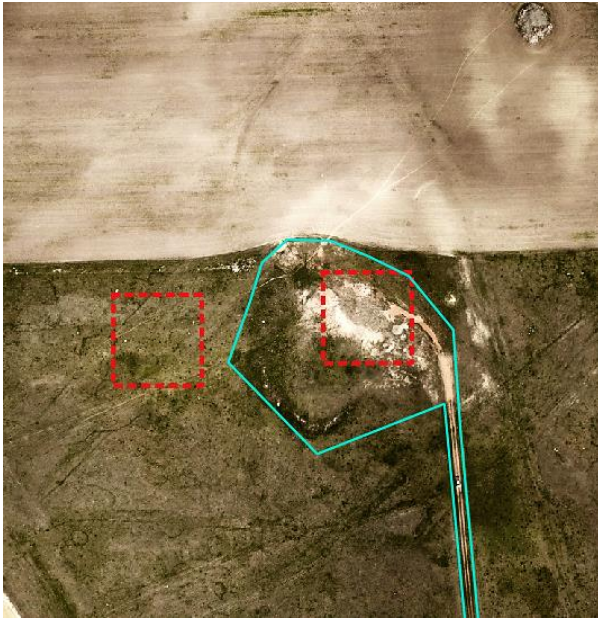
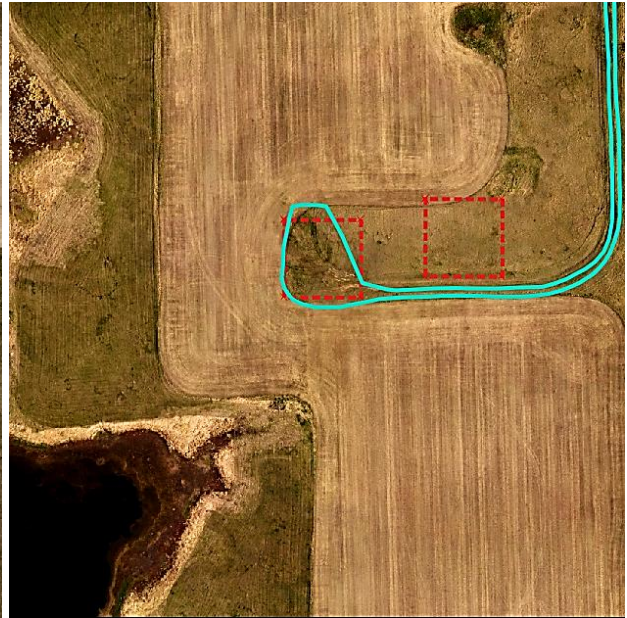
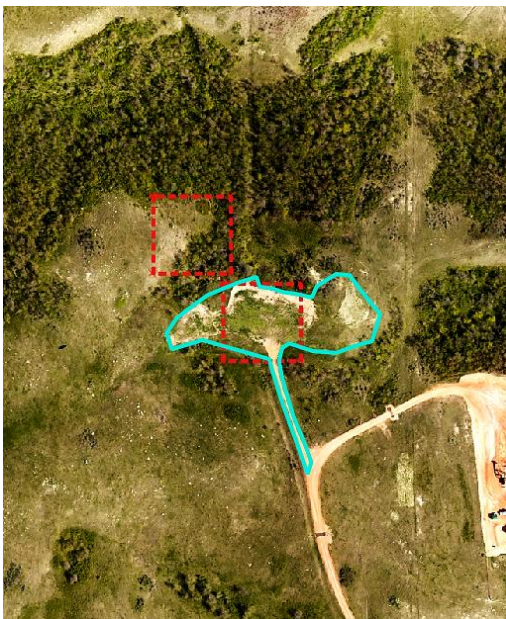
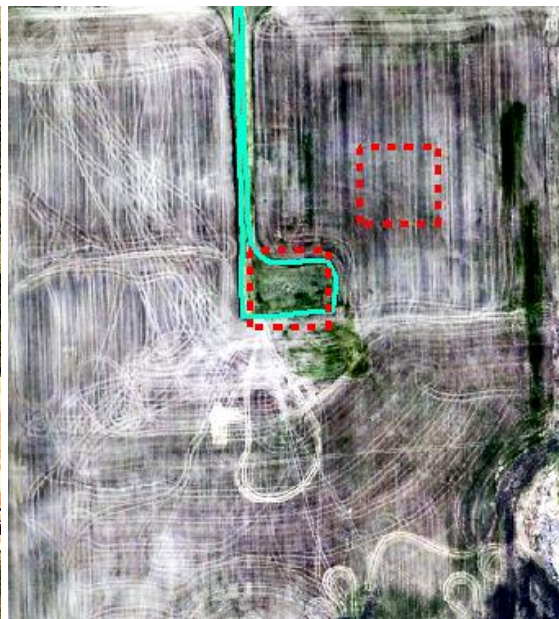
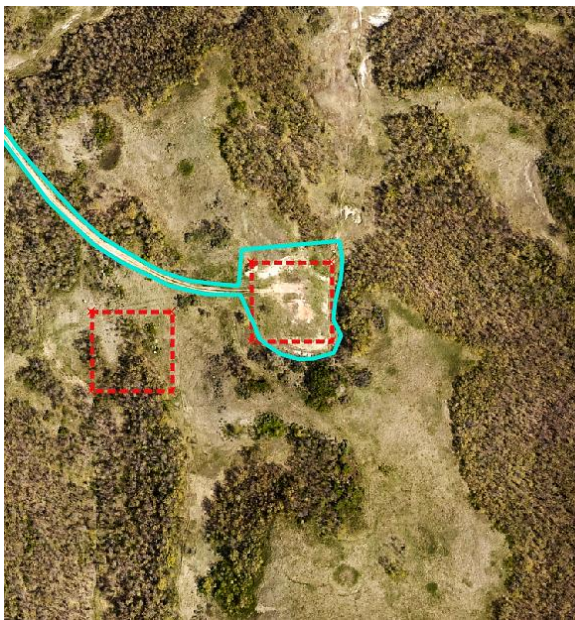
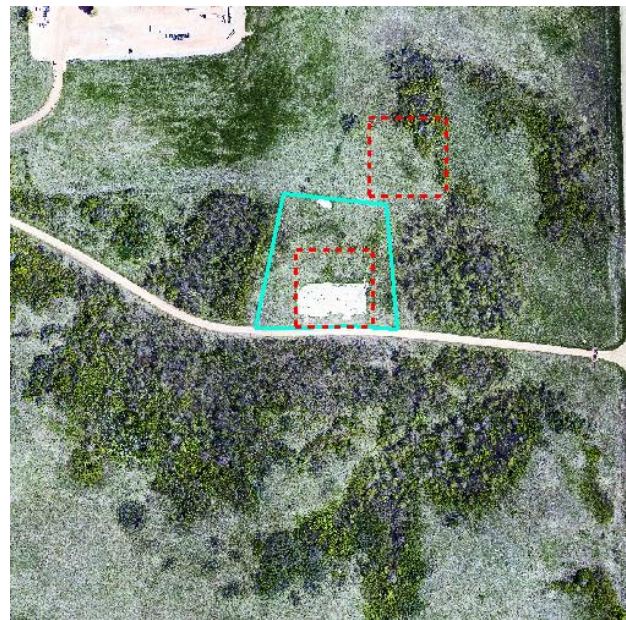
Figure 29: Selection of areas (50x50m) inside of pad boundary and outside pad for comparison.

Therefore, to quantify the magnitude of site degradation (or level or lack of restoration) and the introduction of invasive vegetation, a representative 50m x 50m square test area was selected inside the pad boundaries (disturbed area) and outside (undisturbed area), but with comparable land cover makeup (Figure 28). Though, the land formation inside the site may not be identifiable, due to the site disturbance, its surroundings usually provide sufficient evidence to select a comparable test area outside the site. The similarity characteristics between the two tests areas (i.e., squares inside and outside the pad boundaries) were an important factor in comparing their land cover statistics and derive meaningful conclusions. The 50m x 50m test areas, inside and outside the pad boundaries, are represented by the red-dashed squares in each study site in Figure 29 below.

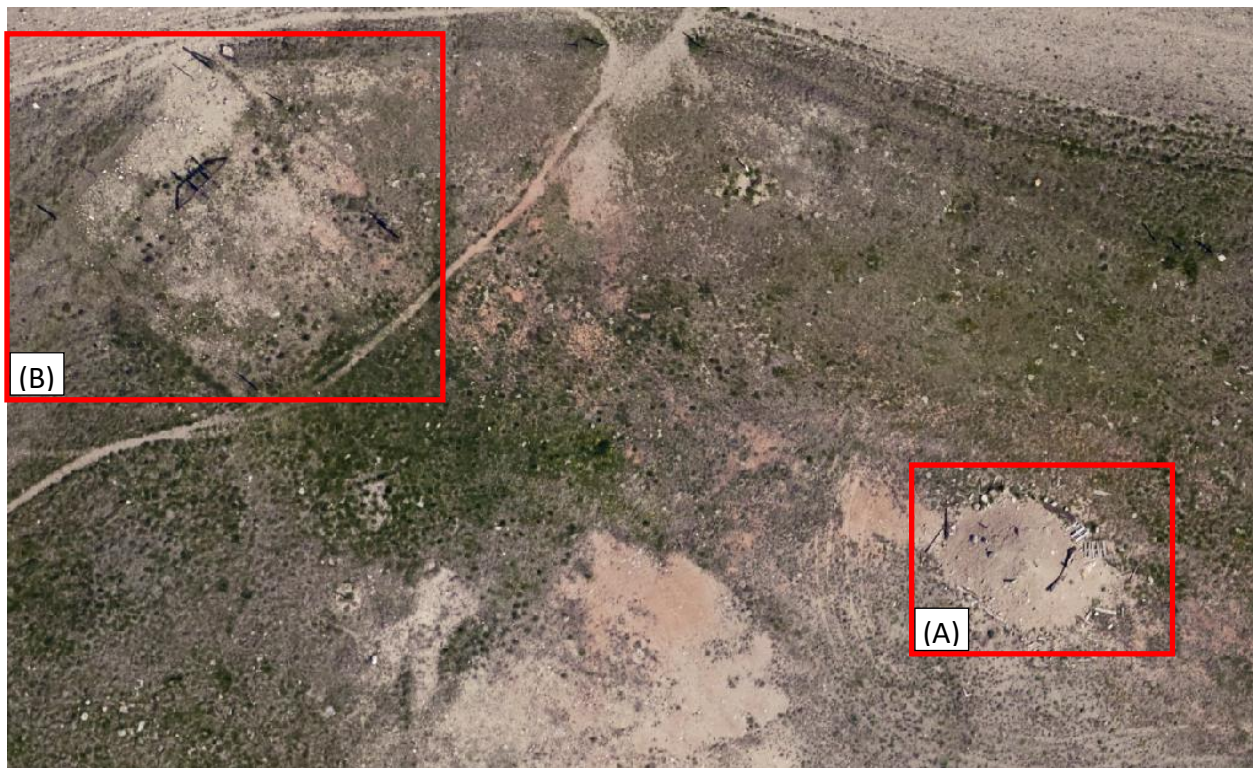
Figure 32: Selected areas for infrastructure detection inside the pad boundaries of Site D-306.

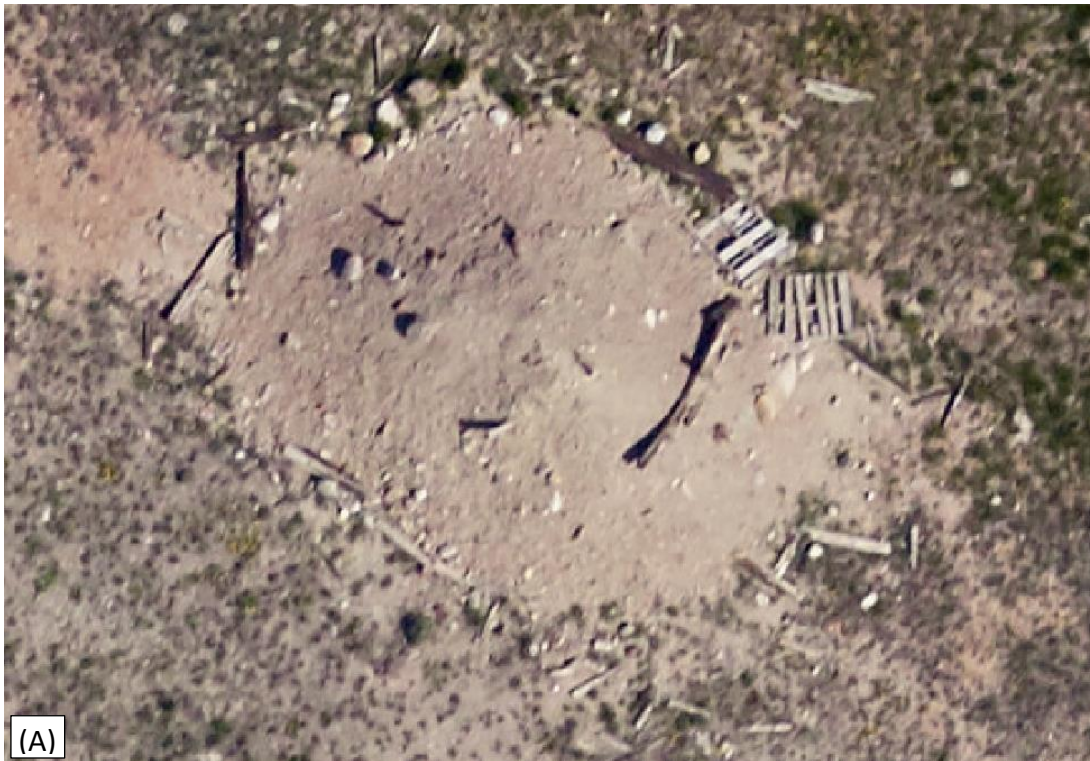
Figure 33A: Visual detection of multiple debris piles in RGB imagery at 3-cm resolution are clearly visible at modest image enlargement (image not maximum zoom)

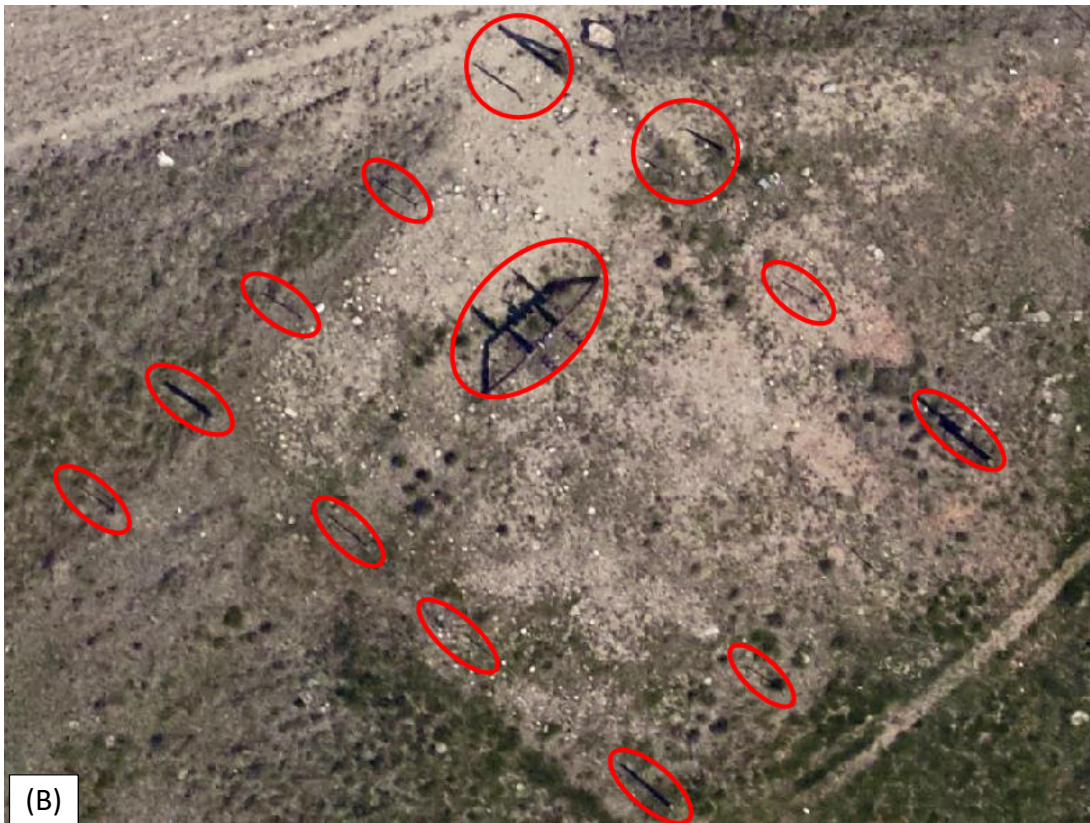
Figure 34B: Visual detection of piping infrastructure of various sizes in RGB imagery at 3-cm resolution are also clearly visible at modest image enlargement (image not maximum zoom).

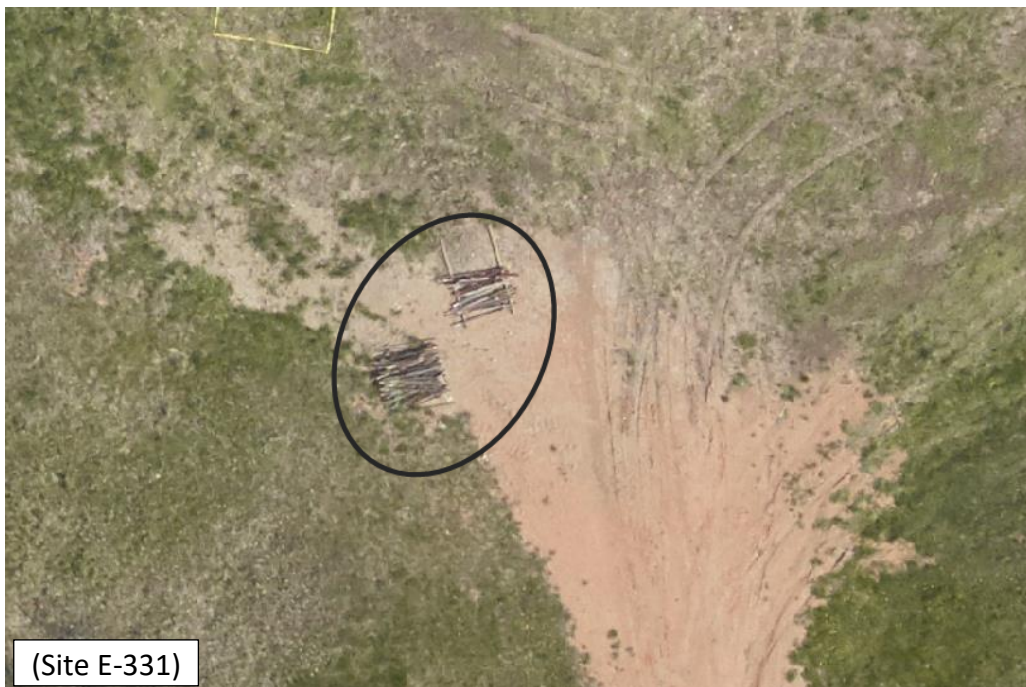
Figure 35: Infrastructure detection in an intermediate restored site (E-331); pipes and debris have been picked-up from the site and stockpiled, but have not yet been removed from the site

Similarly, Figure 34 and Figure 35, representing restoration conditions at a moderate phase (Site E-331) and an advanced phase (E-143), respectively demonstrate the ability of HD-EO imagery to detect infrastructure at various reclamation stages. This capability is important as it reinforces the potential of HD-EO imagery to quantify the conditions of a site to establish its conformity in accordance with North Dakota Administrative Code (NDAC) regulations.

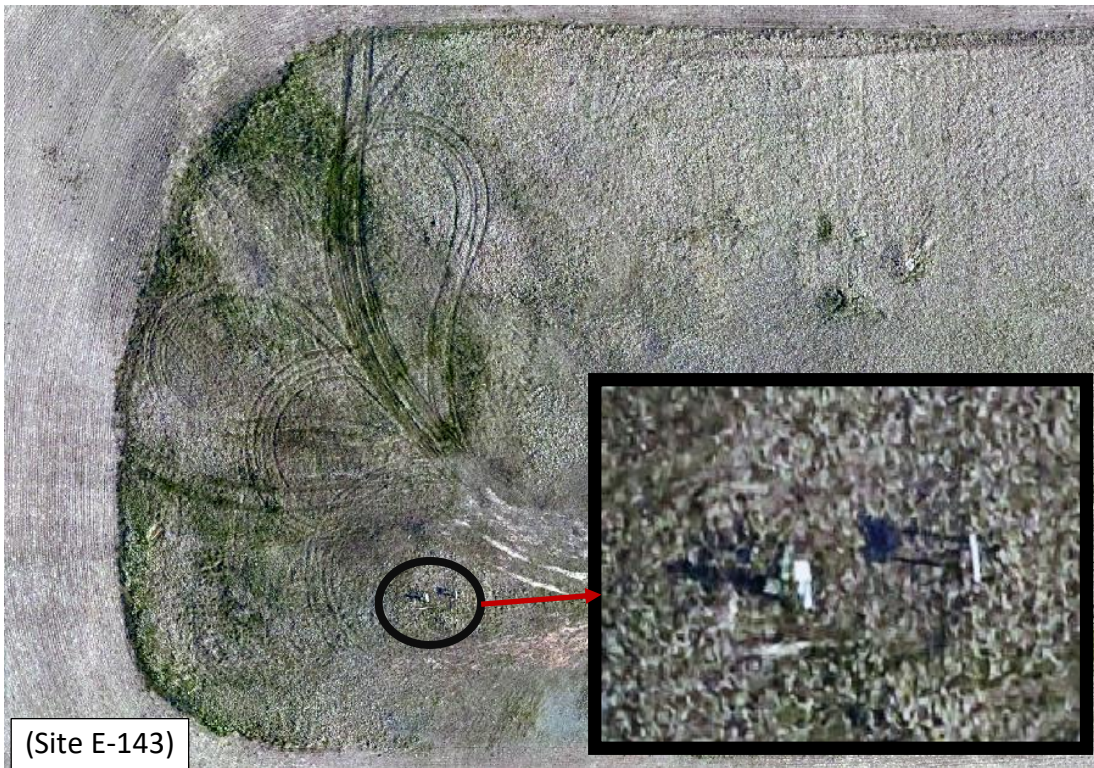
Figure 36: Infrastructure detection at a site at an advanced stage of restoration (E-143); site mostly cleared of infrastructure, but some structures are still standing at the site.

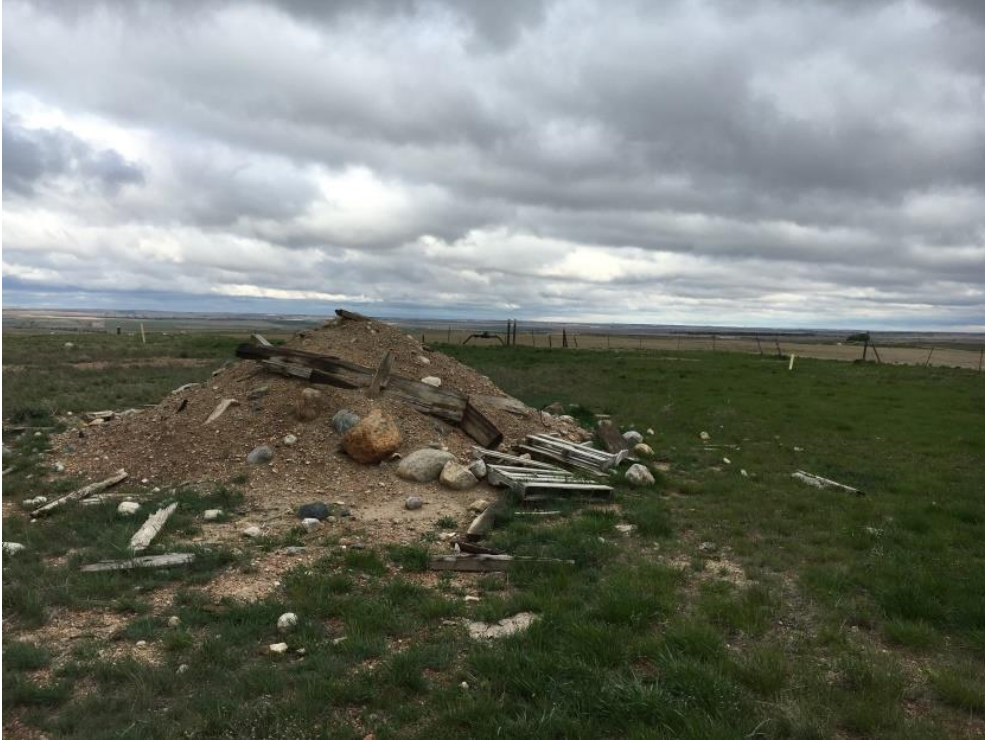
Figure 39: Ground truth photograph of D-306 debris pile.

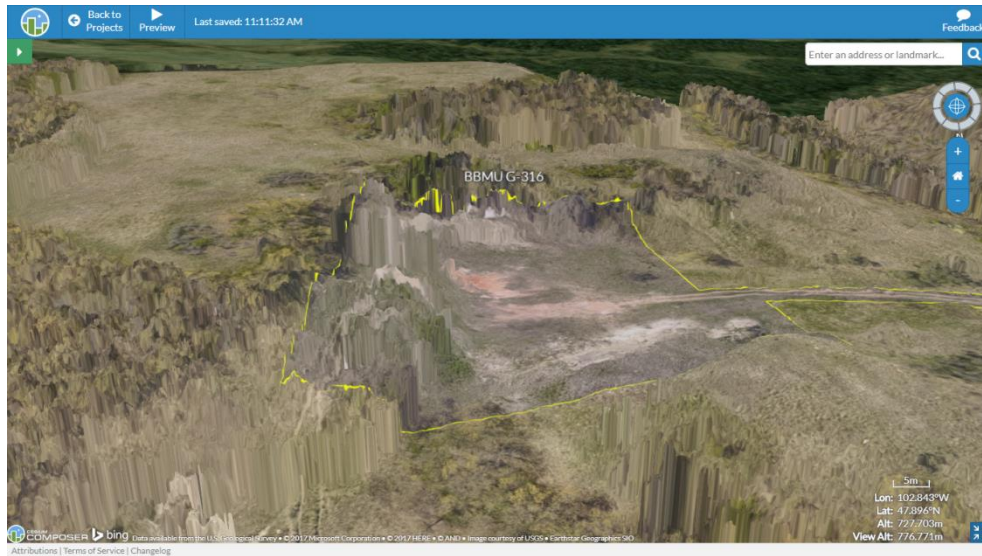
Figure 43: High resolution imagery and DTM of G-316. Vegetation (trees and shrubs) is represented as surface features.

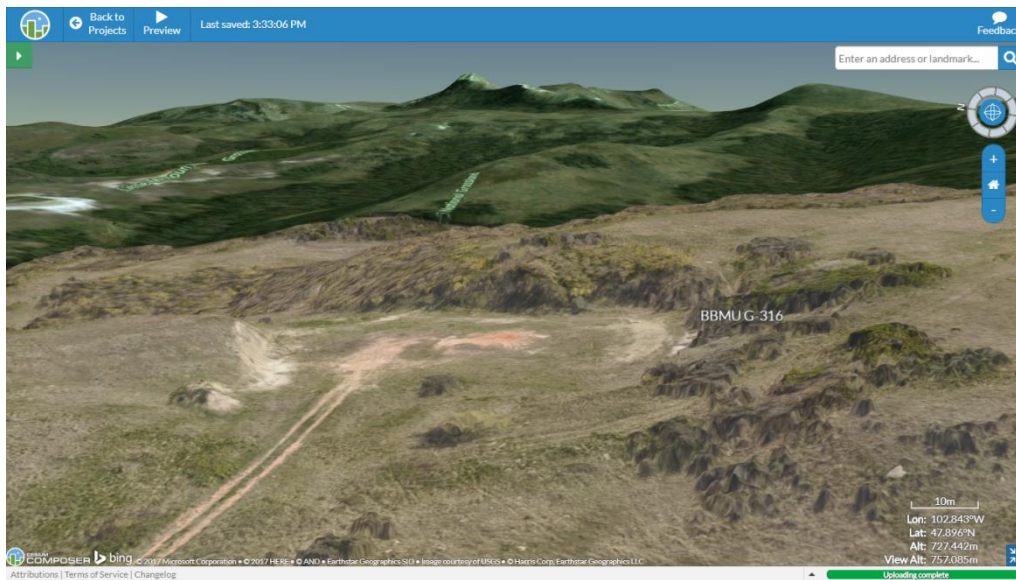
Figure 45: High resolution imagery and DTM of G-316 looking to the east. The site appears to have been excavated out of the hillside.

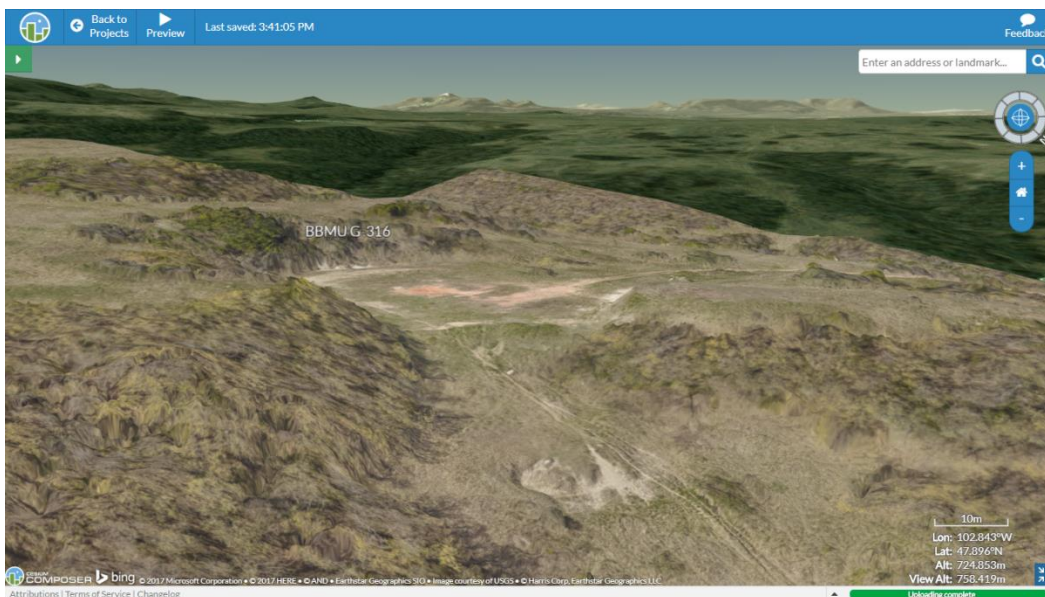
Figure 46: High resolution imagery and DTM of G-316 looking to the south west. The imagery suggests that the excavated soil was pushed down the slope at the front of the image (North East).

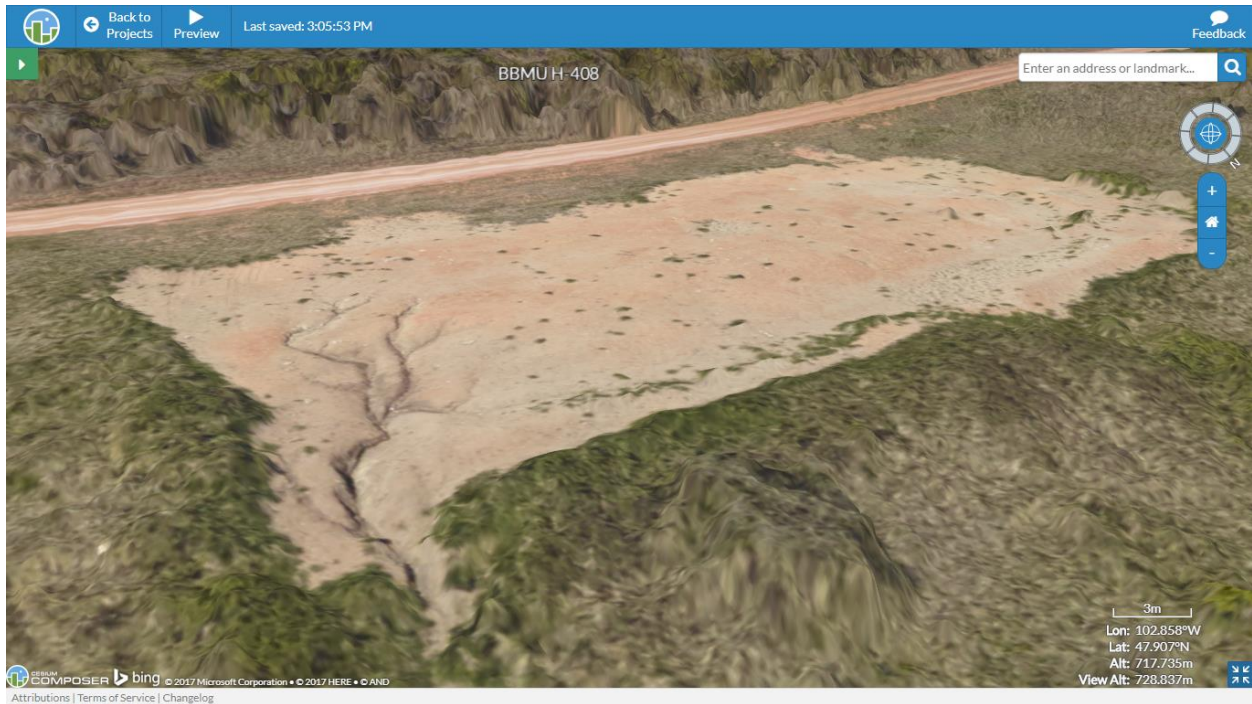
Figure 47: High resolution imagery and DTM of H-408 and erosion features.
