Collection and Development Of Actionable Reclamation Data Using Aerial Remote Sensing

Contract No. G-037-73

Final Report

Mark Jackson
Hell Creek Environmental LLC
15399 Cranes Mill Rd.
Canyon Lake, TX 78133

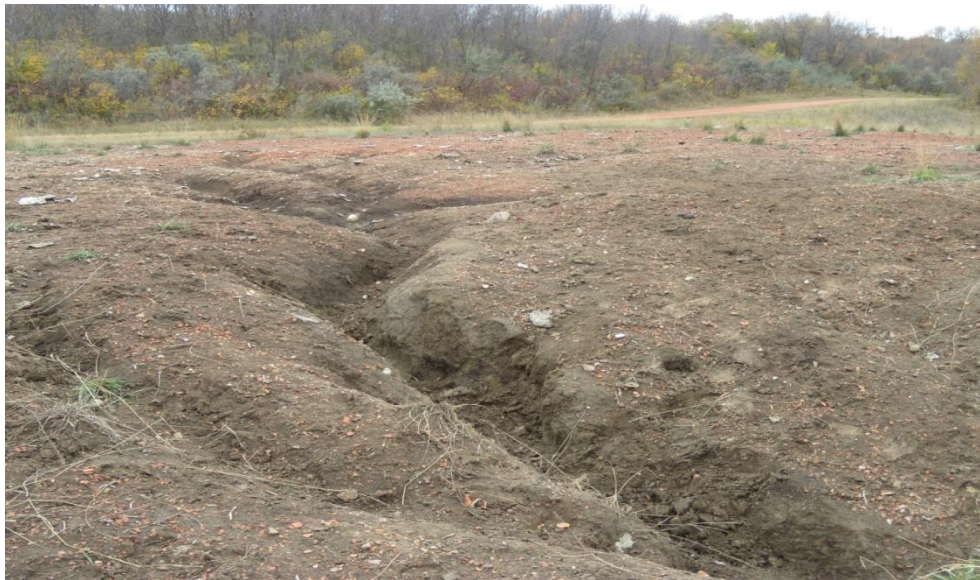
Figure 48: Ground truth photograph of the H-408 and erosion features.

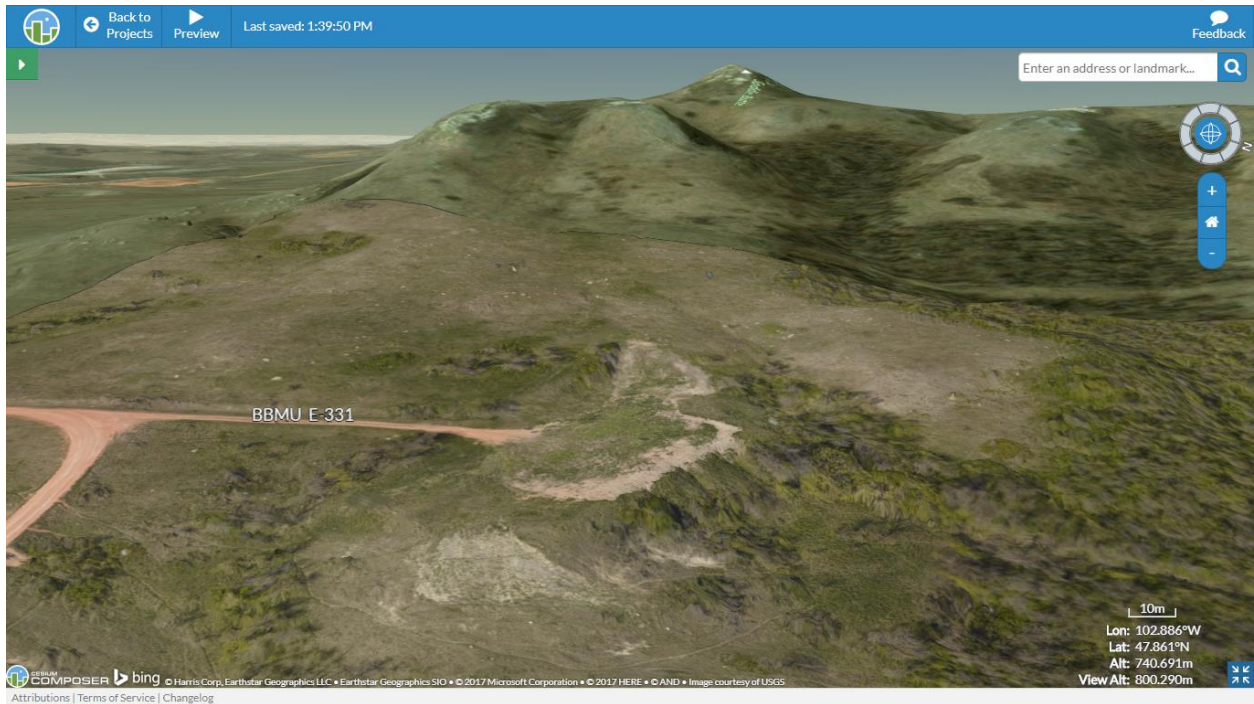
Figure 49: Imagery and DTM of the E-331 looking west showing persisting disturbed conditions. Contours and ground cover can be evaluated in context of the surrounding areas.

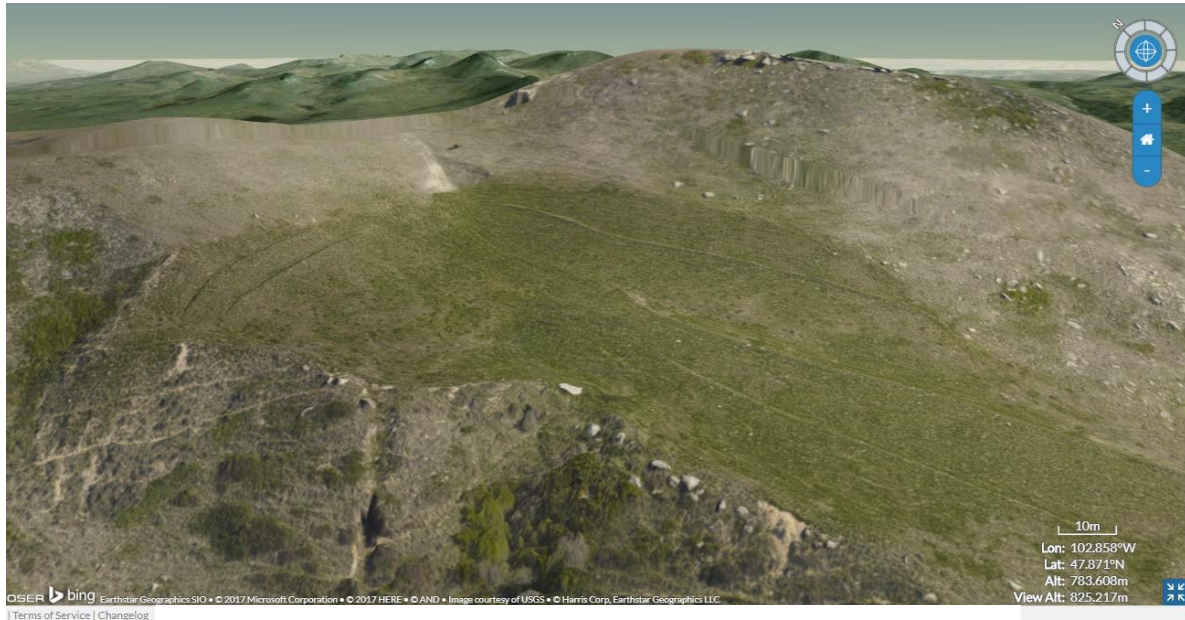
Figure 51: Imagery and DTM of the F-429 looking north east.
