Electrokinetic Based Soil Desalinization System Achieves Closure at a Brine Contaminated Site

Christopher J. Athmer, P.E.
Terran Corporation

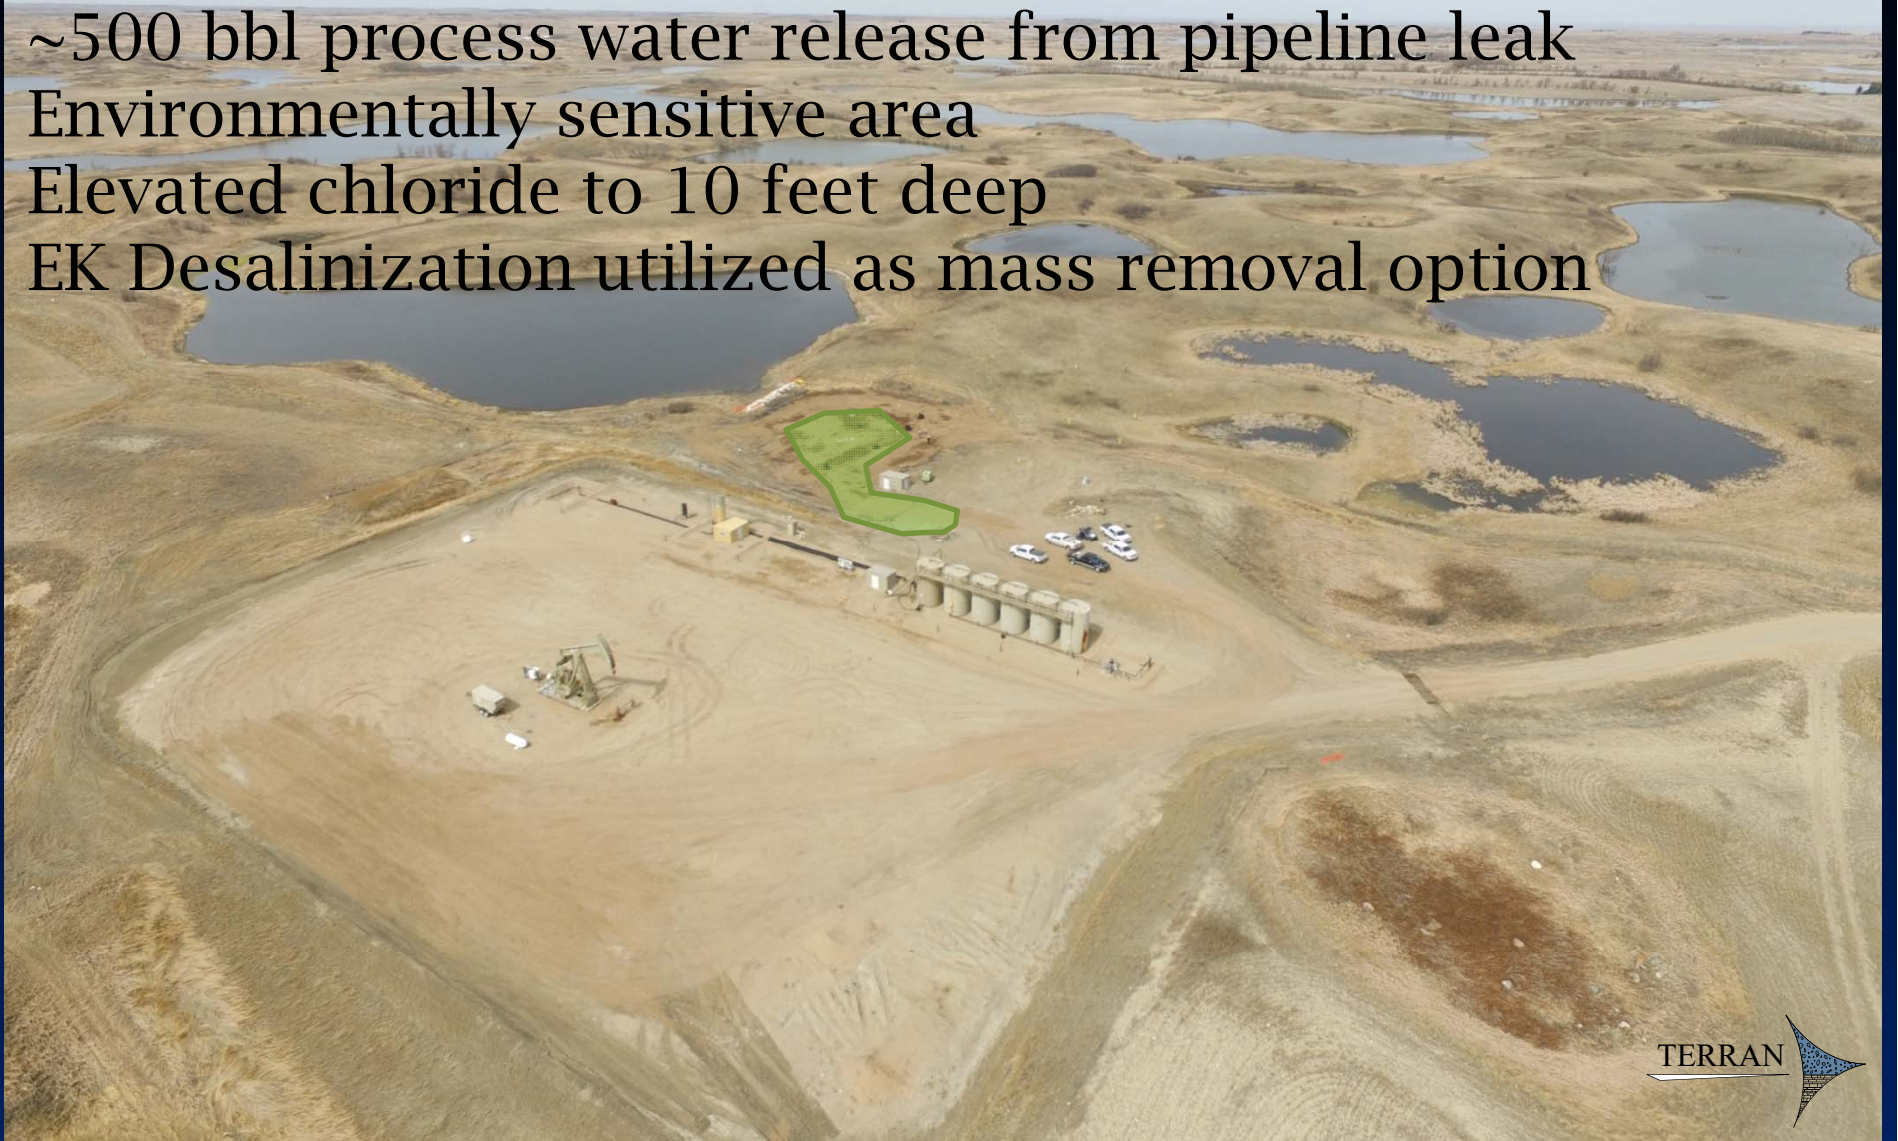
First action was to isolate the small slough from larger, begin pumping affected water from the small slough, and excavate contaminated soil around release point and above the slough.

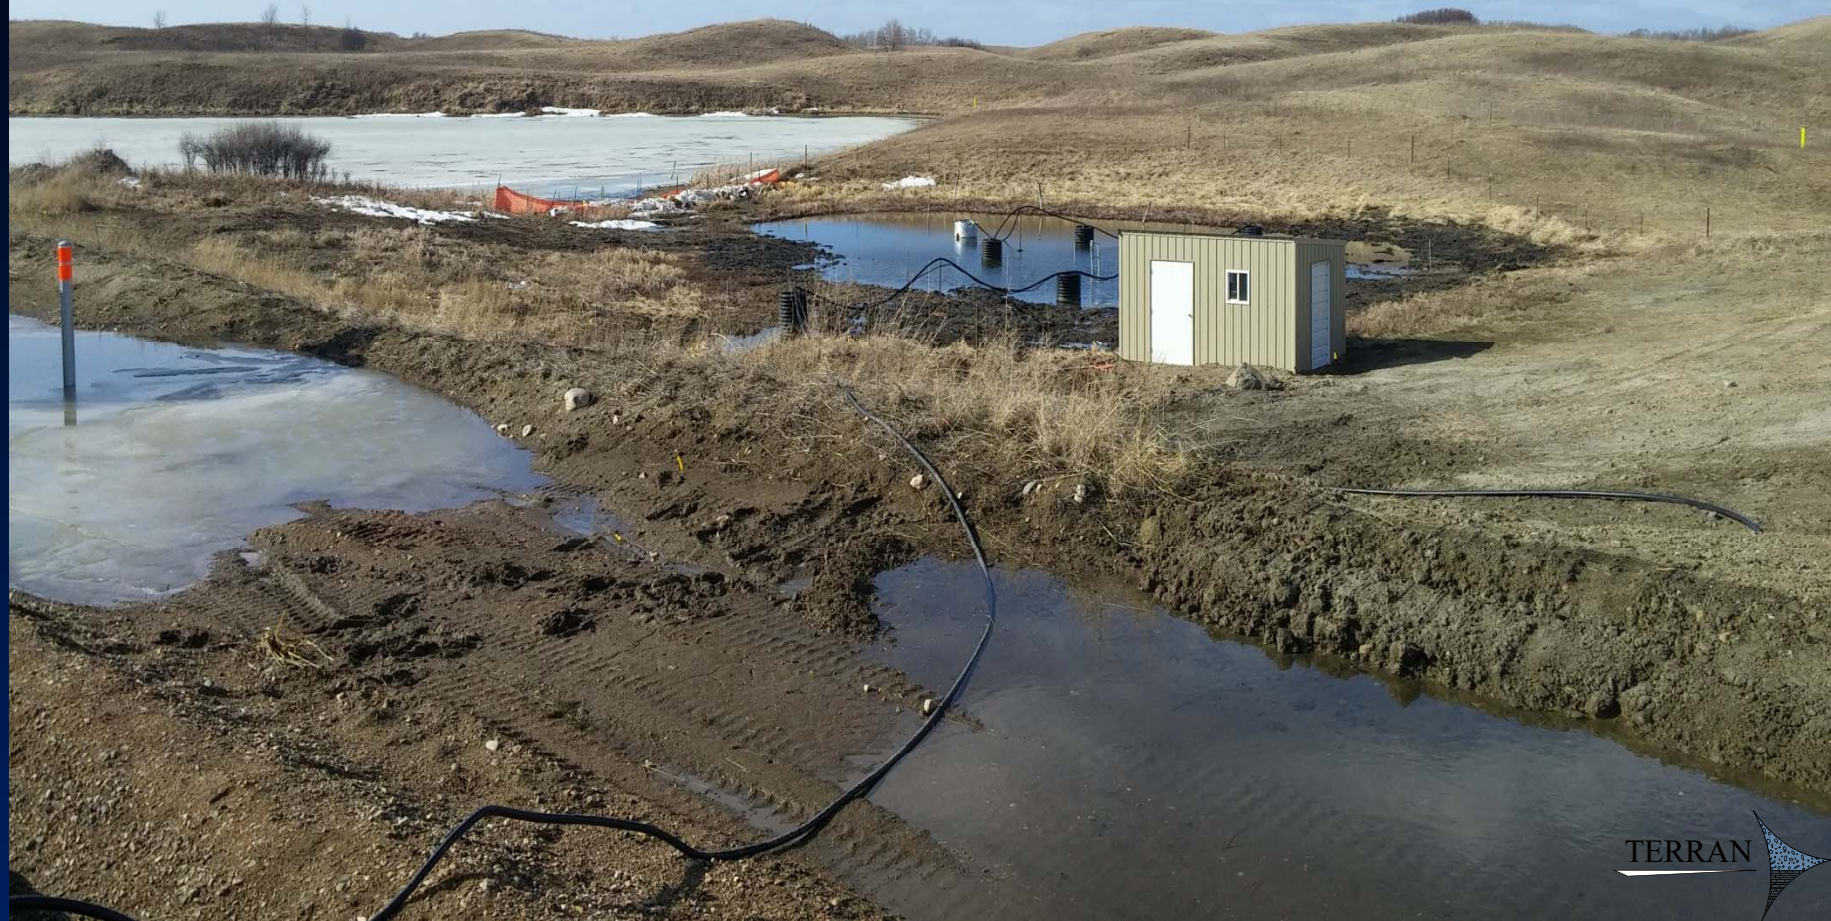
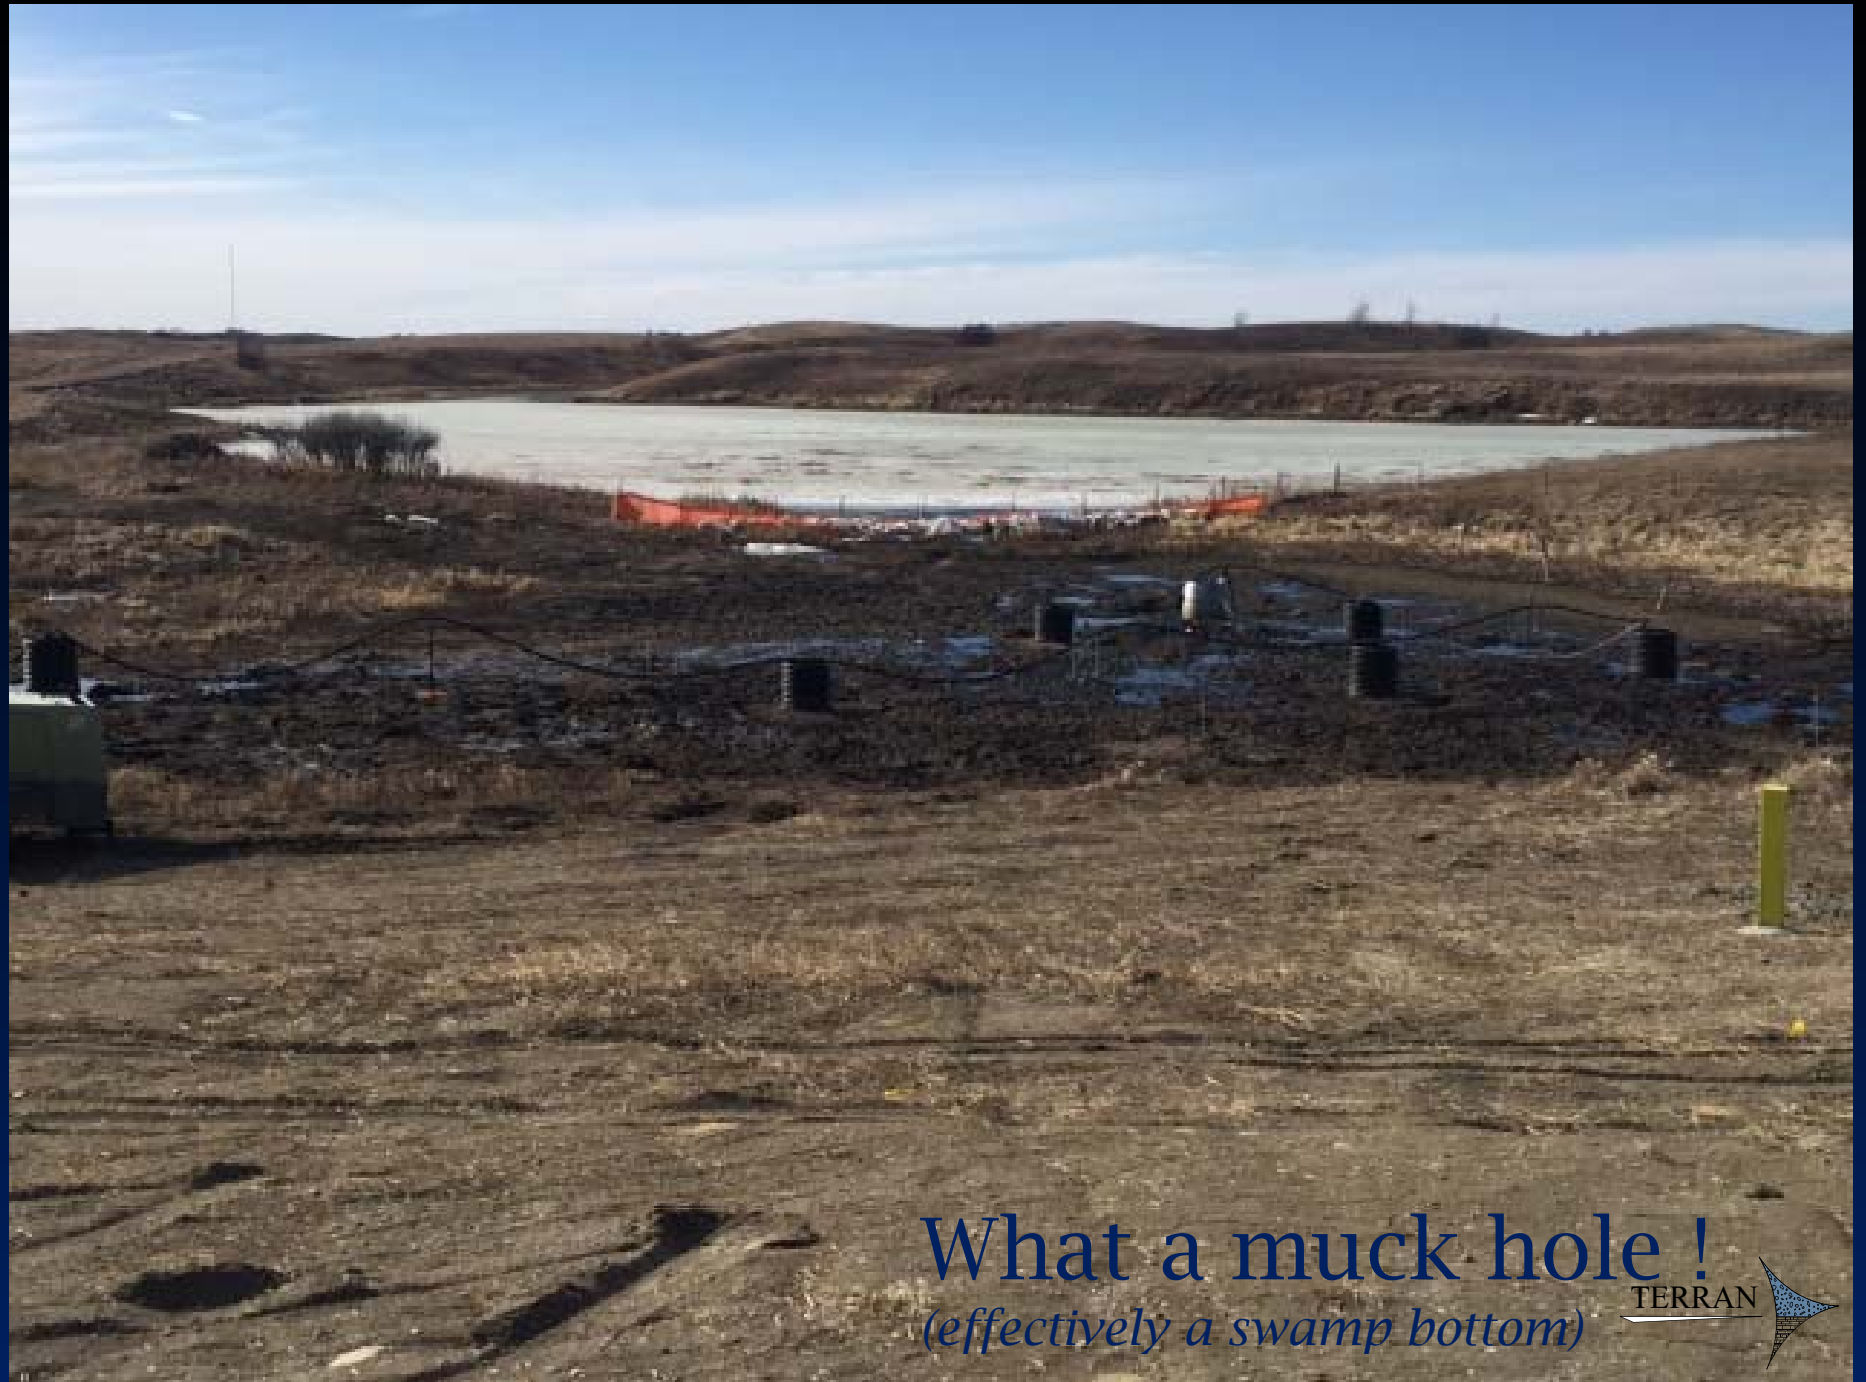
What a muck hole !
(effectively a swamp bottom)

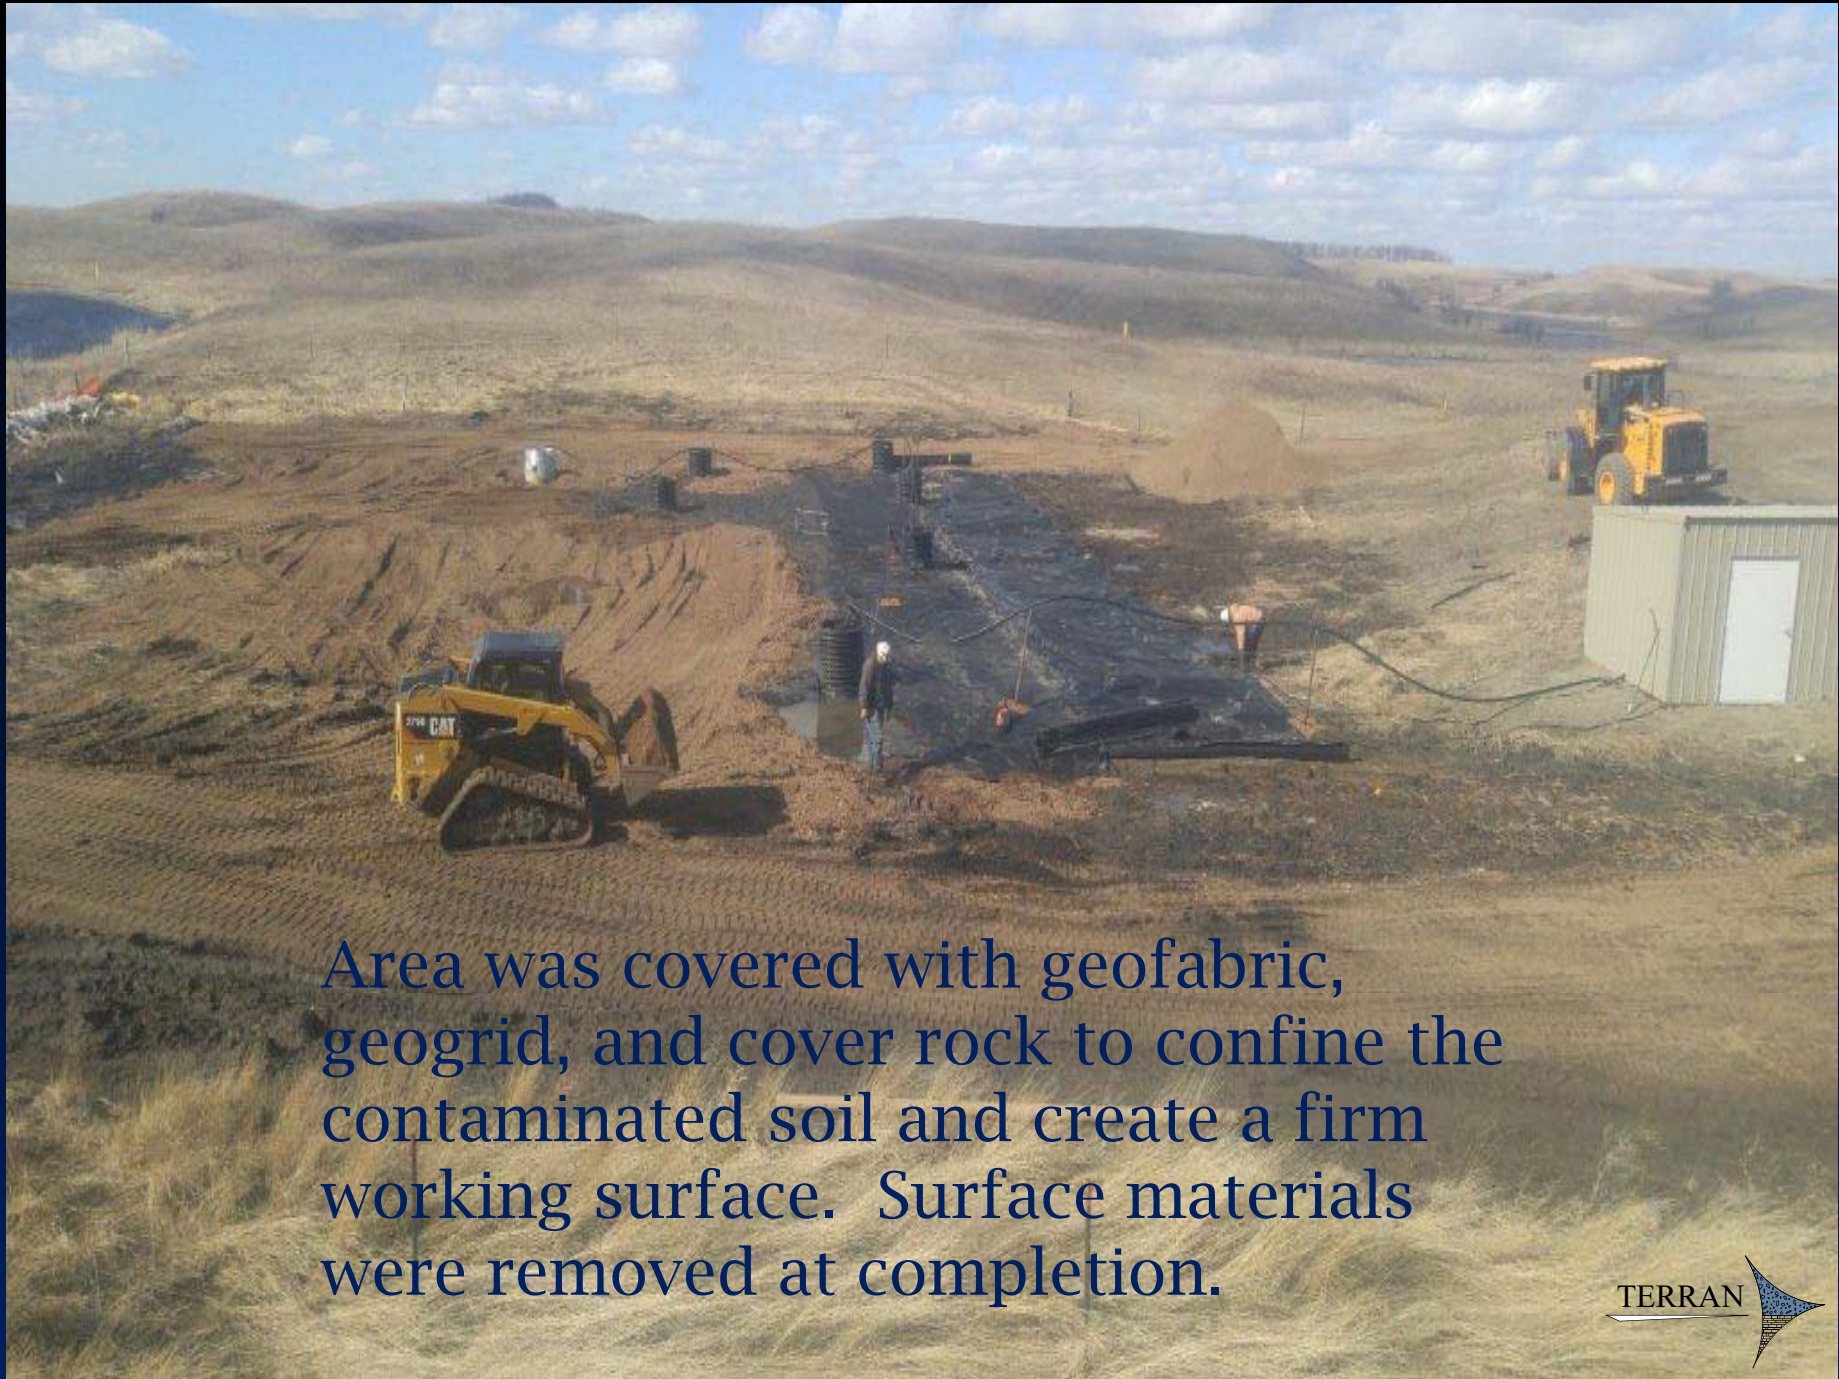
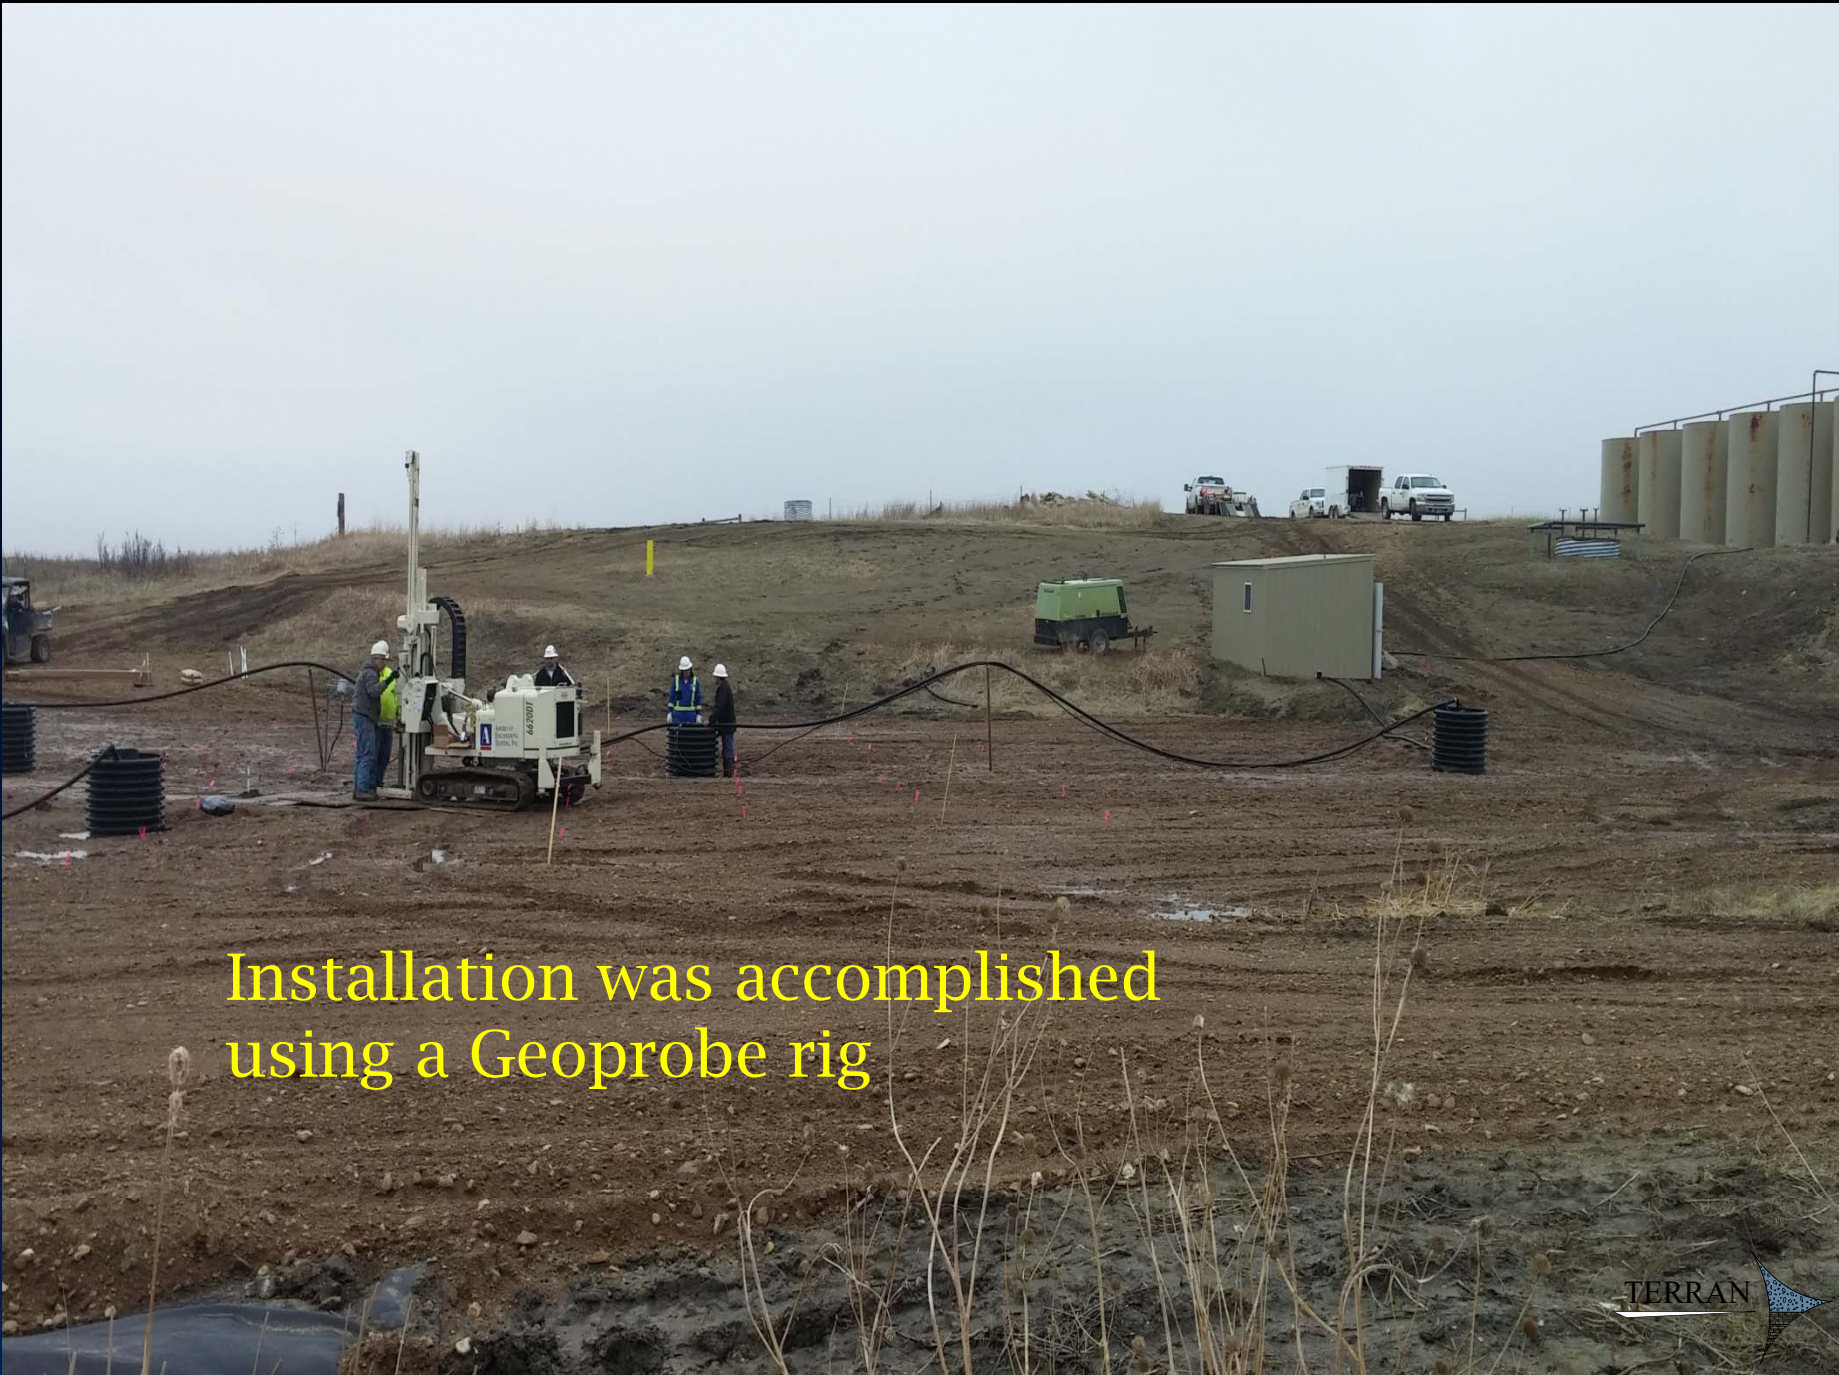
Area was covered with geofabric, geogrid, and cover rock to confine the contaminated soil and create a firm working surface. Surface materials were removed at completion.

Installation was accomplished
using a Geoprobe rig

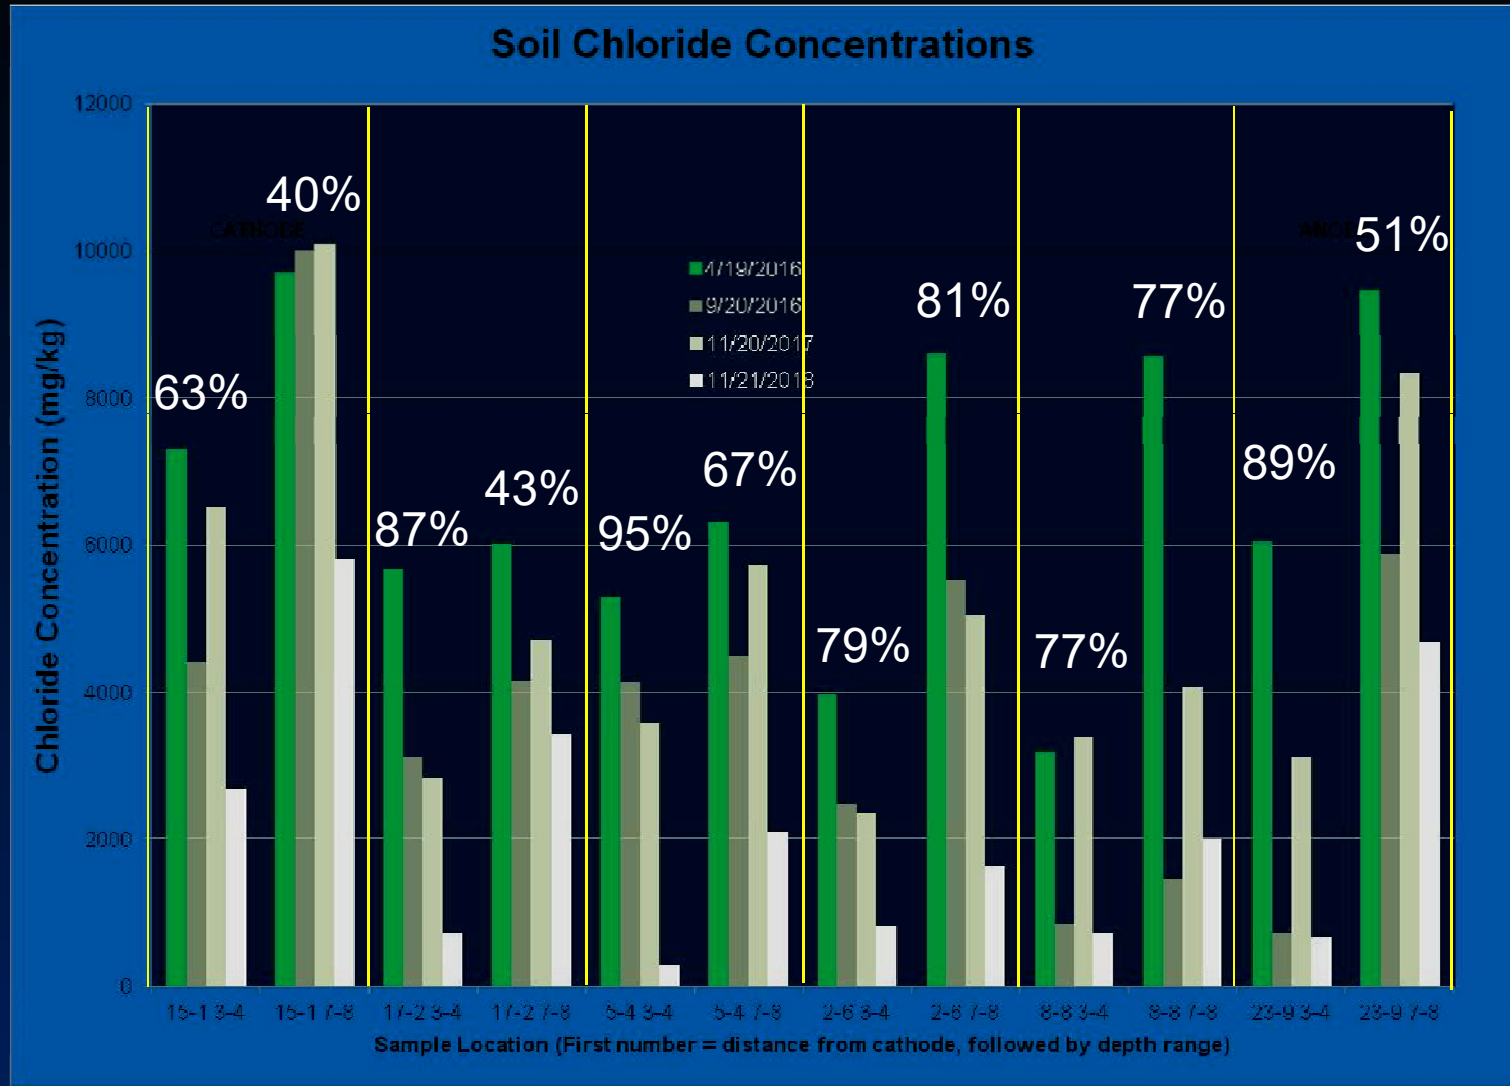
Chloride Soil Data

- For the 3rd summer (2018), the electrode conductors were replaced and operations went much smoother.
 - November 2018 results show an overall 68% removal – very close to the target of 70-80%
 - Site Closure was granted by the North Dakota Department of Health

- First summer (2016) operations went well: Removal after 1st summer was 41%
- Poor electrode operations during second summer contributed to lower rates. July 2017 interim samples showed 47% removal. Conductance and EM surveys confirmed reductions
- Results for November 2017 sampling indicated a regress to only 25% removal ????.
 - 2017 was a dry year and water was brought in to hydrate the electrodes and a reverse-pulse was attempted
