NDIC Brine Pond Study

Phase II: Site Assessments

June 25, 2018

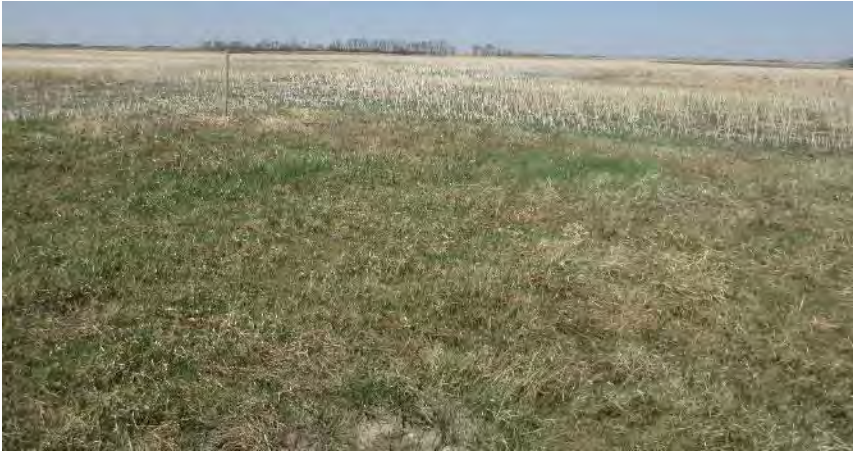
B1-1

Photograph facing north off of an oilfield lease road showing no visual impacts in agricultural field.

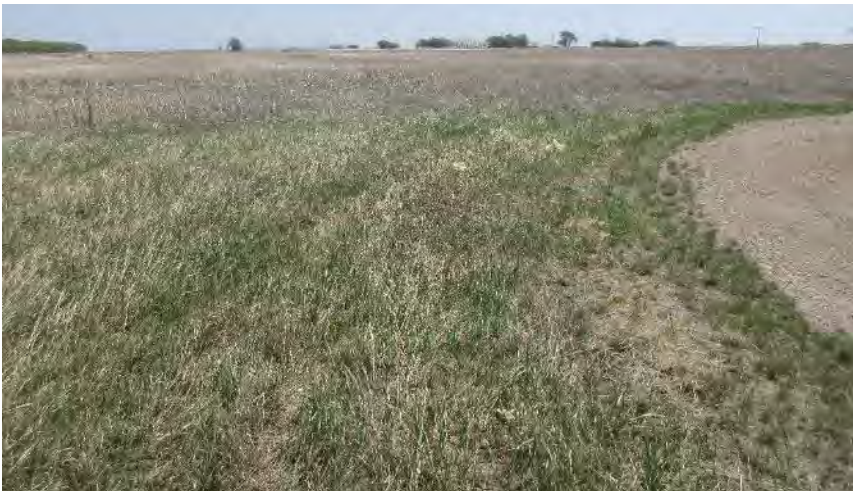
Photograph facing northeast off of an oilfield lease road showing no visual impacts in agricultural field.

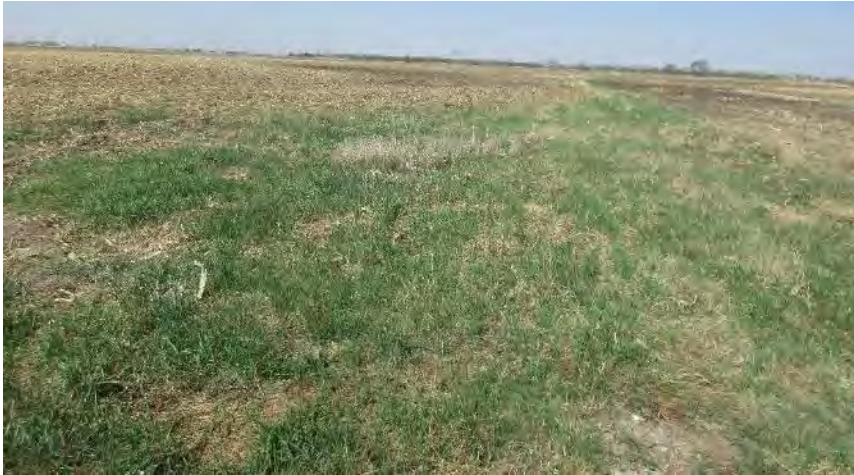
B1-5

Photograph facing northwest off of an oilfield lease road showing agricultural fields. The site is located 1,000 feet further northwest and could not be accessed.

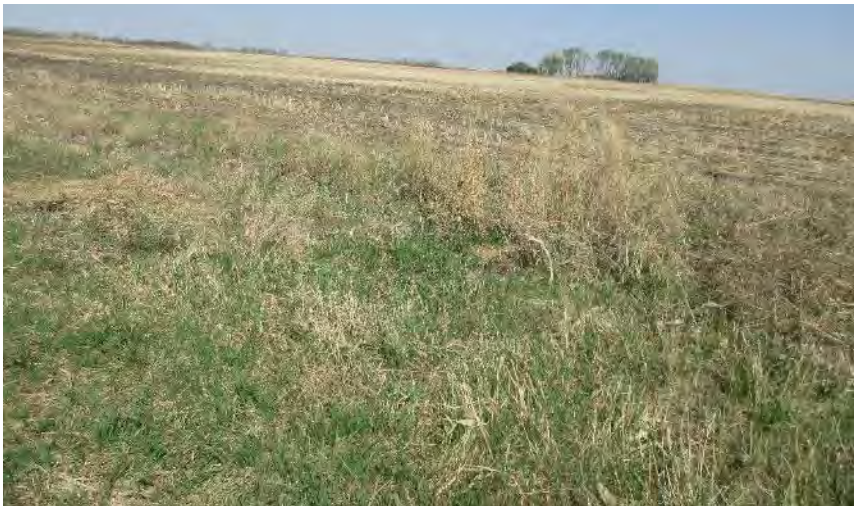
Photograph facing north off of an oilfield lease road showing an agricultural field. The site could not be accessed due to access limitations.

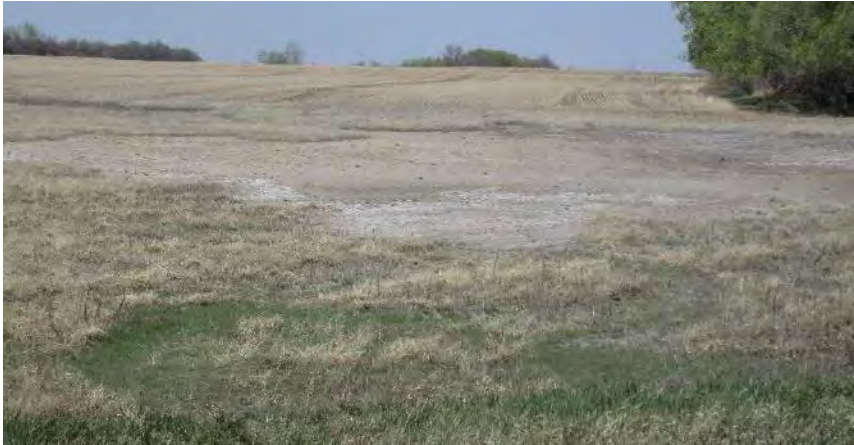
Photograph facing north off of 104th St NW showing a visually impacted area. Extensive dead zones and salt crusts were observed.

B1-8 was inspected on May 15th, 2018, and is located approximately 100 feet north of 104th St NW and 200 feet west of an oilfield lease road. The site is currently used for agricultural purposes, and is surrounded by agricultural fields. Visual impacts were observed, including an area of barren ground with stressed vegetation and salt crusting; the area of visual impacts measured approximately 125 feet by 100 feet. The site topography slopes steeply to the south. Aboveground powerlines were observed to the south of the site.

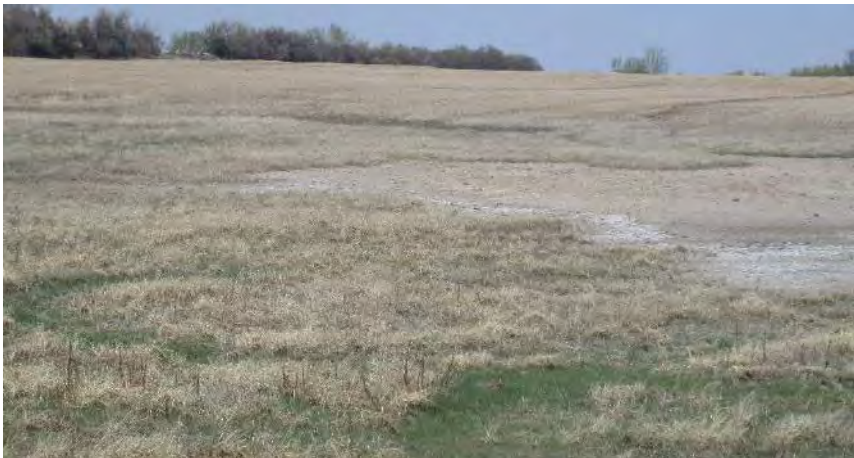
Photograph facing northwest off of 104th St NW showing visually impacted area with salt crusts in an agricultural field.

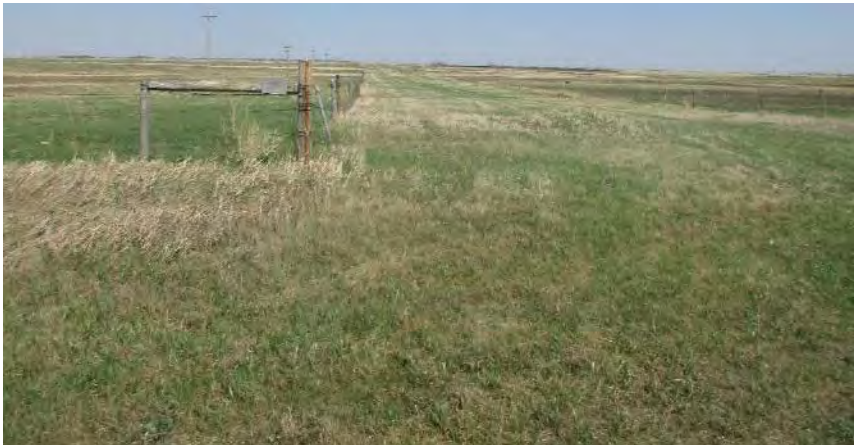
B1-11

Photograph facing east off of 31st Ave NW showing native grasslands with no visual impacts. The site is located approximately 500 feet further southeast in a fenced off field.

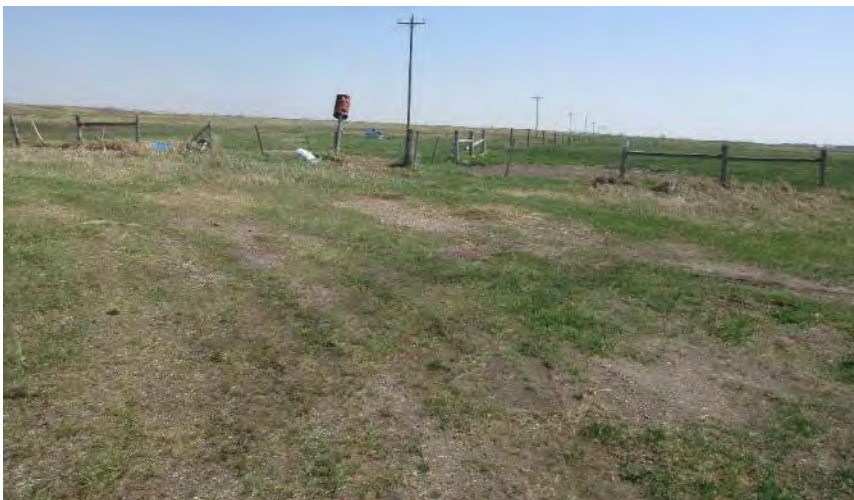
Photograph facing south off of 31st Ave NW. The site is located approximately 500 feet southeast in a fenced off field. Aboveground powerlines are located approximately 500 west of site.

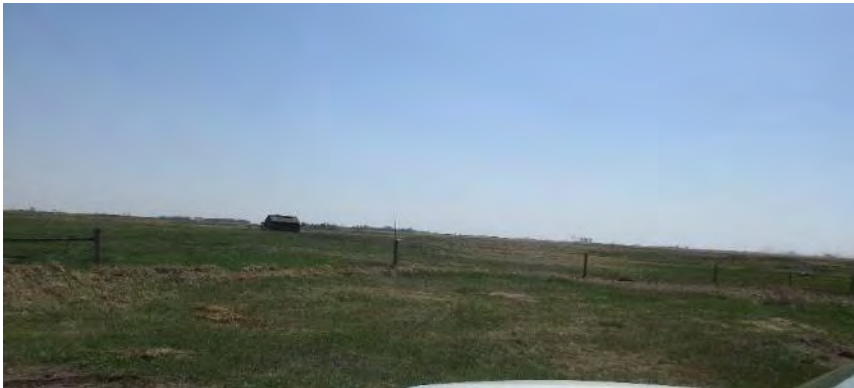
B1-13

Photograph facing southwest off of 31st Ave NW. Site is in fenced off pasture land approximately 1,500 feet further southwest.

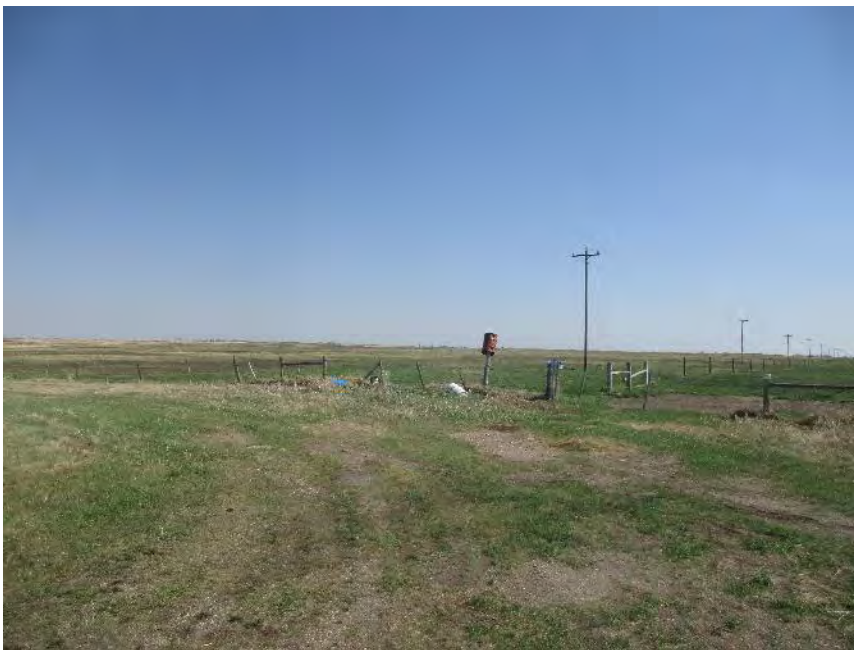
Photograph facing southwest off of 31st Ave. NW. The site is in fenced-off pasture land. Aboveground powerlines are located approximately 500 feet east of the site.

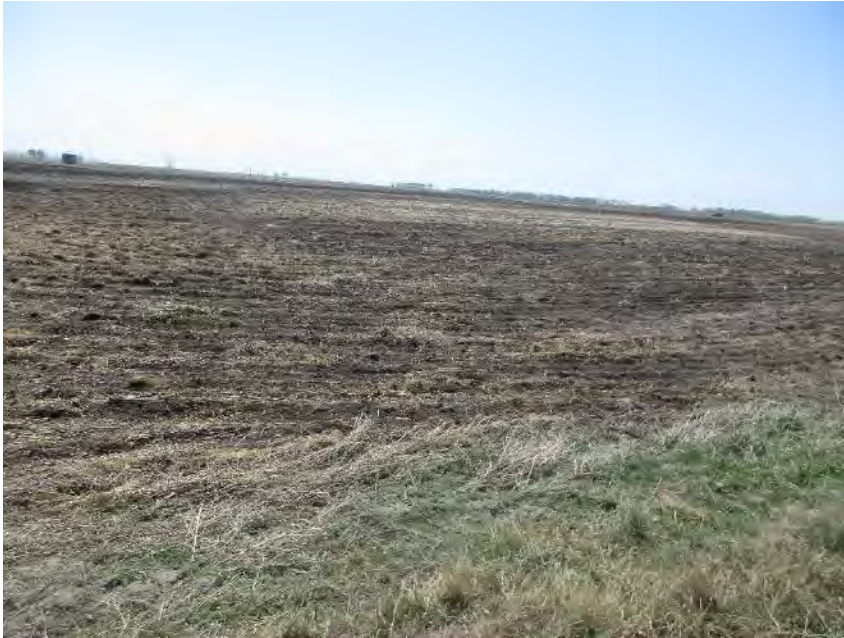
B3-2 (May 2018)

Photograph facing east off of 19th Ave NW. No visual impacts were observed at the time of the May 16, 2018 site visit.

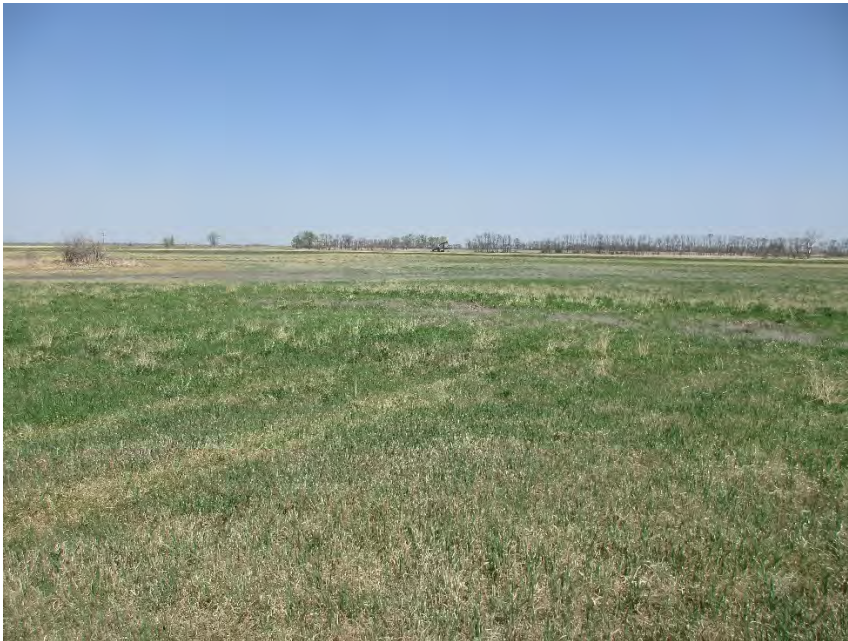
Photograph facing southeast, taken northwest of the wetland. The wetland lies northwest of the area of stressed vegetation. The site topography is generally flat and slopes to the west.

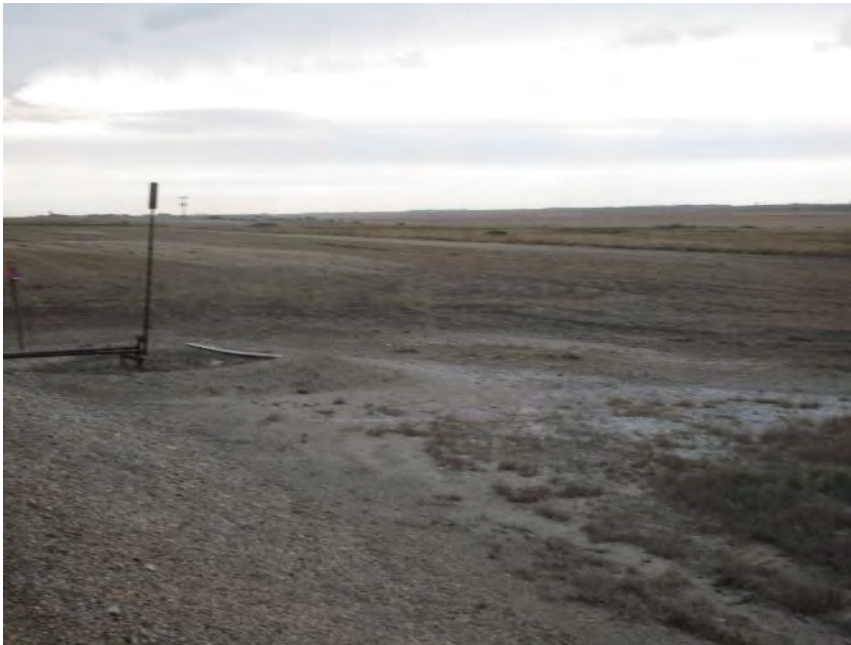
Photograph showing a closer view of the area of stressed vegetation and salt residues.

B4-5 was inspected on May 17th, 2018, and is located approximately 600 feet south of 108th St NW and just east of an oilfield lease road. The site is currently used for agricultural purposes. Agricultural land lies to the north and grasslands lie to the east and south. An oil & gas facility was observed to the west, consisting of five aboveground storage tanks, one heater treater, one flare pit, and one shack. Visual impacts were observed, including an area of stressed vegetation and salt residues; the area of visual impacts measured approximately 50 feet by 50 feet. The site topography is generally flat and slopes to the east/southeast.

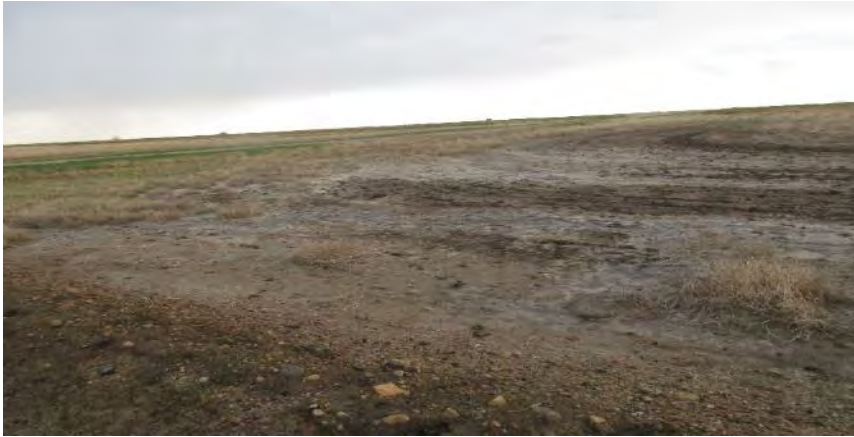
Photograph facing northwest off of an oil & gas facility showing the visually impacted area. Visual impacts follow the edge of the oil & gas facility.

B4-6 was inspected on May 17th, 2018, and is located approximately 250 feet south of 108th St NW and just east of an oilfield lease road. The site is currently used for agricultural purposes, and is surrounded by agricultural fields. An oil & gas facility was observed to the west, consisting of one shack. Visual impacts were observed along the eastern edge of the oil & gas facility, including an area of stressed vegetation and salt residues; the area of visual impacts measured approximately 200 feet by 20 feet. The site topography is generally flat and slopes to the southeast.

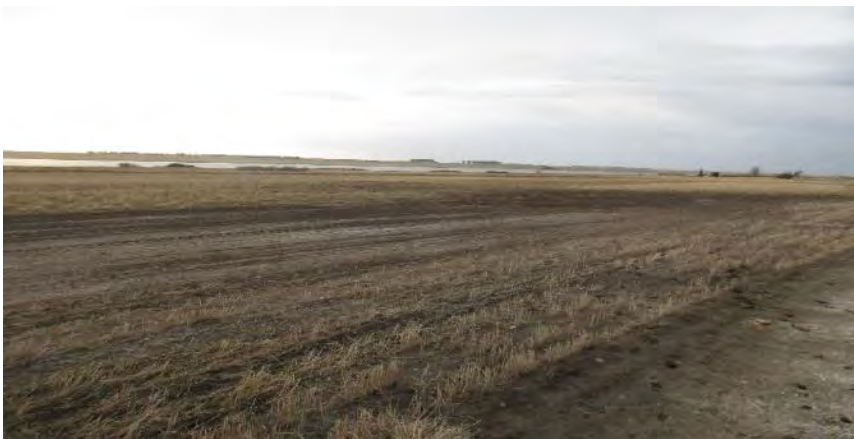
Photograph facing southeast off of the oil & gas facility showing the visually impacted area between the facility and an agricultural field. The Souris River can be seen in the background.

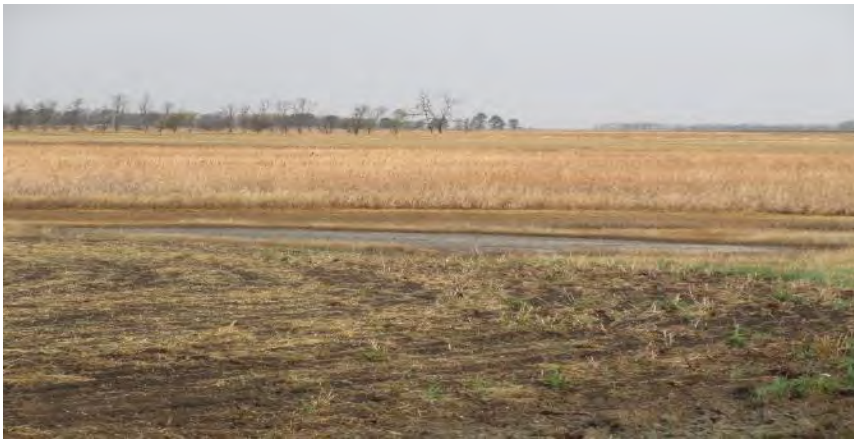
Photograph facing southwest off of an oil & gas facility showing the visually impacted area lacking vegetation. The visually impacted area is north of a wetland visible in the background.

B5-2 was inspected on May 17th, 2018, and is located approximately 200 feet south of an oilfield lease road. The site is currently used for agricultural purposes. A wetland lies to the west/southwest, and agricultural fields lie to the east/southeast. An oil & gas facility was observed to the north, consisting of three aboveground storage tanks, one heater-treater, one flare pit, one pump jack, and one shack. Visual impacts were observed, including an area of barren soils with little to no vegetation growth; the area of visual impacts measured approximately 100 feet by 50 feet. The site topography is generally flat and slopes to the northwest.

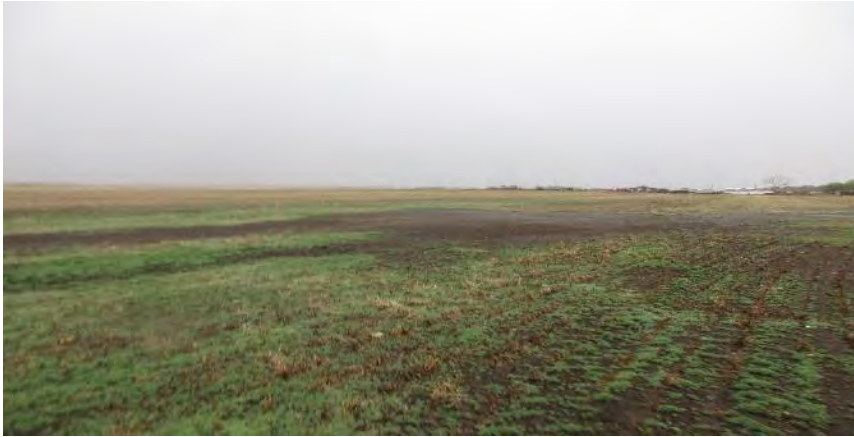
Photograph facing southeast off of an oil & gas facility. A visually impacted area lacking vegetative growth can be seen.

B5-3 was inspected on May 17th, 2018 and is located approximately 600 feet east of County Road 27A and just east of an oilfield lease road. The site is currently used for agricultural purposes and is surrounded by agricultural fields. An oil & gas facility was observed to the west, consisting of four aboveground storage tanks, two heater-treaters, one flare pit, one pump jack, and one shack. Visual impacts were observed, including an area of barren soils with little to no vegetation growth; the area of visual impacts measured approximately 100 feet by 75 feet. The site topography is generally flat and slopes to the north.

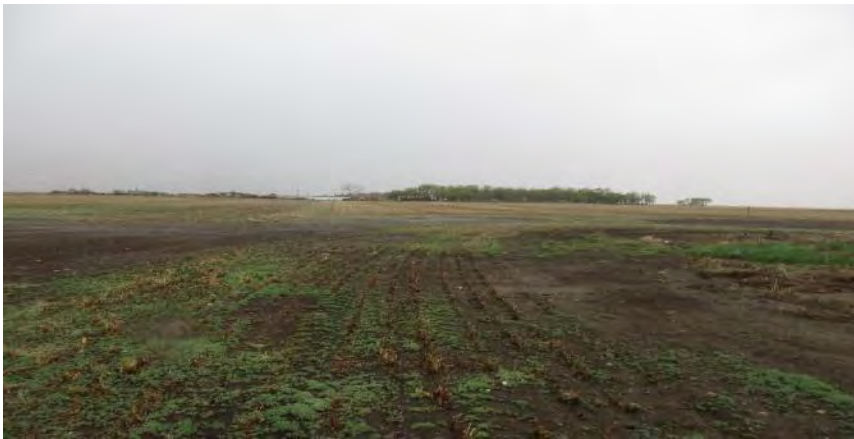
Photograph facing south off of an oil & gas facility showing the lack of vegetative growth in the visually impacted area.

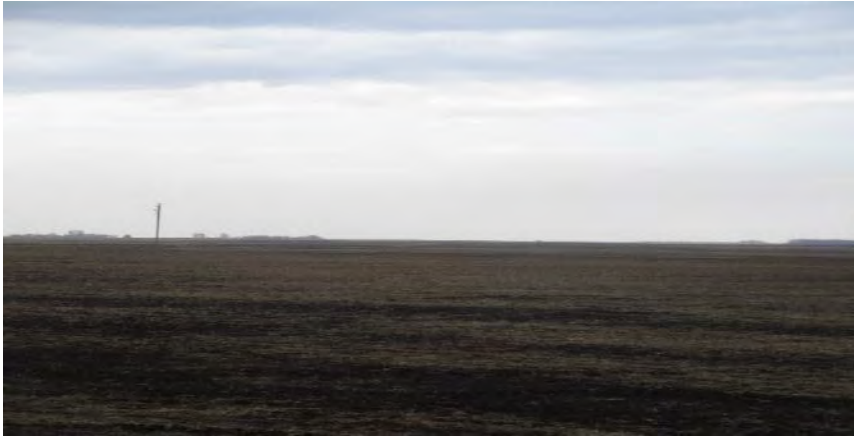
Photograph facing northwest off of an oilfield lease road showing the site. No visual impacts could be observed due to access limitations.

B6-1 was inspected on May 17th, 2018, and is located approximately 500 feet northwest of an oilfield lease road. The site could not be accessed at the time of the site visit. The site is currently used for agricultural purposes, and is surrounded by agricultural fields. Visual impacts were not able to be observed at the time of site visit due to access limitations. The site topography is generally flat and slopes to the south. An aboveground powerline was observed to the south of the oilfield lease road and west of the site.

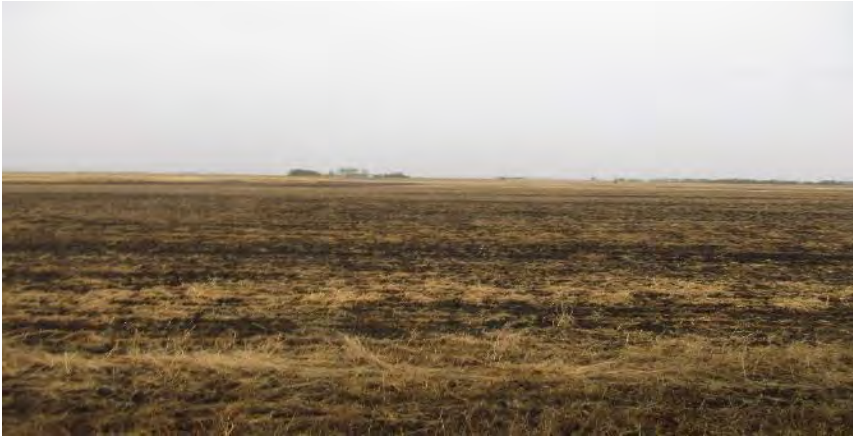
Photograph facing south off of an oilfield lease road showing the site. No visual impacts could be observed due to access limitations.

B6-2 was inspected on May 17th, 2018, and is located approximately 500 feet southwest of an oilfield lease road. The site could not be accessed at the time of the site visit. The site is currently used for agricultural purposes, and is surrounded by agricultural fields. Visual impacts were not able to be observed at the time of site visit due to access limitations. The site topography is generally flat and slopes to the north.

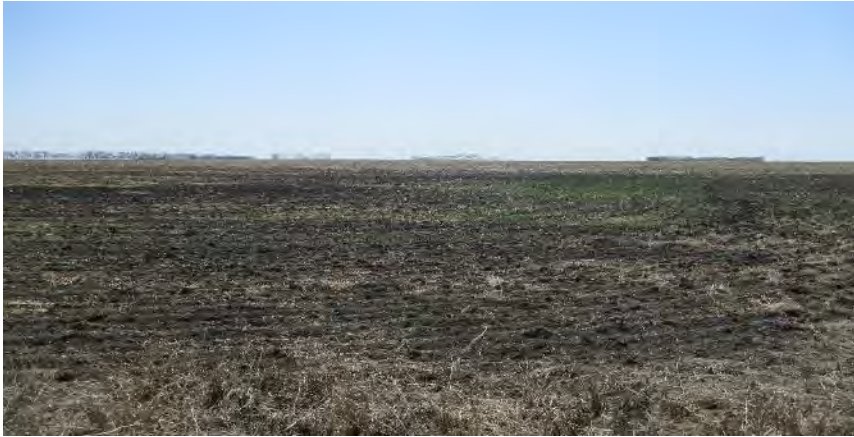
B6-3 (May 2018)

Photograph facing south off of an oilfield lease road showing the site. No visual impacts could be determined at the time of the May 17, 2018 site visit due to recent disturbance in the field.

B6-3 was inspected on May 17th, 2018 and is located approximately 1,500 feet north of 106th St. NW and 200 feet south of an oilfield lease road. The site is currently an agricultural field that was freshly plowed and is surrounded by agricultural fields. Visual impacts were not observed due to the recent disturbance. The site topography is generally flat and slopes to the west/northwest.

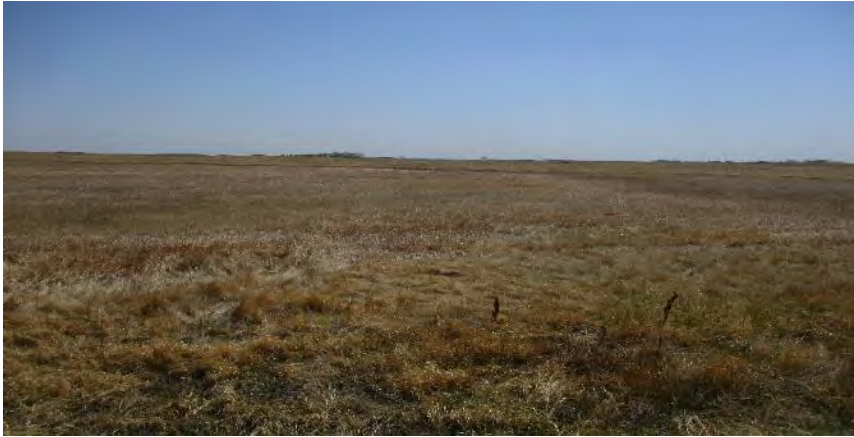
Photograph facing south off of 109th St NE showing the site. The site appears to have been recently reclaimed. No visual impacts were observed during the site visit.

B7-1 was inspected on May 16th, 2018, and is located approximately 300 feet south of 109th St NE. The site appears to be a recently reclaimed oil & gas pad. Agricultural fields lie to the south and west, and grasslands lie to the east. A wetland was observed to the east of the site. No visual impacts were observed at the time of the site visit. The site topography is generally flat and slopes to the northeast towards the wetland.

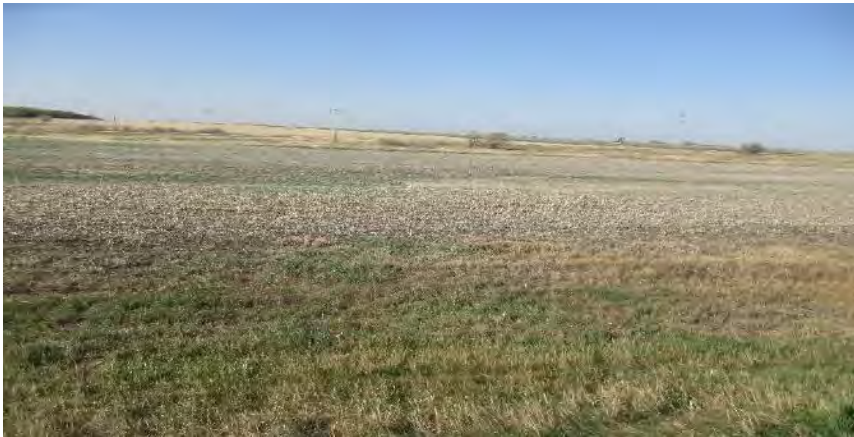
Photograph facing southwest off of an oilfield lease road showing the visually impacted area lacking vegetative growth.

B11-4 was inspected on May 16th, 2018, and is located approximately 250 feet north of 96th St NW and 50 feet south of an oilfield lease road. The site is currently used for agricultural purposes, and is surrounded by agricultural fields. An oil & gas facility lies to the east, consisting of eight aboveground storage tanks, one heater-treater, and one pump jack. A wetland was observed to the north of the site, and an intermittent stream was observed 200 feet south of the site. Visual impacts were observed, including an area of barren soil with stressed vegetation; the area of visual impacts measured approximately 40 feet by 15 feet. The site topography is generally flat and slopes to the west/southwest. An aboveground powerline was observed west of the site.

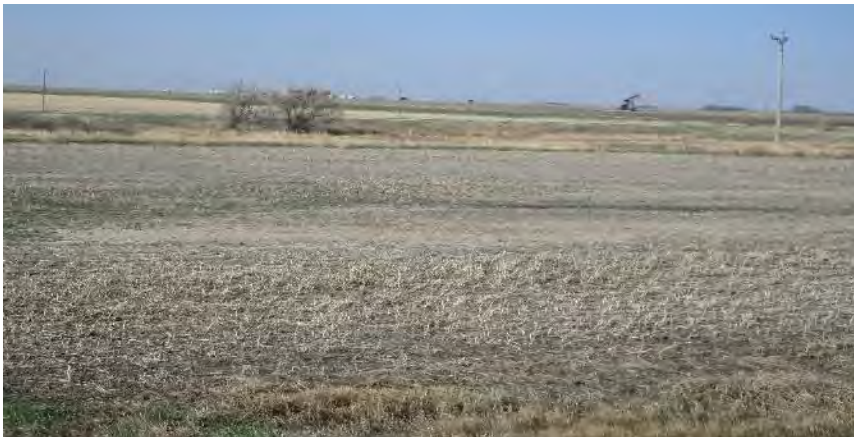
Photograph facing southwest showing a closer view of the visually impacted area located on agricultural land. Aboveground powerlines and an intermittent stream can be seen in the background.

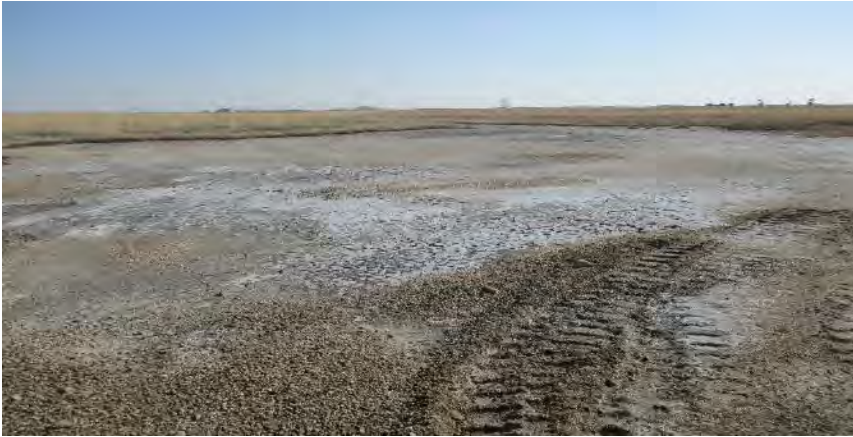
Photograph facing southwest off of an oil & gas facility showing the visually impacted area. Soil cracking and salt crusting were observed.

B13-2 was inspected on May 14th, 2018 and is located approximately 500 feet west of 23rd Ave NW and just east of an oilfield lease road. The site is currently used as an oil & gas facility, consisting of six aboveground storage tanks, one heater treater, and one horizontal vessel. Wetlands surround the site to the west, east, and south. Native grassland lies to the north. Extensive visual impacts were observed, including numerous barren areas devoid of vegetation and exhibiting salt crusting. Three major impacted areas were observed, which were located south and northwest of the oil & gas facility. The areas measured approximately 50 feet by 50 feet, 50 feet by 30 feet, and 50 feet by 50 feet. The site topography is generally flat and drains to the east.

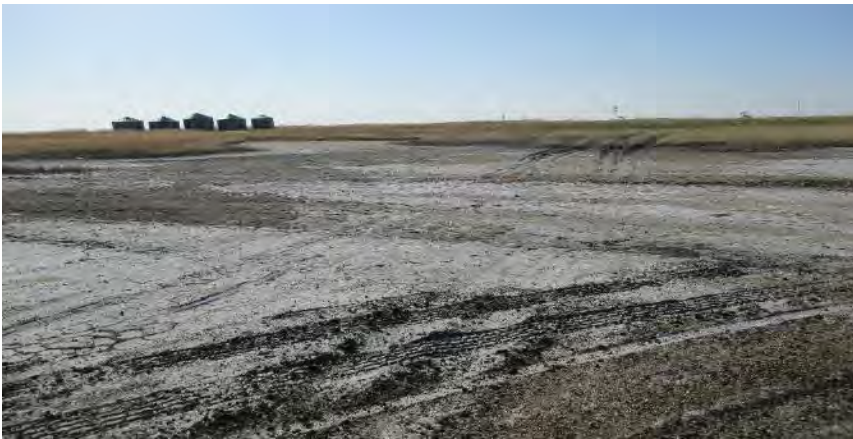
Photograph facing northwest off of an oil & gas facility showing the visually impacted area. Salt crusting and a lack of vegetative growth can be seen.

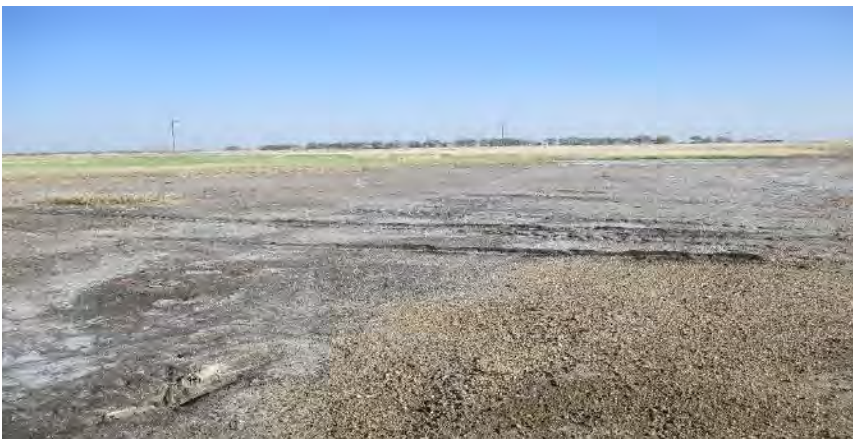
Photograph facing northeast off of an oil & gas facility showing the visually impacted area.

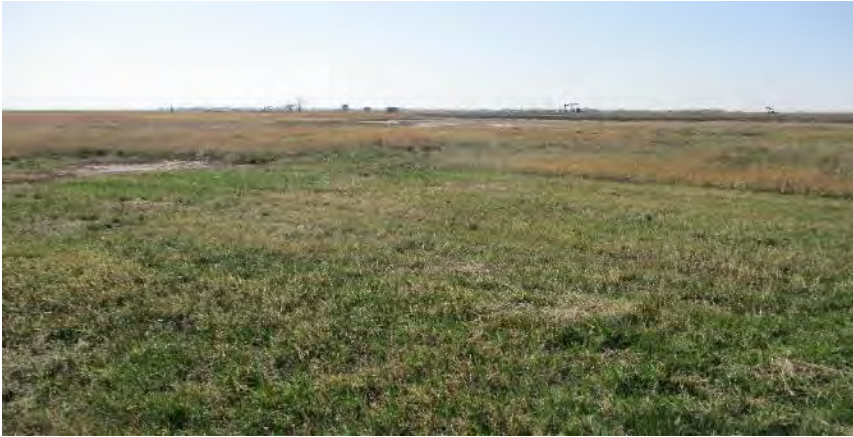
Photograph facing northeast off of an oil & gas facility showing the visually impacted area. A lack of vegetative growth can be seen.

B13-3 was inspected on May 14th, 2018 and is located approximately 500 feet north of 97th St NW and 200 feet northwest of an oilfield lease road. The site is currently grassland and also used in part for agricultural purposes. Agricultural fields lie to the north, and grasslands lie to the east and south. A wetland lies to the west. An oil & gas facility consisting of one pump jack lies to the southeast of the site. Visual impacts were observed, including a barren area devoid of vegetation and salt crusting; the area of visual impacts measured approximately 100 feet by 50 feet. Additional salt crusting was observed on the oil & gas pad to the southeast, where the pump jack is located. The site topography is generally flat and drains to the north.

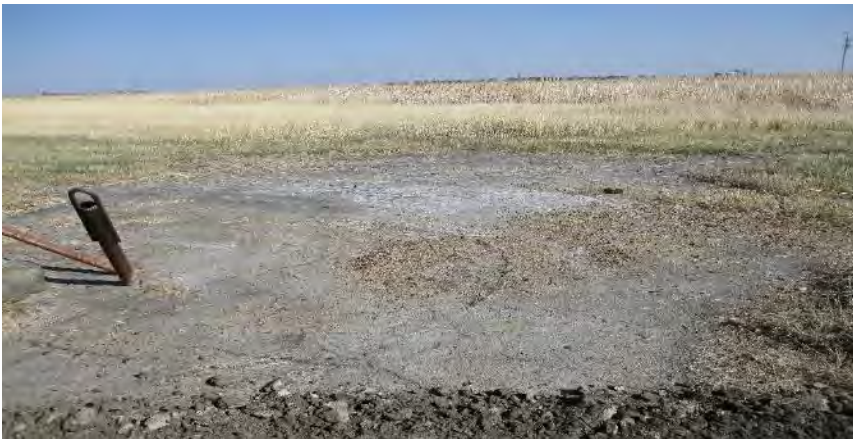
Photograph facing west off of an oil & gas facility showing additional salt crusting on an oil & gas well pad, where a pump jack was located.

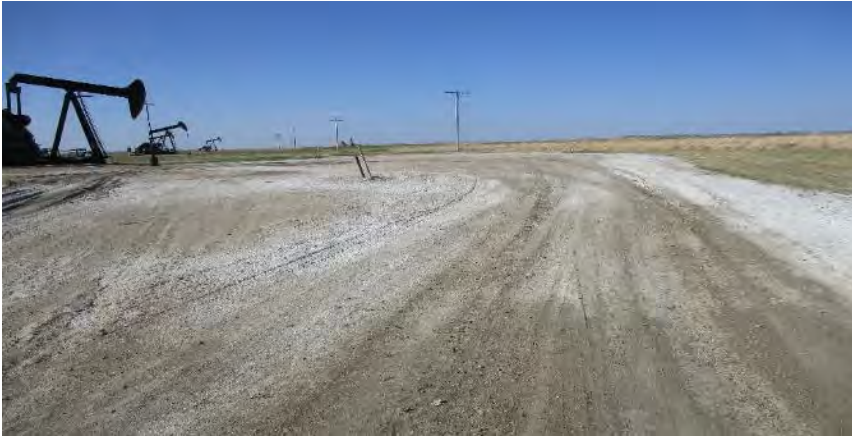
Photograph facing north off of an oil & gas well pad showing visually impacted area with salt crusting.

B13-4 was inspected on May 14th, 2018 and is located approximately 100 feet north of 97th St NW and 50 feet west of 23rd Ave NW, just south of an oilfield lease road. The site is currently used as an oil & gas facility, consisting of one pump jack. Grassland lies to the south of the site, and wetlands lie to the east and west. Another oil & gas facility consisting of one pump jack lies further north of the site. Visual impacts were observed, including salt crusting on the oil & gas pad where the pump jack is located. The impacted area measured approximately 100 feet by 50 feet. The site topography is generally flat and drains to the east. Aboveground powerlines were also observed to the south and east, running along 97th St NW and 23rd Ave NW, respectively.

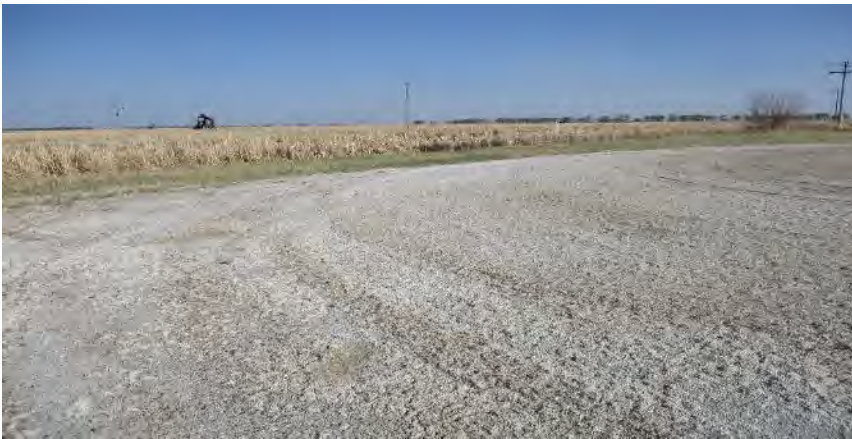
Photograph facing southeast off of an oil & gas well pad showing the visually impacted area with salt crusting. A wetland and aboveground powerlines can be seen in the background.

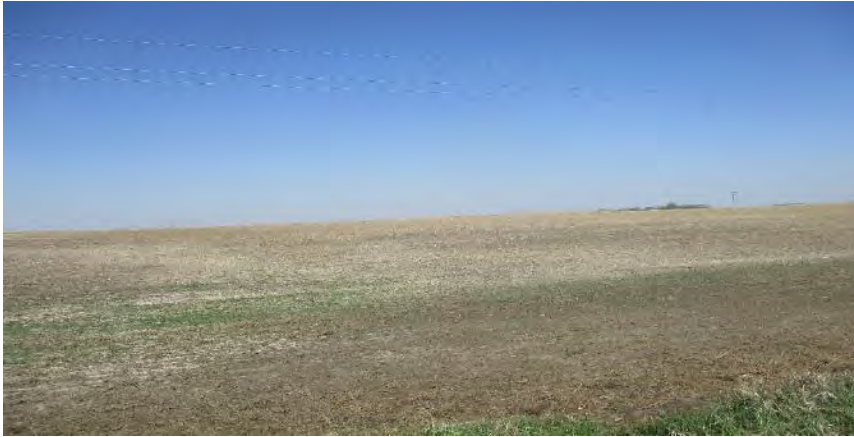
Photograph facing west off of 15th Ave SE showing the visually impacted area with stressed vegetation.

B14-5 was inspected on May 16th, 2018, and is located approximately 50 feet west of 15th Ave SE. The site is currently used for agricultural purposes and is surrounded by agricultural fields. A wetland was observed to the east of the site, past 15th Ave SE. Visual impacts were observed, including lighter colored soils and stressed vegetation; the area of visual impacts measured approximately 50 feet by 25 feet. The site topography is generally flat and slopes to the north/northeast. Aboveground powerlines were observed to the east of the site, along 15th Ave SE.

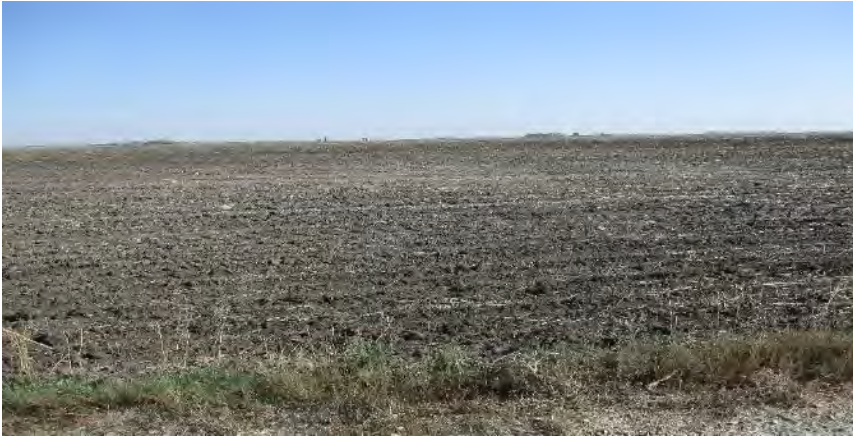
Photograph facing north off of an oilfield lease road showing the visually impacted area with some barren soils and slightly stressed vegetation.

B14-8 was inspected on May 16th, 2018 and is located approximately 600 feet north of 98th St NW and just north of an oilfield lease road. The site is currently used for agricultural purposes and is surrounded by agricultural fields. An oil & gas facility was observed to the north, consisting of two aboveground storage tanks, one heater treater, and one pump jack. Visual impacts were observed, including an area of slightly barren ground with slightly stressed vegetation; the area of visual impacts measured approximately 50 feet by 20 feet. The site topography is generally flat and slopes to the southwest. Aboveground power lines and an underground oil & gas pipeline were observed to the north of the site, along 98th St NW.

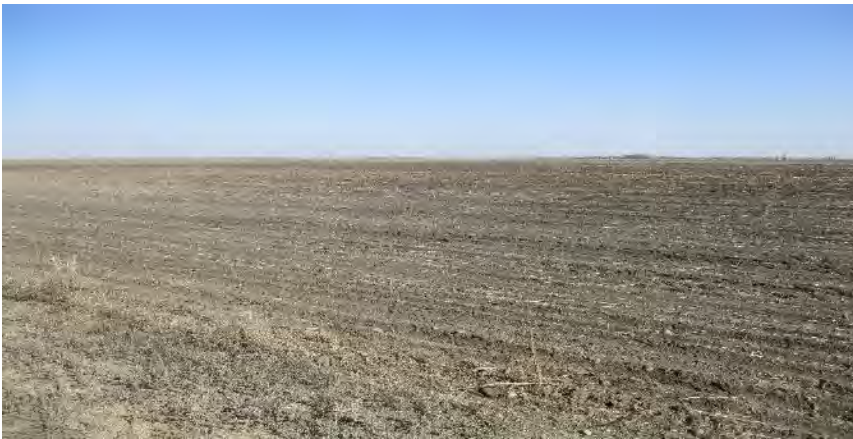
Photograph facing north west off of an oilfield lease road showing the visually impacted area.

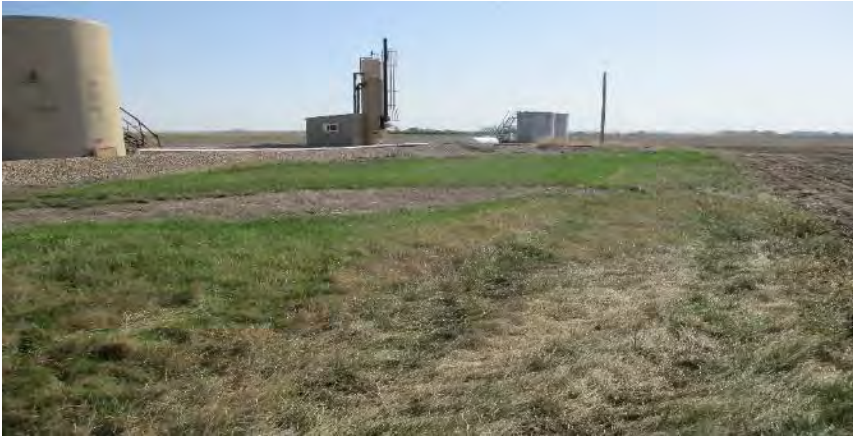
Photograph facing west off of an oil & gas facility showing the visually impacted area with little vegetative growth.

B14-9 was inspected on May 16th, 2018 and is located approximately 700 feet south of 99th St NW and just south of an oilfield lease road. The site is an agricultural field that was recently plowed and is surrounded by agricultural fields. An oil & gas facility was observed to the north, consisting of three aboveground storage tanks, one heater treater, and one pump jack. Visual impacts were observed, including an area of slightly barren ground with stressed vegetation; the area of visual impacts measured approximately 25 feet by 10 feet. The impacts appeared to be migrating from the oil & gas pad from the north. Stressed vegetation was also observed in the plowed agricultural field but appeared to be a result of the ground disturbance. The site topography is generally flat and slopes to the south/southeast. Aboveground powerlines were observed to the north of the site, on the oil & gas pad, running to the south across the site.

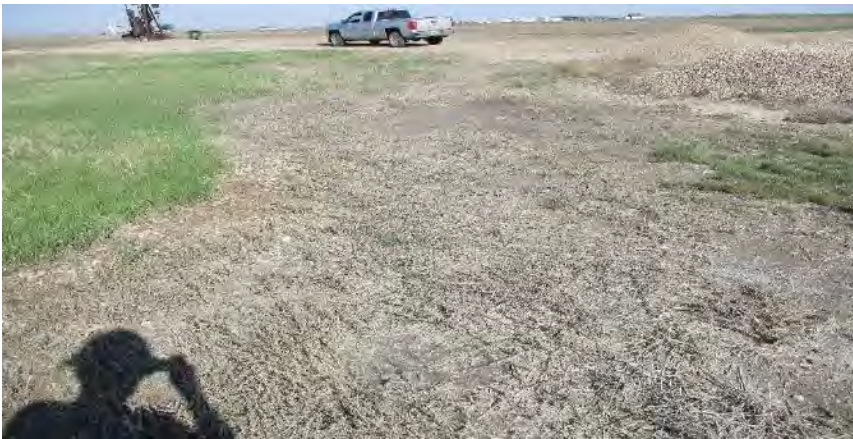
Photograph facing northwest showing the visually impacted area with stressed vegetation. The impacts appeared to be migrating from the oil & gas facility that lies to the north.

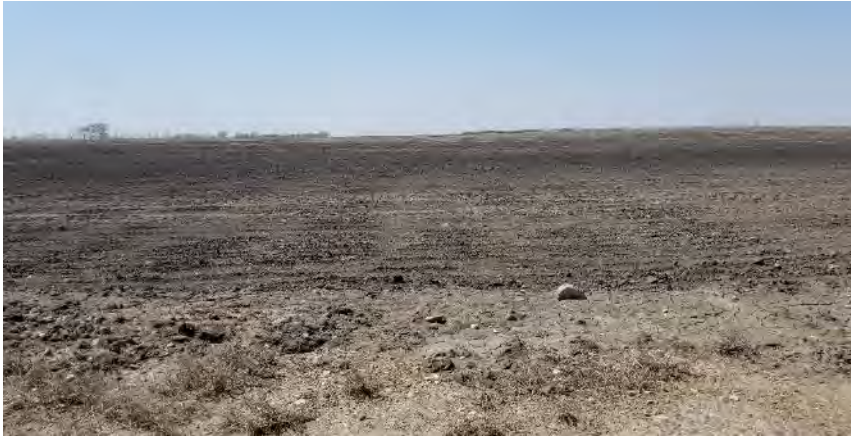
Photograph facing north off of an oil & gas facility showing the visually impacted area directly adjacent to the facility. The agricultural field to the north of the site can be seen in the background.

B14-15 was inspected on May 15th, 2018, and is located at the end of an oilfield lease road. The site is currently used in part for agricultural purposes, and in part as an oil & gas facility measuring approximately 500 feet by 100 feet. The facility consists of two pump jacks and one shack. Agricultural fields surround the site. Visual impacts were observed, including salt crusting and barren soils along the north and west edges of the oil & gas pad. The area of visual impacts measured approximately 200 feet by 100 feet in total. The site topography is generally flat and slopes to the north.

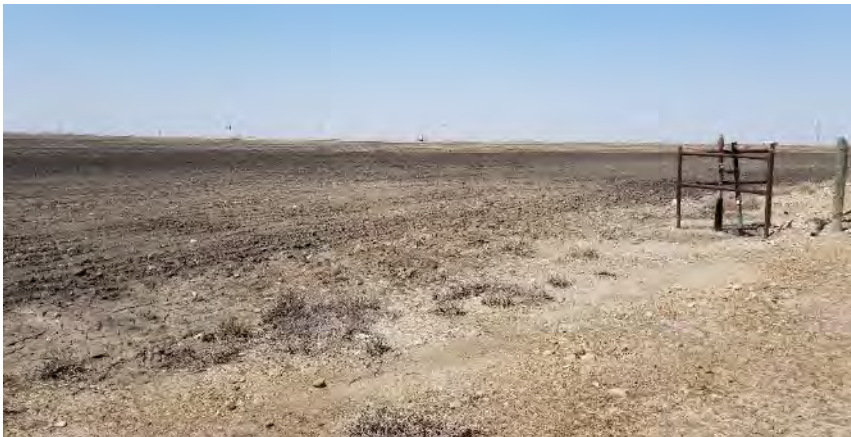
Photograph facing northeast off of the oil & gas facility showing the visually impacted area adjacent to the facility. The agricultural field surrounding the site can be seen in the background.

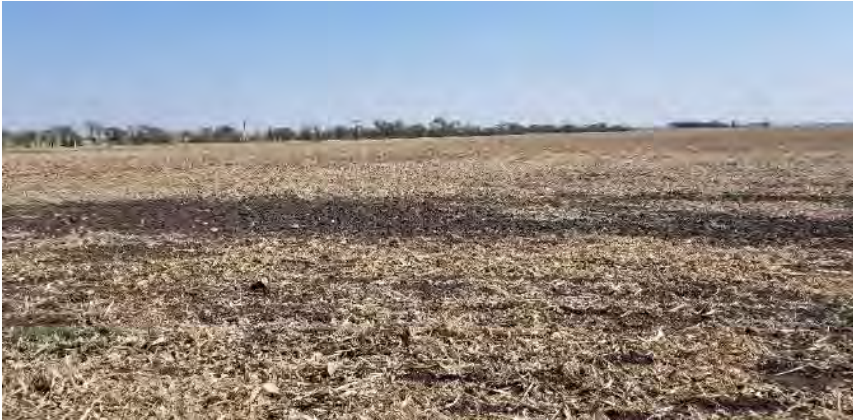
Photograph facing east off of an oil & gas facility showing the visually impacted area with slightly stressed vegetation.

B14-17 was inspected on May 15th, 2018, and is located approximately 150 feet south of an oilfield lease road. The site is currently used for agricultural purposes, and is surrounded by agricultural fields. An oil & gas facility was also observed to the west, consisting of one pump jack. Minimal visual impacts were observed, including slightly stressed vegetation; the area of visual impacts measured approximately 40 feet by 20 feet. The site topography is generally flat, slightly undulating, and slopes to the southeast.

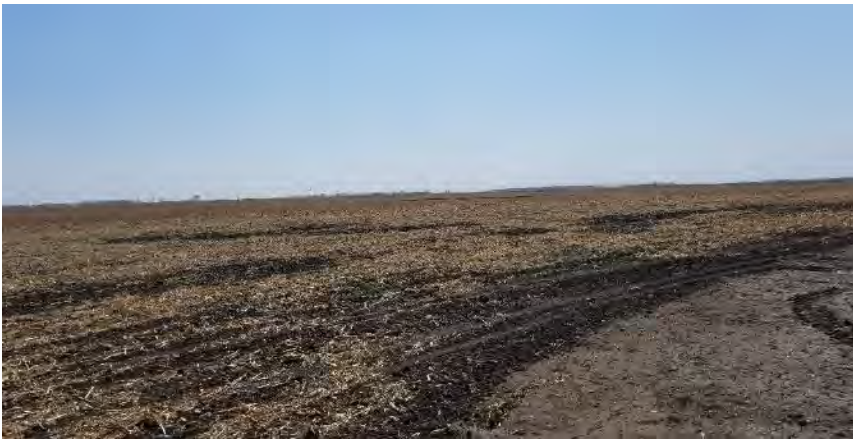
Photograph facing southeast off of an oil & gas facility showing the visually impacted area with slightly stressed vegetation. The site is located in an agricultural field.

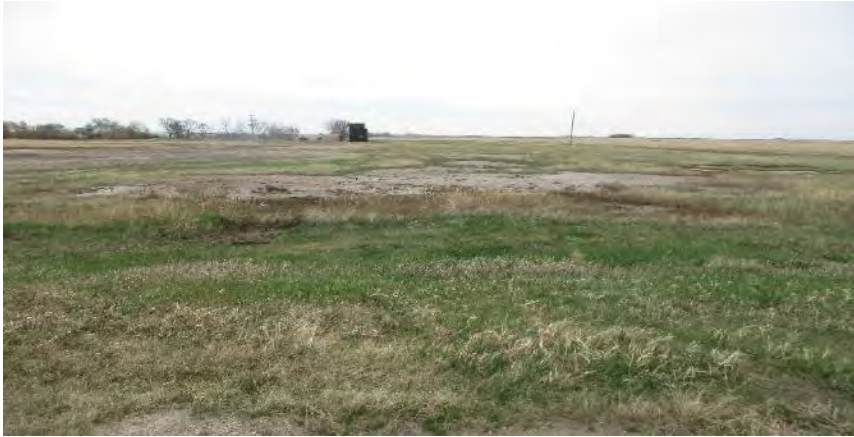
Photograph facing west off of an oilfield lease road showing the visually impacted area. Barren soil lacking vegetative growth and stressed vegetation can be seen.

B20-2 was inspected on May 10th, 2018, and is located approximately 100 feet east of 35th Ave NW and 50 feet north of an oilfield lease road. The site is currently native grassland. Agricultural fields lie to the north and south. Grassland lie to the east and west. An oil & gas facility consisting of two aboveground storage tanks was also observed to the east/northeast. A wetland was observed to the north/northeast of the site. Visual impacts were observed, including barren ground lacking vegetation and salt crusting; the area of visual impacts measured approximately 100 feet by 100 feet. Within this area, hydrocarbon impacts were observed in an area approximately 10 feet by 10 feet. The site topography is generally flat and slopes slightly to the northwest. An Enbridge underground petroleum product pipeline was observed to the north of the site, and aboveground powerlines were observed to the west of the site.

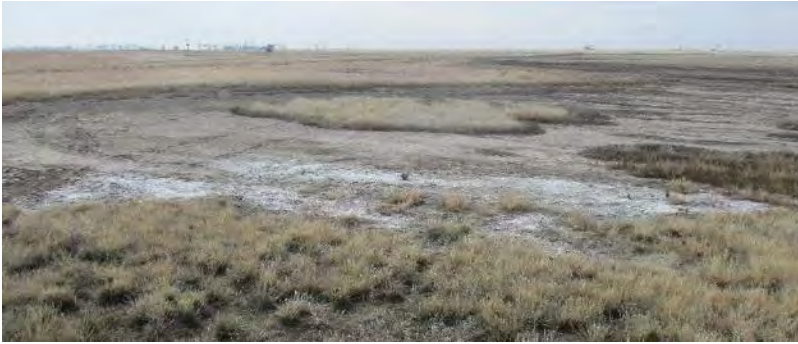
Photograph facing south/southeast off of an oilfield lease road showing visually impacted area, including barren soil and salt crusts. 93rd St NW is approximately 1,000 feet north of site.

B21-4 was inspected on May 2nd, 2018, and is located approximately 1,000 feet south of 93rd St NW and 25 feet south of an oilfield lease road. The site is currently native grassland with wetlands to the north and east. Agricultural fields are located to the south. Oil & gas facilities were observed to the north, consisting of seven aboveground storage tanks, a pump jack, a shack, and other miscellaneous oilfield equipment. Visual impacts were observed, including barren ground, salt crusts, and stressed vegetation; the area of visual impacts measured approximately 100 feet by 50 feet. The site topography is predominantly flat and drains to the south.

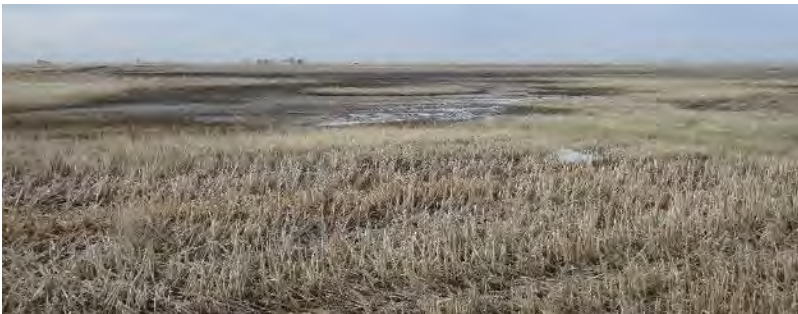
Photograph facing south off of an oilfield lease road showing visually impacted area. A wetland is located along the oilfield lease road.

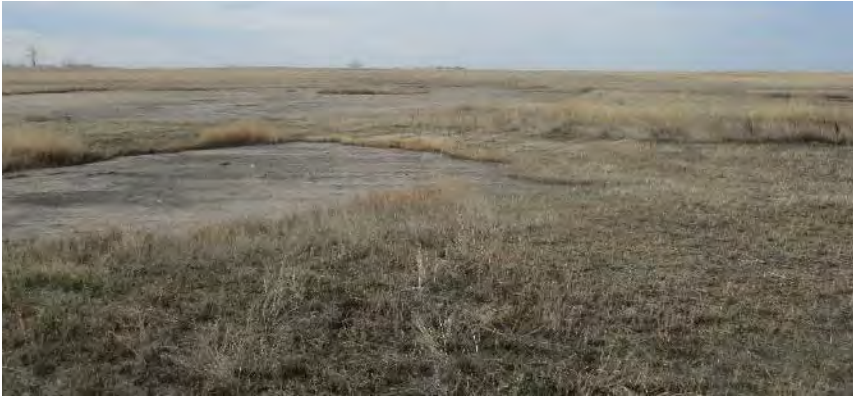
Photograph facing south off of an oilfield lease road showing visually impacted area. The site is on native grassland, with a wetland to the west and agricultural fields to the east.

B21-5 was inspected on May 2nd, 2018, and is located approximately 50 feet south of an oilfield lease road. The site is currently native grassland with wetlands approximately 100 feet to the east. Agricultural fields lie to the west and south. An oil & gas facility was observed to the north, consisting of four aboveground storage tanks, a pump jack, and a shack. Visual impacts were observed, including barren ground and stressed vegetation; the area of visual impacts measured approximately 400 feet by 200 feet. The site topography slopes inward to a depression at the center of the site.
