NDIC Brine Pond Study

Phase II: Site Assessments

June 25, 2018

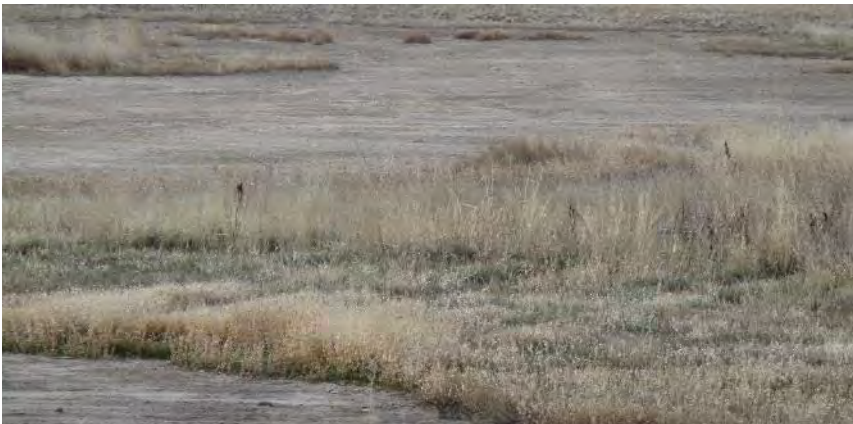
B21-5

Photograph facing south off of oilfield lease road showing close up of visual impact area. Salt crusts and extensive dead zones are visible.

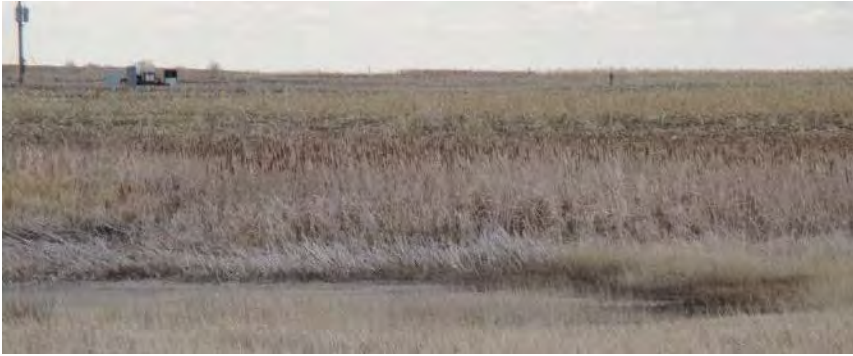
Photograph facing south off of an oilfield lease road showing visually impacted area. Site is on native grassland adjacent to a wetland to the south.

B21-6 was inspected on May 2nd, 2018, and is located approximately 200 feet west of 25th Ave NW and 100 feet south of an oilfield lease road. The site is currently native grassland with wetlands to the east and south. Agricultural fields are located to the north and south. Oil & gas facilities were observed to the north, consisting of four aboveground storage tanks, a pump jack, two horizontal separators, a shack, and other miscellaneous oilfield equipment. Visual impacts were observed, including barren ground and stressed vegetation; the area of visual impacts measured approximately 20 feet by 20 feet. The site topography slopes inward toward a depression at the center of the site. Aboveground powerlines and underground oil & gas lines were observed to the north, in the vicinity of the oil & gas facilities.

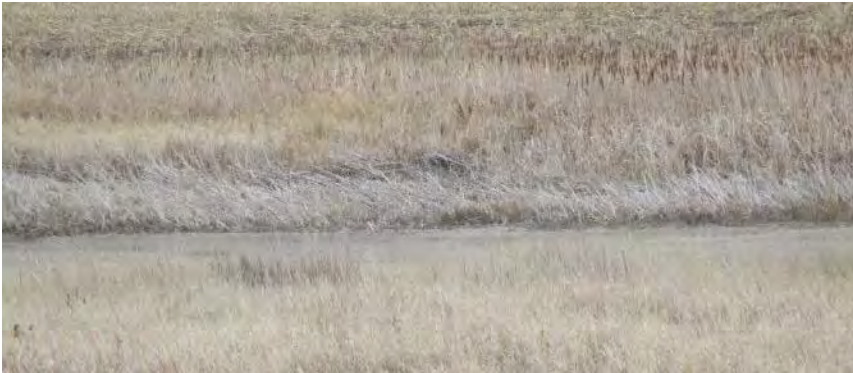
Photograph facing south off of an oilfield lease road showing close up of visually impacted area. Extensive dead zones were observed.

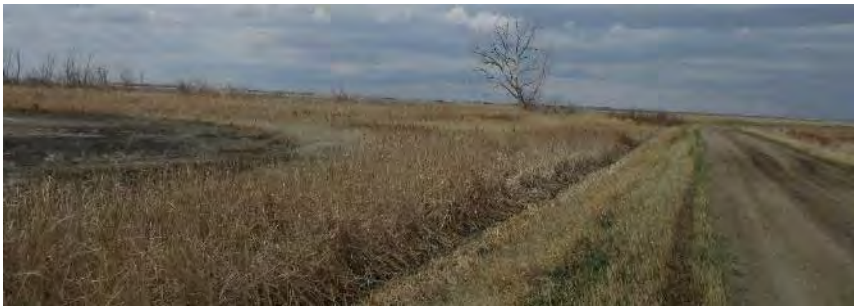
B21-7

Photograph facing southwest off of an oilfield lease road showing impacted area and wetland along the road.

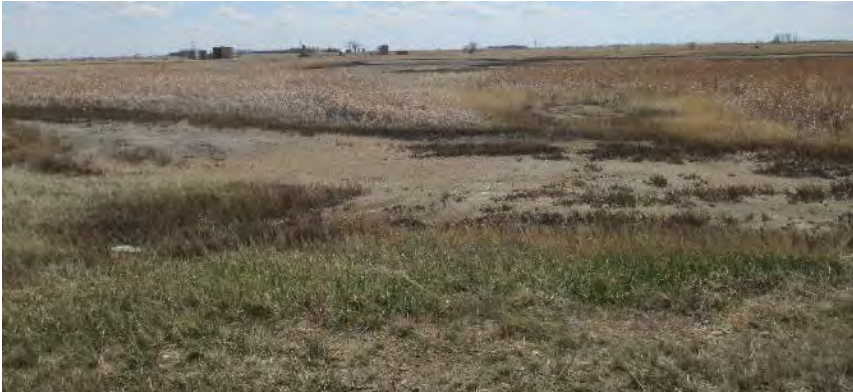
Photograph facing southwest off of an oilfield lease road showing two large visually impacted areas. The site is located on native grassland.

B21-9 was inspected on May 2nd, 2018, and is located approximately 200 feet north of 92nd St NW. The site is currently native grassland and is surrounded by grasslands. Oil & gas facilities were observed further to the southeast and northwest. Visual impacts were observed, including two areas of extensively barren soils with little to no vegetation. The western area is approximately 200 feet by 200 feet and the eastern area is approximately 400 feet by 300 feet. The site topography is generally flat and generally slopes to the north. The west side of the site slopes to a slight depression towards the center of the site.

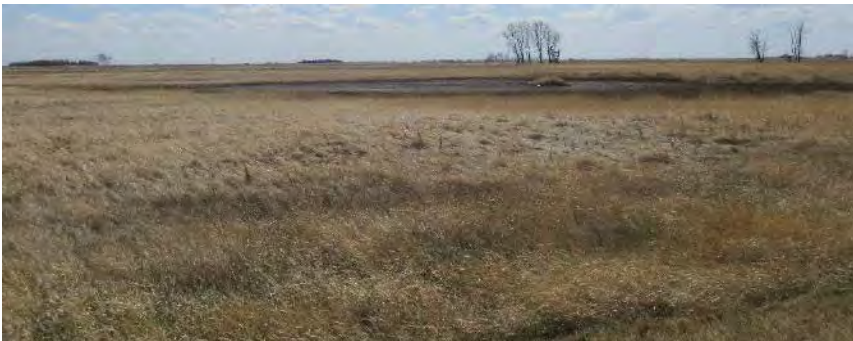
Photograph facing south-southwest off of an oilfield lease road showing one visually impacted area of approximately 200 feet by 200 feet.

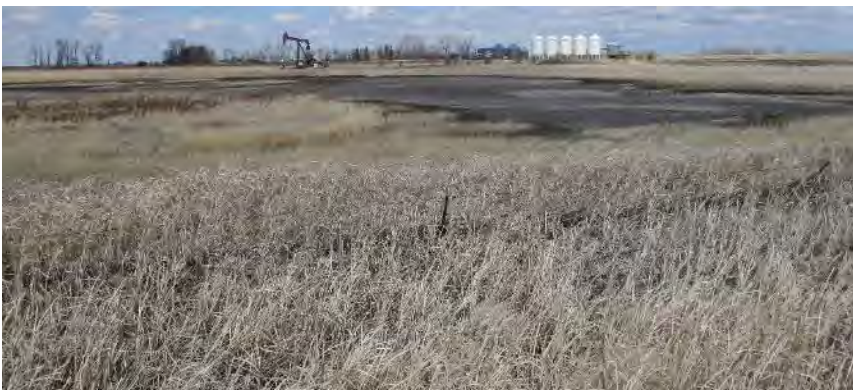
Photograph facing north-northeast off of 92nd St NW showing another visually impacted area of approximately 400 feet by 300 feet.

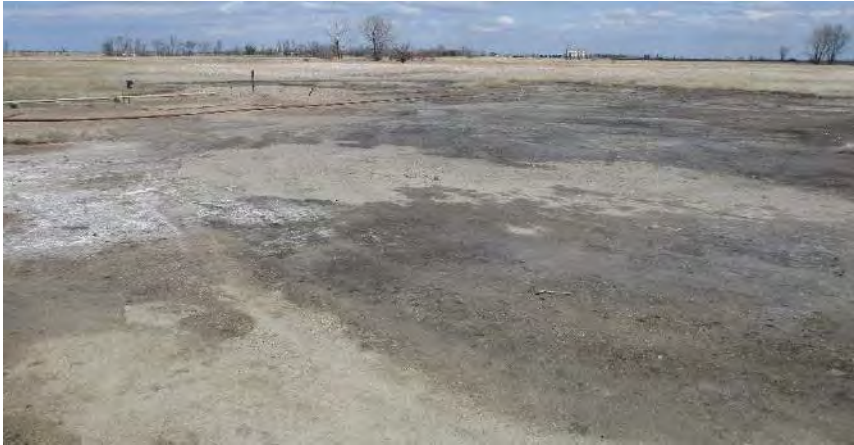
Photograph facing northeast off of an oilfield lease road, showing visually impacted area. The site is approximately 100 feet east of an oil & gas facility. Extensive dead zones and salt crusts were observed.

B21-14 was inspected on May 2nd, 2018, and is located approximately 500 feet south of 92nd St NW and 100 feet east of an oilfield lease road. The site is currently native grassland, with agricultural fields to the north and grasslands to the west, south, and east. An oil & gas facility was also observed to the west, consisting of six aboveground storage tanks and other oilfield equipment. Wetlands were observed to the north, east, and south of the site. Visual impacts were observed, including extensive dead zones, salt crusts, and soil cracks; the area of visual impacts measured approximately 100 feet by 50 feet. The site topography is generally flat, and slopes towards a depression at the center of the site. Aboveground pipelines were observed on-site, and an aboveground powerline was observed to the west/southwest.

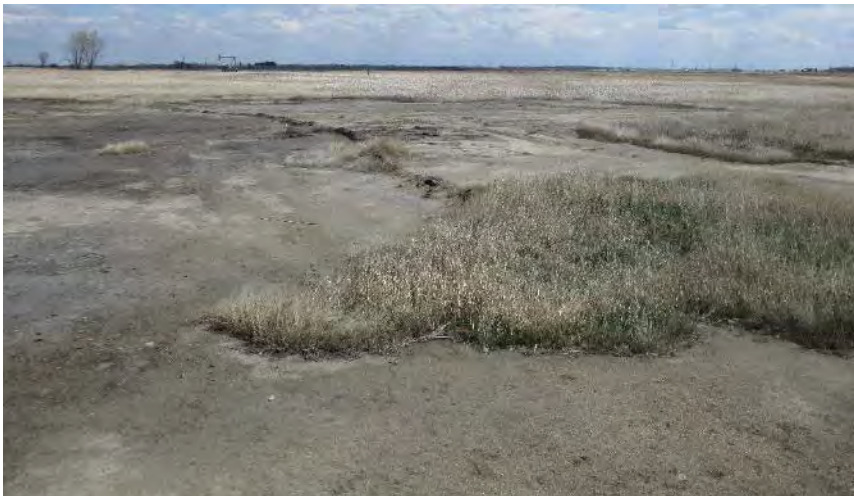
Photograph facing east off of an oilfield lease road showing large patches of barren ground and stressed vegetation.

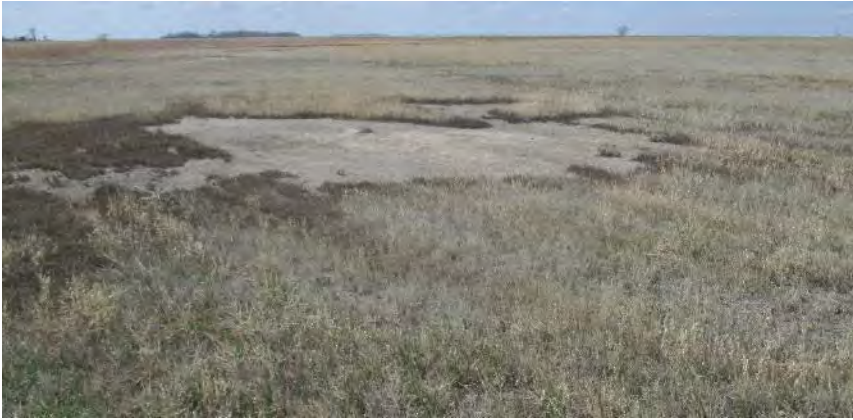
Photograph facing north off of an oilfield lease road, showing visually impacted area measuring approximately 100 feet by 100 feet.

B21-15 was inspected on May 2nd, 2018, and is located approximately 600 feet east of 25th Ave NW and 200 feet north of an oilfield lease road. The site is currently native grassland and is surrounded by grasslands. An oil & gas facility was observed to the northeast, consisting of two pump jacks. A wetland was also observed to the south of the site. Visual impacts were observed, including extensive dead zones and stressed vegetation, in three areas. The areas measured approximately 100 feet by 100 feet, 25 feet by 25 feet, and 50 feet by 20 feet. The site topography is generally flat and gently slopes towards the south and southwest. Impacted areas appear to drain south to the wetland.

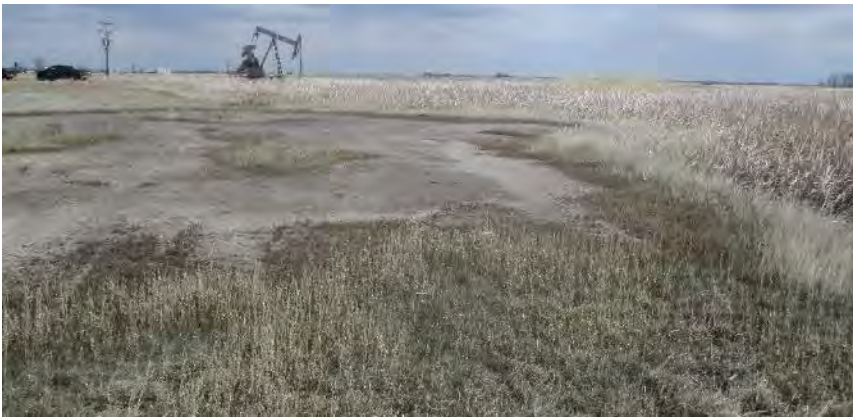
Photograph facing east-northeast off of an oilfield lease road, showing an extensive dead zone. Site is approximately 150 feet west of a pump jack. The site is on native grassland adjacent to wetlands to the south and east.

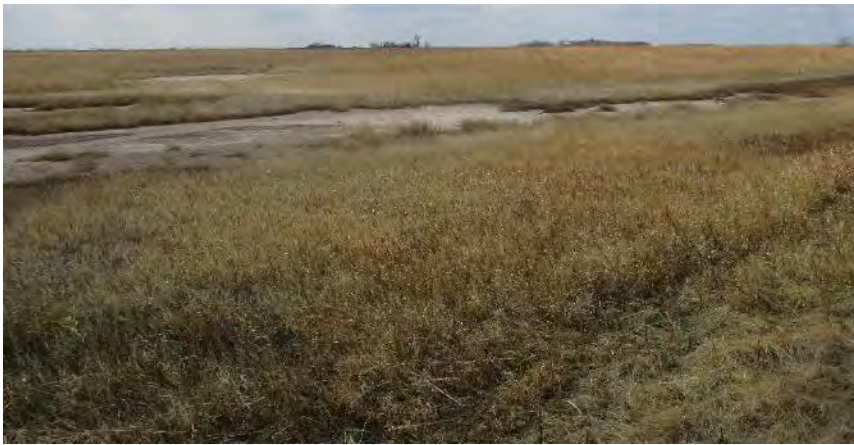
B21-16

Photograph facing southwest off of oilfield lease road showing site along road, with extensive dead zones and stressed vegetation.

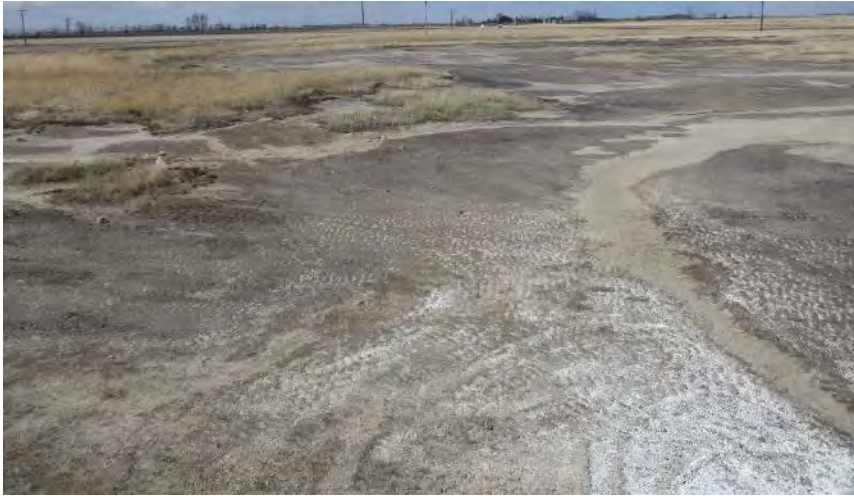
Photograph facing north off of an oilfield lease road showing a visually impacted area. Extensive dead zones, salt crusts, and soil cracks were observed. The site is on native grassland adjacent to agricultural land.

B21-18 was inspected on May 2nd, 2018, and is located approximately 500 feet west of 25th Ave NW and just north of oilfield lease road. The site is currently native grassland, and is surrounded by agricultural land. An oil & gas facility was also observed to the south, consisting of eight aboveground storage tanks, numerous shacks, and other miscellaneous oilfield equipment. A wetland was observed to the north. Visual impacts were observed, including extensive dead zones, soil cracks, and salt crusts; the area of visual impacts measured approximately 200 feet by 200 feet. The site topography is relatively flat and slightly drains to the northwest. Aboveground powerlines were observed to the north of the site, and an underground powerline was observed to the south.

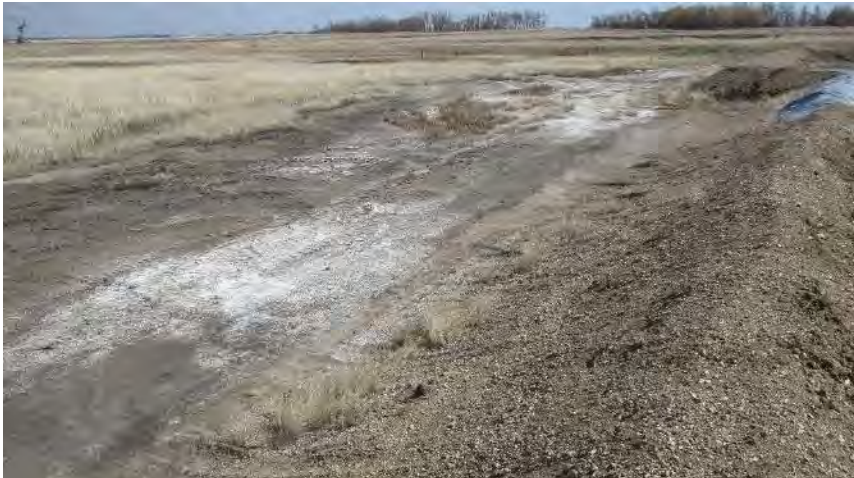
Photograph facing southeast off of oilfield lease road. Large section of salt crusting is visible along berm.

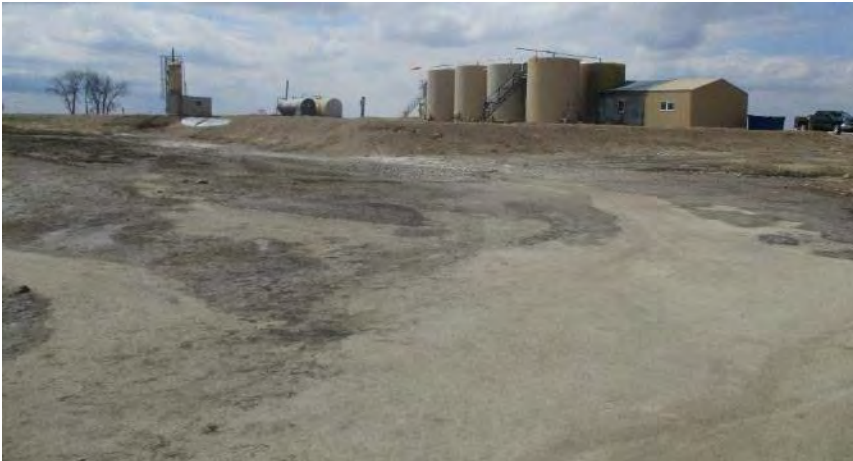
Photograph facing southwest off of an oilfield lease road. Large sections of barren ground, soil cracks, erosion, and salt crust along berm were observed.

B21-19 was inspected on May 2nd, 2018, and is located approximately 500 feet west of 25th Ave NW and 25 feet north of an oilfield lease road. The site is currently native grassland, and is surrounded by agricultural land. An oil & gas facility was observed to the south, consisting of eight aboveground storage tanks, a heater treater, and a horizontal separator. A wetland and residential areas were observed to the northeast. Visual impacts were observed, including extensive dead zones, soil cracks, and salt crusts; the area of visual impacts measured approximately 500 feet by 375 feet. The site topography is relatively flat and slopes to the north/northeast. The impacts appear to be migrating from the oil & gas facility located to the south. An aboveground powerline was observed to the north.

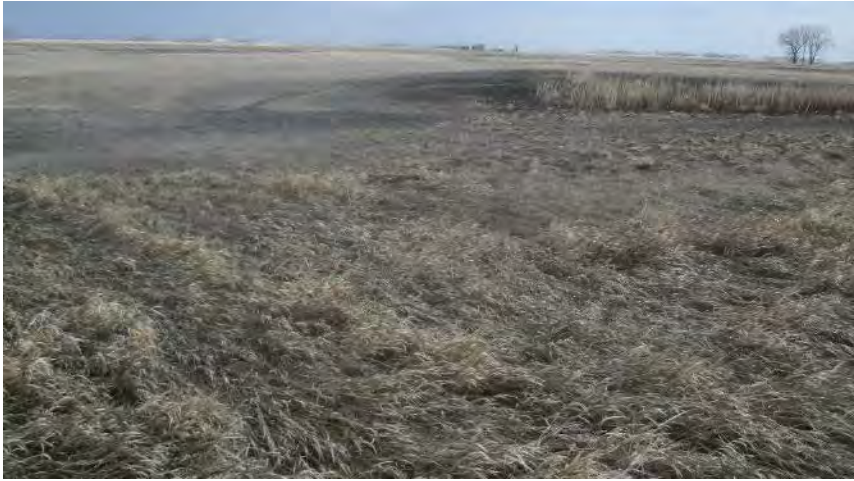
Photograph facing northeast from 91st St NW. Site could not be accessed due to it being located on private agricultural land. No evidence of visual impacts in the agricultural field was apparent.

B21-22 was inspected on May 2nd, 2018, and is located approximately 600 feet north of 91st St NW. The site could not be accessed at the time of the site visit. The site is currently used for agricultural purposes, and is surrounded by agricultural fields. No visual impacts were observed from a distance at the time of the site visit. Wetlands were observed to the east. The site is generally flat, and a drainage direction could not be determined due to access limitations.

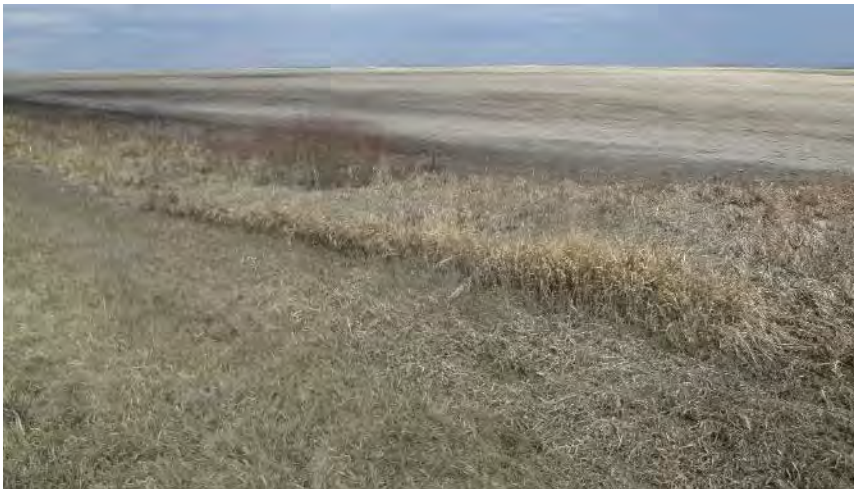
Photograph facing northwest from 91st St NW. Site could not be accessed due to it being located on private agricultural land.

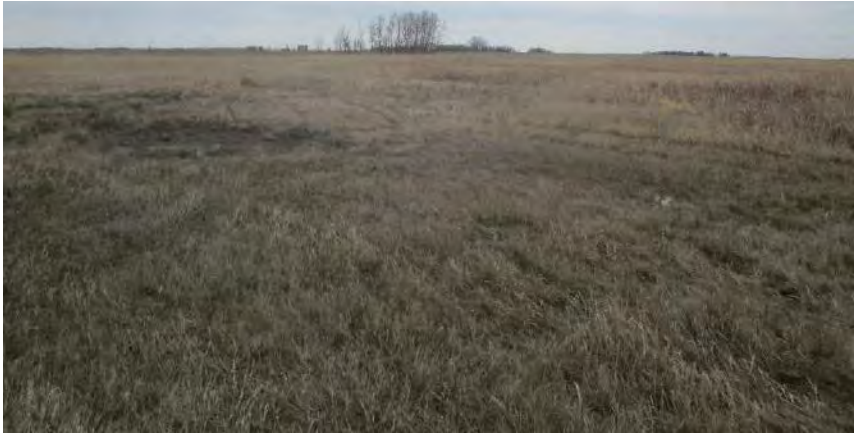
Photograph facing south from an oilfield lease road. Site could not be accessed due to it being located on private land. No evidence of visual impacts at the site was apparent.

B21-23 was inspected on May 2nd, 2018, and is located approximately 600 feet south of an oilfield lease road. The site could not be accessed at the time of the site visit. The site is currently native grassland, surrounded by agricultural fields. An oil & gas facility was observed to the northeast, consisting of a shack and pipe rack. No visual impacts were observed from a distance at the time of the site visit. Wetlands were observed to the east. The site is generally flat, and a drainage direction could not be determined due to access limitations.

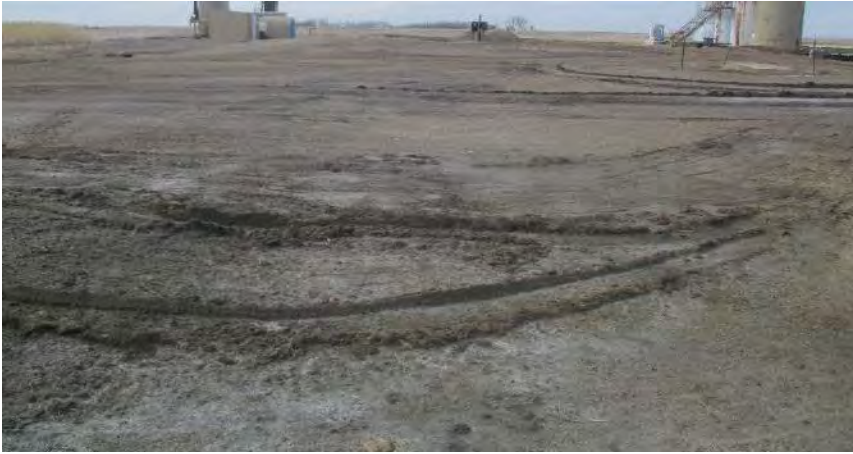
Photograph facing south on an oilfield lease road showing salt crusts and barren soils. The site is partly used as an oil & gas facility.

B21-25 was inspected on May 2nd, 2018, and is located approximately 400 feet west of 24th Ave NW. The site is partly used as an oil & gas facility, consisting of 10 aboveground storage tanks, two heater treaters, a shack, and miscellaneous oilfield equipment. The site is surrounded by grasslands. Visual impacts were observed, including dead zones, soil cracks, and salt crusts. The impacts were located on the oil & gas production pad, and measured approximately 40 feet by 30 feet. The site topography is predominantly flat and drains to the south.

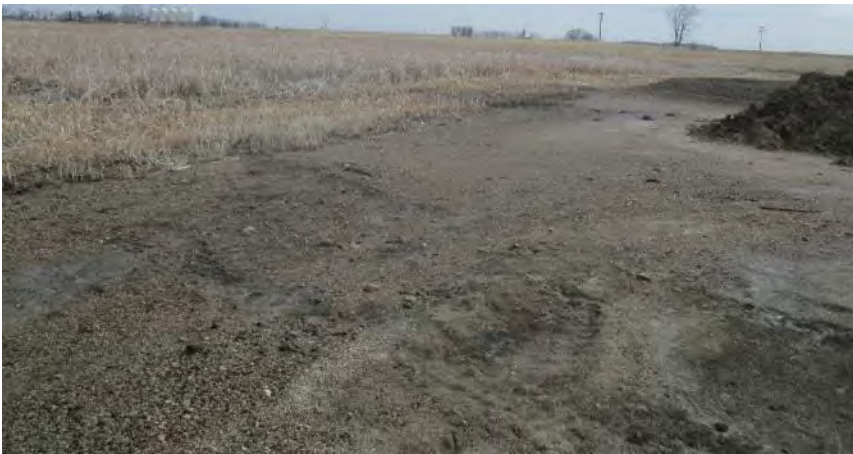
Photograph facing northeast from oilfield production pad showing dead zone and stressed vegetation.

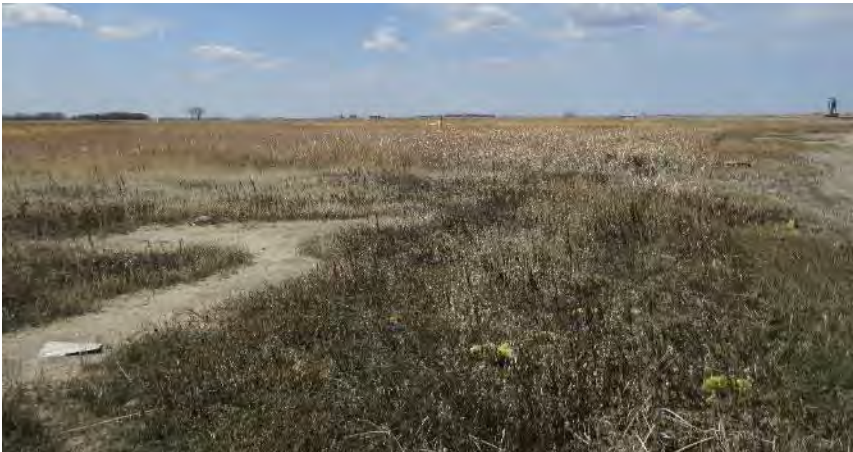
Photograph facing southwest off of an oilfield lease road showing the site. Wetlands can be seen in the background.

B22-4 was inspected on May 3rd, 2018, and is located approximately 50 feet south of an oil & gas facility. The site is approximately 200 feet east of an oilfield lease road. The site is partly native grassland, and partly used as an oil & gas facility. Oilfield equipment consisted of four aboveground storage tanks, a flare, and a separator, and a shack. Visual impacts were observed, including patches of barren ground, stressed vegetation, salt crusts, and cracks in the surface soils. The impacts were generally located in one area measuring approximately 50 feet by 20 feet. Wetlands were observed immediately west and east of the impacted areas. Agricultural land lies to the south of the site. The site topography is predominantly flat, slightly undulating, and drains to the south/southeast. An Enbridge underground petroleum pipeline was apparent to the west of the site.

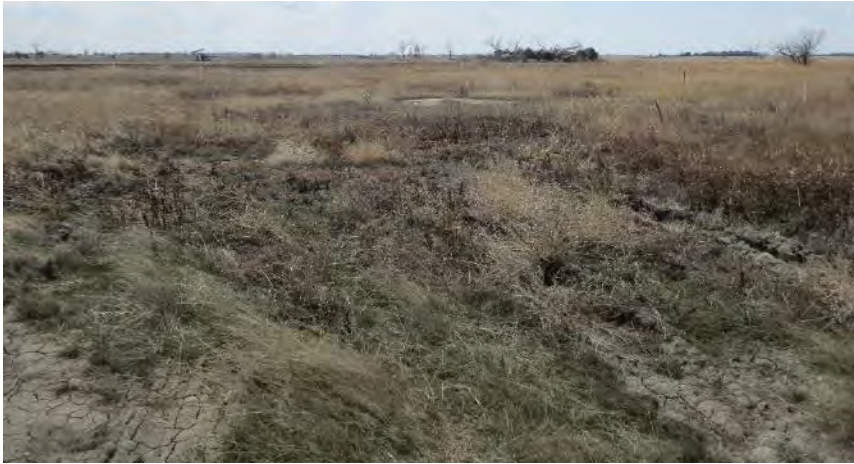
Photograph facing south off of an oilfield lease road showing the site. Dead zones and stressed vegetation were observed.

Photograph facing west off of an oil & gas pad showing soil cracks, salt residues, and barren zones.

B22-8 was inspected on May 3rd, 2018, and is located approximately 500 feet west of 23rd Ave NW and 50 feet south of an oilfield lease road. The site is extensively surrounded by wetlands. An oil & gas facility was observed to the north, consisting of eight aboveground storage tanks, a heater treater, and a horizontal separator. Agricultural land lies further north of the lease road. A barren area with no vegetation was observed at the site, measuring approximately 50 feet by 20 feet. A power pole was observed to the north, indicating underground utilities may be found at the site. The site drains slightly to the southwest.

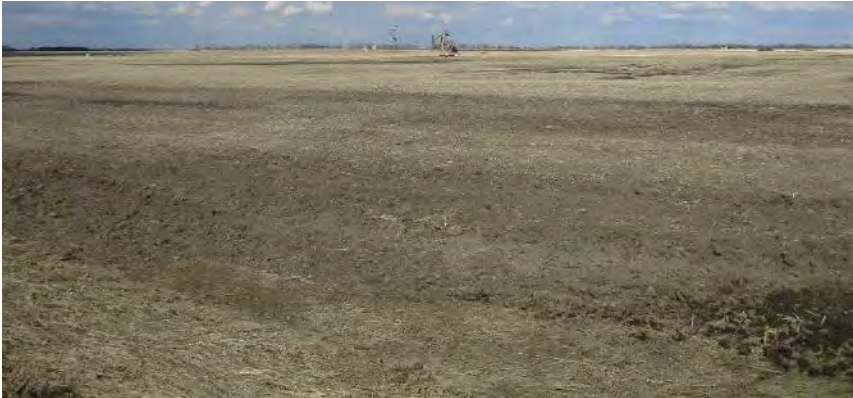
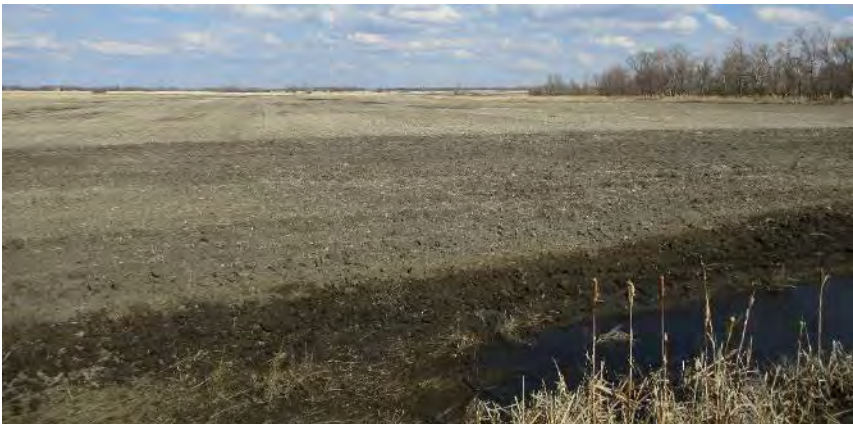
Photograph facing northeast off of 24th Ave NW showing an area of barren soils with no vegetation.

Photograph facing south off of 24th Ave NW showing the visually impacted area. Standing water was observed in a ditch along 24th Ave NW, as can be seen in the bottom right-hand corner of the photograph.

B22-9 was inspected on May 2nd, 2018, and is located approximately 300 feet east of 24th Ave NW and 500 feet south of an oilfield lease road. The site is currently used for agricultural purposes, and is surrounded by agricultural fields. A pump jack and a wetland were apparent further to the north. Visual impacts were observed, including an area of little to no vegetation and patchy ground; the area of visual impacts measured approximately 150 feet by 50 feet. The site topography is generally flat, and drains to the area where the visual impacts were observed, which appeared to be a low spot compared to the rest of the site.

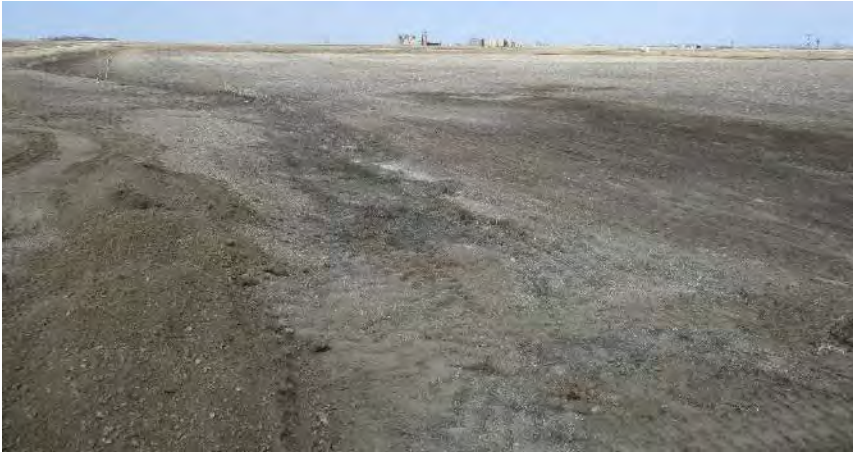
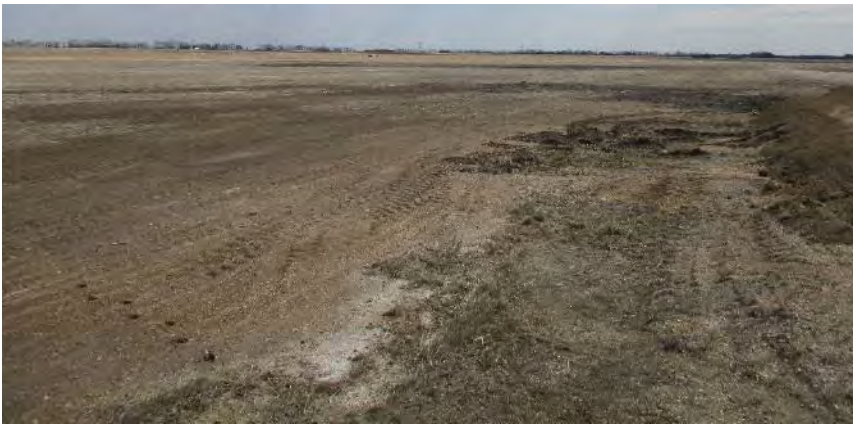
Photograph facing west off of an oilfield lease road showing stressed vegetation, dead zones, and salt crusts at the site.

Photograph facing east off of an oilfield lease road showing stressed vegetation, dead zones, and salt crusts.

B22-11 was inspected on May 3rd, 2018, and is located approximately 500 feet east of 24th Ave NW and 10 feet north of the terminating point of an oilfield lease road. The site is currently used for agricultural and oil & gas purposes. A pump jack was apparent to the south, on the lease road. Agricultural fields surround the site otherwise. Visual impacts were observed, including stressed vegetation, a lack of vegetation, and apparent salt crusting; the area of visual impacts measured approximately 50 feet by 20 feet. The site topography is generally flat and drains to the east/southeast. An underground power line was observed to the southeast.

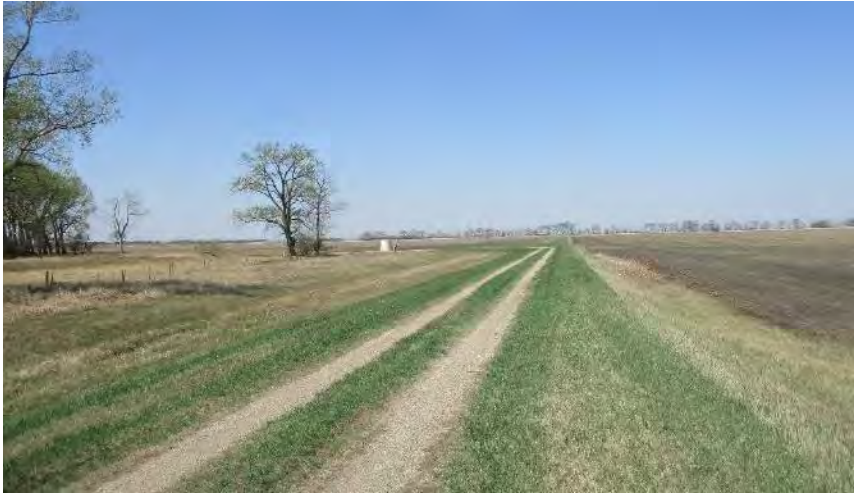
Photograph facing west off of 12th Ave NW showing the site. The site could not be accessed at the time of the site visit. No visual impacts were observed from a distance.

B23-1 was inspected on May 15th, 2018, and is located 500 feet west of 12th Ave NW and 50 feet south of an oilfield lease road. The site could not be accessed at the time of the site visit. The site is currently used for agricultural purposes. Agricultural fields lie to the north, west, and south. An oil & gas facility was observed to the east, and consisted of a single shack. Grasslands lie further to the east, before 12th Ave NW. Visual impacts could not be observed from a distance at the time of the site visit. The site topography is predominantly flat, but drainage direction could not be determined due to access limitations.

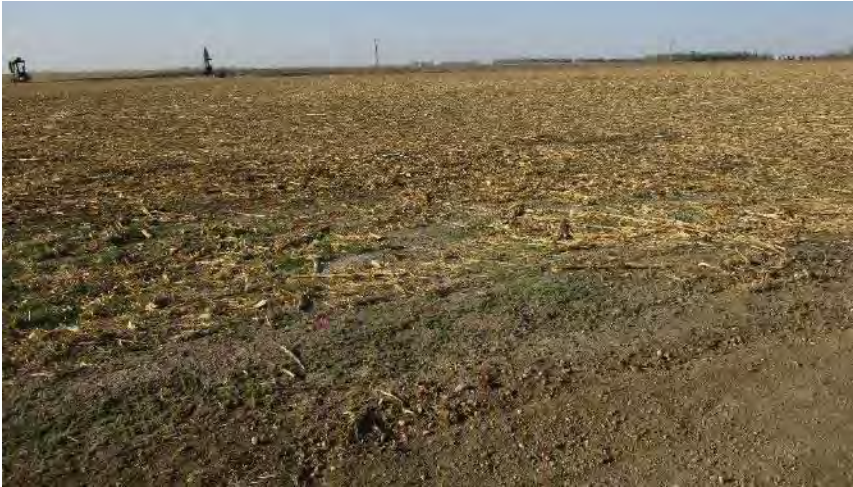
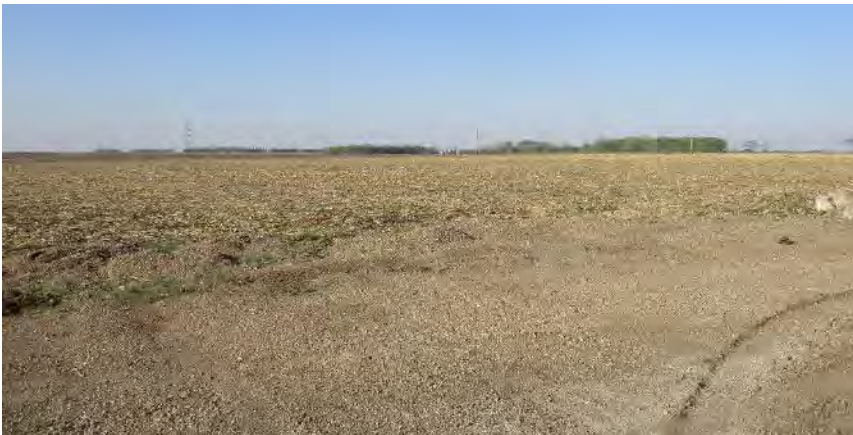
Photograph facing south off of an oilfield lease road showing the site. No visual impacts were observed.

Photograph facing southwest off of an oilfield lease road. Aboveground powerlines are visible in the background, approximately 500 feet south of site.

B24-1 was inspected on May 15th, 2018, and is located approximately 100 feet west of an oilfield lease road. The site is currently used for agricultural purposes, and is surrounded by agricultural fields. An oil & gas facility was observed to the northeast, consisting of a heater treater, shack and a storage tank. Visual impacts were not observed at the time of the site visit. A slight depression was observed at the site in the middle of the agricultural field. The site topography is generally flat and drains towards the depression.

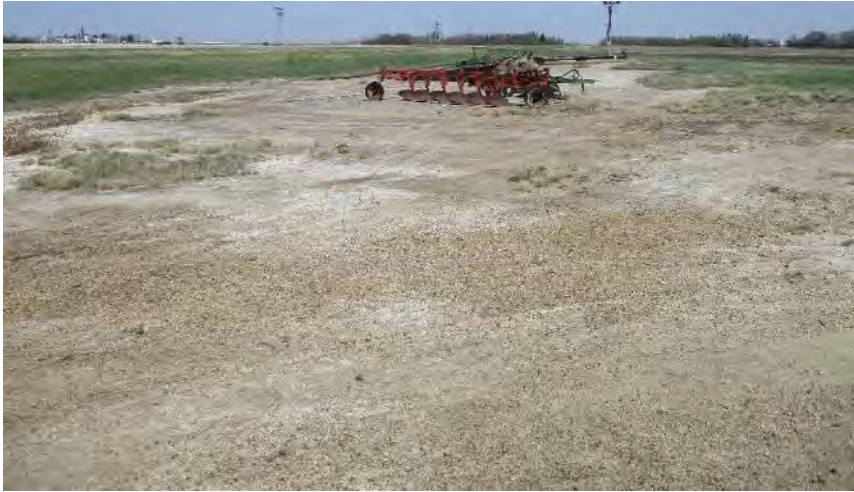
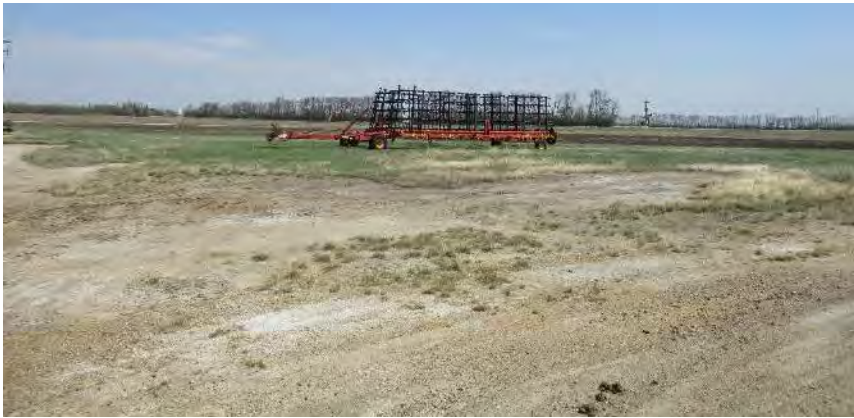
Photograph facing north off of an oilfield lease road showing the visually impacted area. Extensive dead zones, cracks, and salt crusts are visible. Aboveground powerlines were observed at the site running along 10th Ave NW

Photograph facing northeast off of an oilfield lease pad showing the visually impacted area. Farming equipment is parked on-site.

B24-2 was inspected on May 15th, 2018, and is located approximately 50 feet east of 10th Ave NW and 50 feet north of an oil & gas facility. The site is currently a combination of natural grassland, agricultural field, and an oil & gas facility. The oil & gas facility consisted of a heater treater, storage tank, and shack. Agricultural fields lie to the north, east, and west. Visual impacts were observed, including an area of barren soil with little to no vegetation and salt crusting; the area of visual impacts measured approximately 100 feet by 100 feet. The site topography is generally flat and drains south and west. Aboveground powerlines were observed over the site, along the east side of 10th Ave NW. Farming equipment were also observed on the site.

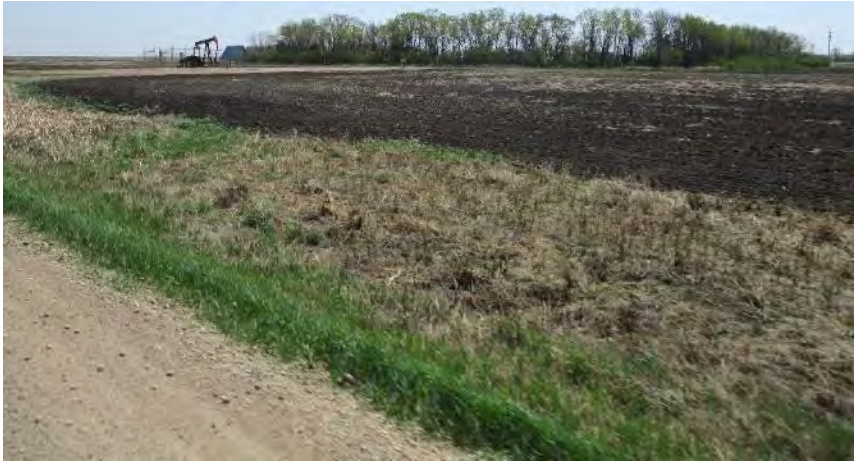
B24-5 (May 2018)

Photograph facing southeast off of an oilfield lease road showing the site. No visual impacts were observed at the time of the May 15, 2018 site visit. A pump jack is visible in the background.

Photograph facing southwest off of an oilfield lease road showing the site. The site is located on agricultural lands.

B24-5 was inspected on May 15th, 2018 and is located approximately 500 feet north of 92nd St NW and 100 feet south of an oilfield lease road. The site is currently used for agricultural purposes, and is surrounded by agricultural fields. A pump jack is located to the east of the site and oil & gas facilities, consisting of 14 above ground storage tanks, heater treater, separator, and various shacks. No visual impacts were observed during the site visit. The site topography is generally flat and drains to the west.

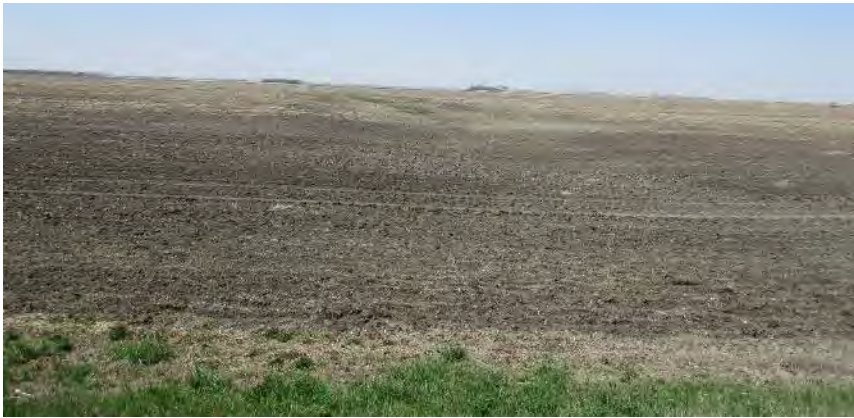
Photograph facing west off of 9th Ave NW showing the visually impacted area in a trough like depression. Aboveground powerlines are located on the east side of 9th Ave NW and a barn is located approximately 300 feet to the south.

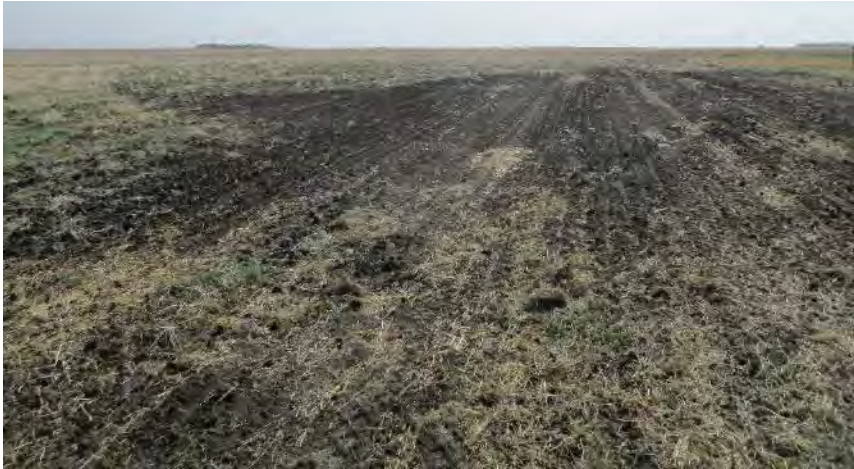
Photograph facing east off of an oilfield lease road showing the visually impacted area. Stressed vegetation and dead zones were observed.

B25-7 was inspected on May 15th, 2018, and is located approximately 20 feet north of an oilfield lease road. The site is currently used for agricultural purposes, and is surrounded by agricultural fields. An oil & gas facility was observed to the south of the site, consisting of one pump jack. Visual impacts were observed, including an area of barren soils measuring approximately 20 feet by 10 feet, and an area of stressed vegetation measuring approximately 50 feet by 20 feet. The site topography is generally flat and slopes to the north. An underground powerline appears to service the pump jack, to the south.

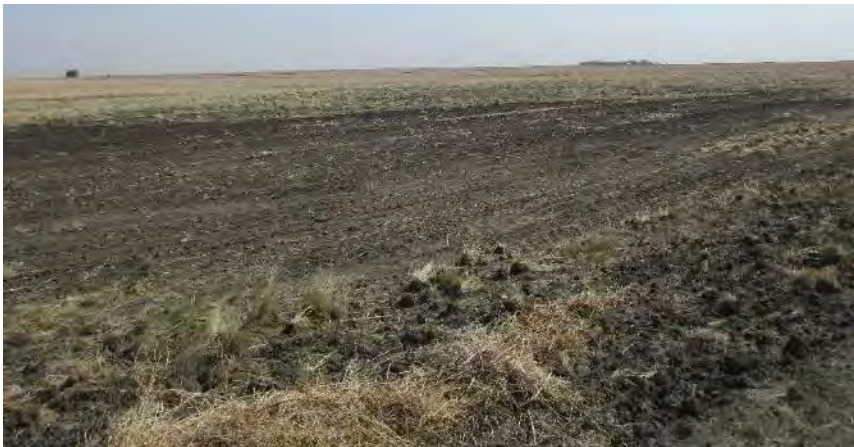
Photograph facing northeast off of an oilfield lease road showing the visually impacted area in an agricultural field. The site is adjacent to a pump jack, which is located approximately 20 feet south of site.

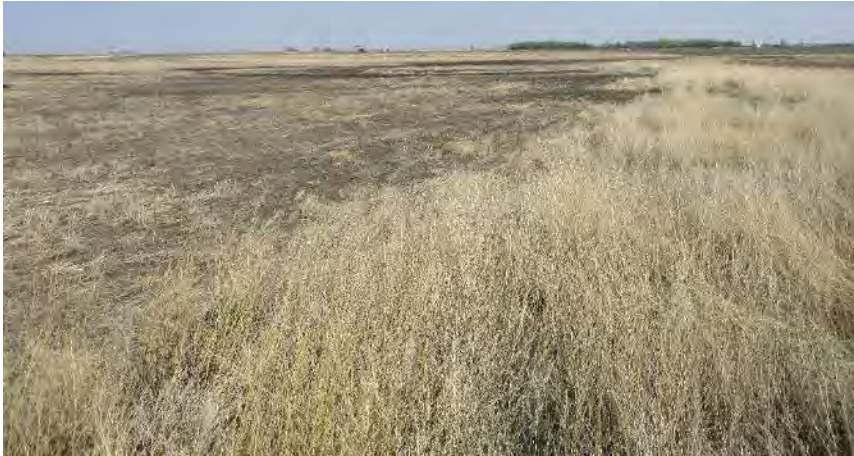
Photograph facing southeast off of an oilfield lease road showing the visually impacted area. Stressed vegetation with barren spots were observed. The site is adjacent to an oilfield pad.

B41-1 was inspected on May 14th, 2018, and is located approximately 200 feet east of an oilfield lease road. The site is currently used for agricultural purposes. Agricultural fields lie to the north and south. A wetland lies to the east, and an oil & gas facility lies to the west. The oil & gas facility consisted of five aboveground storage tanks, a heater treater, and one pump jack. Visual impacts were observed, including a barren area with stressed vegetation; the area of visual impacts measured approximately 500 feet by 50 feet. The site topography is generally flat and drains to the east. Odors of hydrocarbon and hydrogen sulfide were also observed during the site visit.

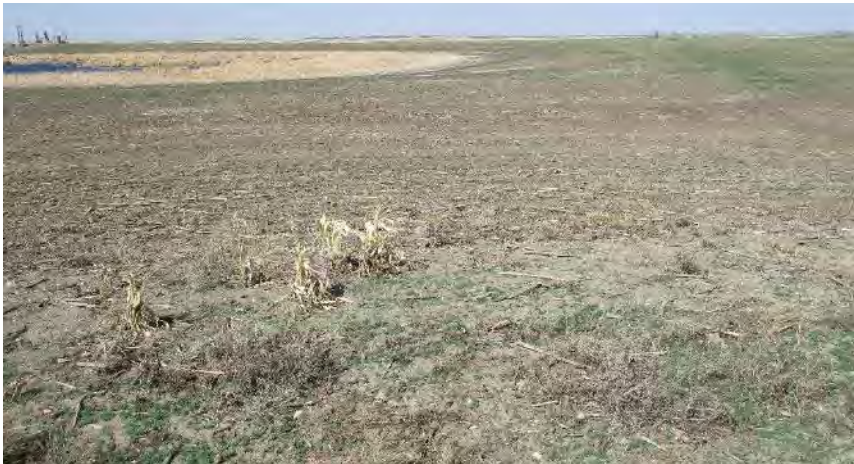
Photograph facing northeast off of an oilfield lease road showing the visually impacted area. Lighter soils and salt crusts were observed around the southeast edge of the wetland.

B41-2 was inspected on May 14th, 2018, and is located approximately 100 feet north of an oilfield lease road. The site is currently used for agricultural purposes. Agricultural fields lie to the east and west. A wetland and pond lie to the north, and an oil & gas facility lies to the south. The oil & gas facility consisted of one wellhead with chemical injection equipment. Visual impacts were observed, including stressed vegetation and salt crusting; the area of visual impacts measured approximately 25 feet by 10 feet. Barren soils were also observed along the southeast edge of the wetland, measuring approximately 50 feet by 5 feet. The site topography is generally flat and drains to the north.

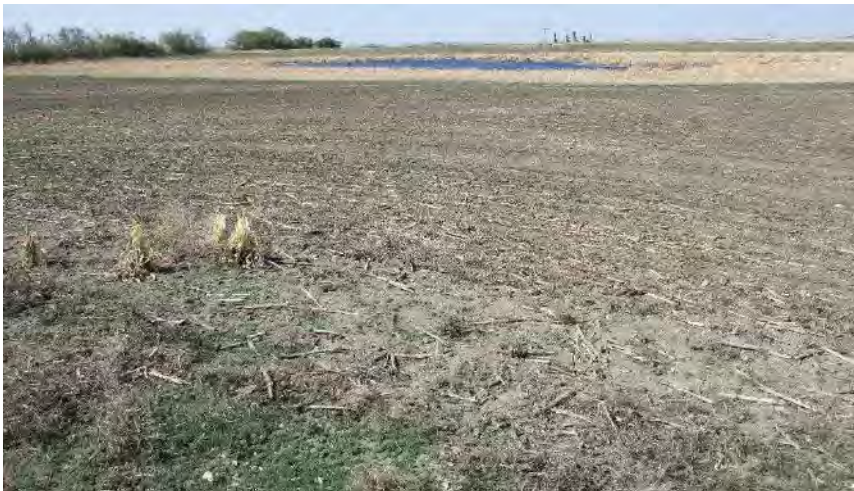
Photograph facing north off of an oilfield lease road showing the visually impacted area and wetland located approximately 50 feet to the north of site. Stressed vegetation is visible within the agricultural field.

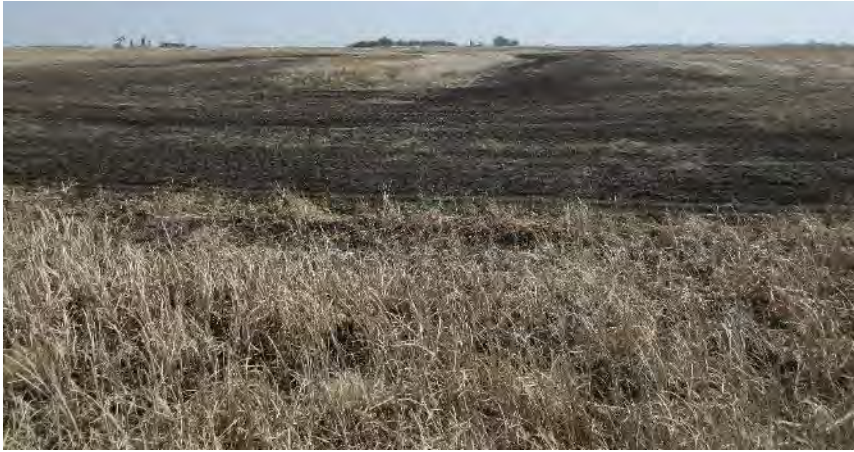
Photograph facing south off of 79th St. NW showing a large wetland measuring approximately 1,000 feet by 500 feet located towards the center of the site. The site could not be accessed at the time of the site visit.

B41-3 was inspected on May 14th, 2018, and is located approximately 1,000 feet south of 79th St NW. The site could not be accessed at the time of site visit. The site is currently used for agricultural purposes, and is surrounded by agricultural fields. A wetland was observed towards the center of the site. Visual impacts were observed from a distance at the time of site visit from a distance. Impacts included stressed vegetation and salt crusts along the shore of the pond. Measurements of the impacts could not be taken due to access limitations. The wetland at the center of the site presents a low point such that the rest of the site drains inwards to it.

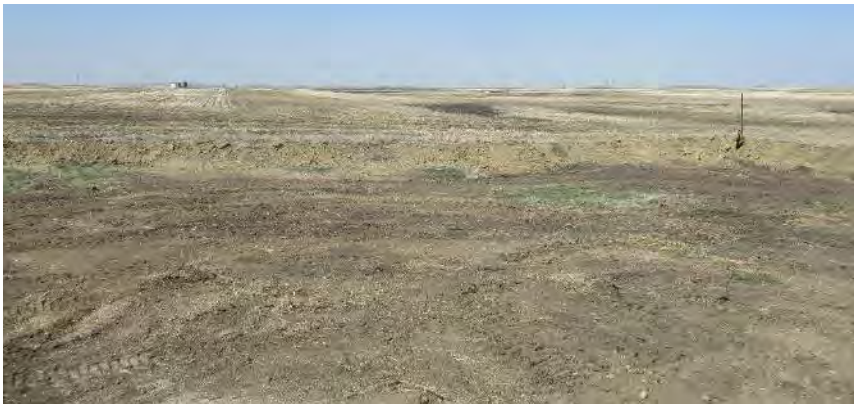
Photograph facing north off of oilfield lease road showing agricultural field. Site is located approximately 1,000 feet further north. Potentially stressed vegetation is visible on edge of wetland.

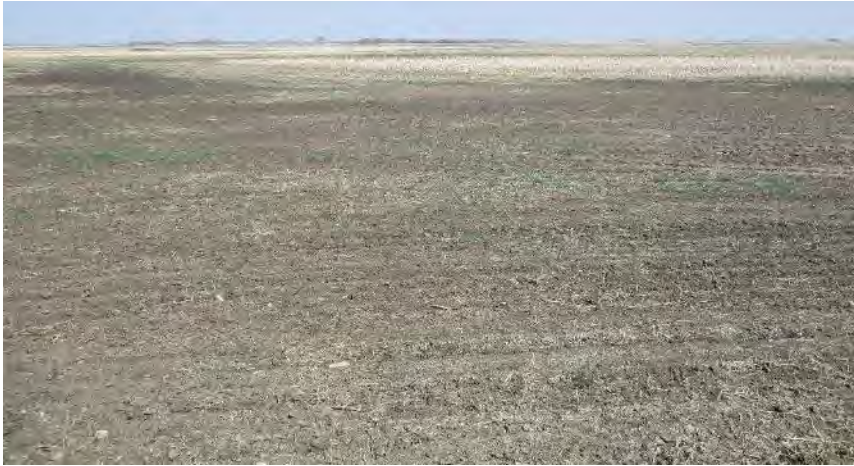
Photograph facing east/northeast off of an oilfield lease road showing the visually impacted area. Stressed vegetation was observed in an approximately 15 feet by 15 feet area.

B42-1 was inspected on May 14th, 2018, and is located approximately 800 feet east of 22nd Ave NW and 200 feet east of an oilfield lease road. The site is currently used for agricultural purposes, and is surrounded by agricultural fields. An oil & gas facility was also observed to the west, consisting of a single pump jack. A wetland was observed towards the east of the site. Minimal visual impacts were observed, including stressed vegetation; the area of visual impacts measured approximately 15 feet by 15 feet. The site topography is generally flat and drains east to the wetland. An aboveground powerline was also observed west of the site, along 22nd Ave NW.

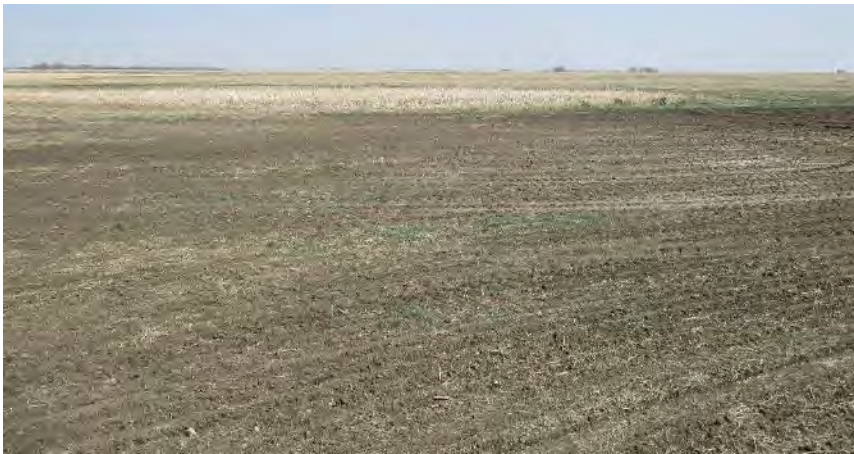
Photograph facing east off of an oilfield lease road showing the visually impacted area and a wetland located northeast of site.

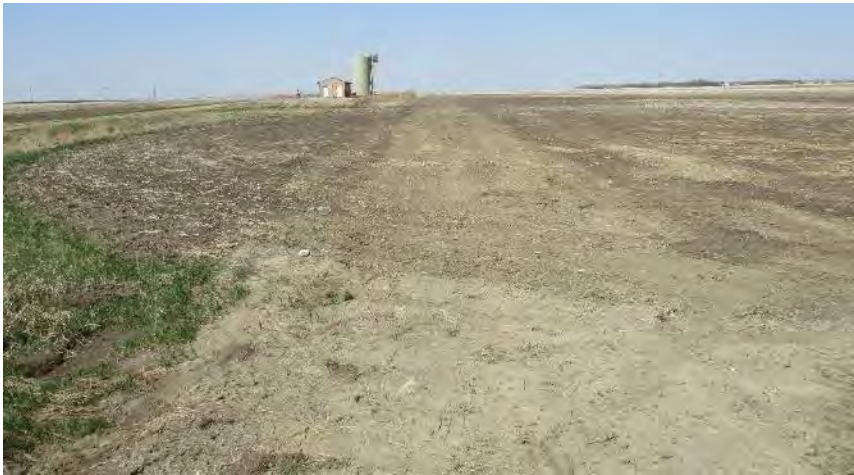
Photograph facing north off of 79th St NW showing the visually impacted area. Stressed vegetation was observed in an agricultural field. Two aboveground storage tanks are located west of the site.

B42-2 was inspected on May 14th, 2018, and is located approximately 500 feet north of 79th St NW and 300 feet east of an oilfield lease road. The site is currently used for agricultural purposes. Agricultural fields lie to the north, east, and south. An oil & gas facility was observed to the west, consisting of two aboveground storage tanks and a shack. A wetland was observed towards the northeast of the site. Minimal visual impacts were observed, including stressed vegetation in an area of subsidence; the area of visual impacts measured approximately 20 feet by 20 feet. The site topography is generally flat and drains southeast. To the west of the site, an Enbridge underground pipeline running north-south along the lease road to the aboveground storage tanks was also observed.
