NDIC Brine Pond Study

Phase II: Site Assessments

June 25, 2018

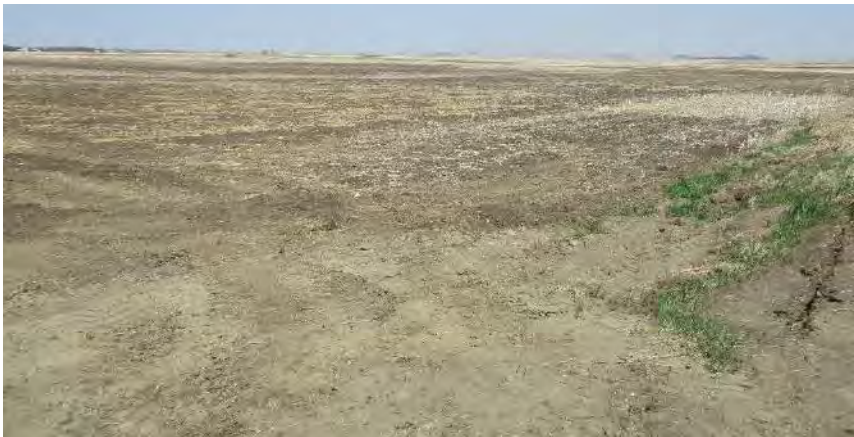
Photograph facing southeast off of an oilfield lease road showing the visually impacted area in an agricultural field.

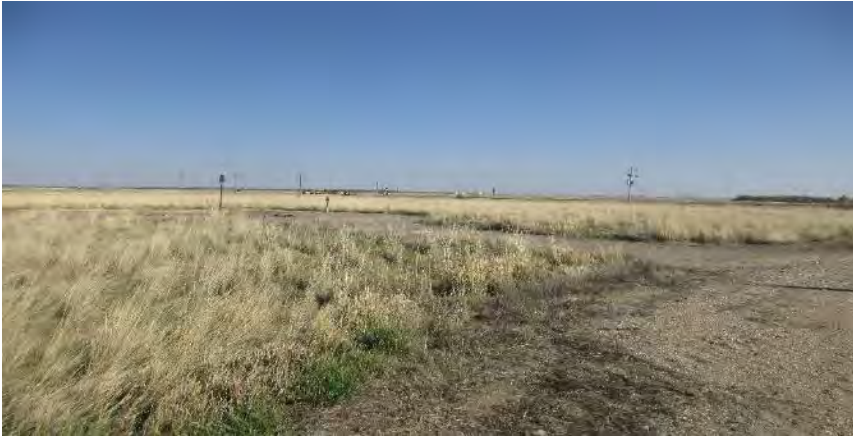
R3-5

Photograph facing southeast off of oilfield lease road showing the site. No visual impacts were observed during the site visit. A flare and flare pit can be seen in the photograph.

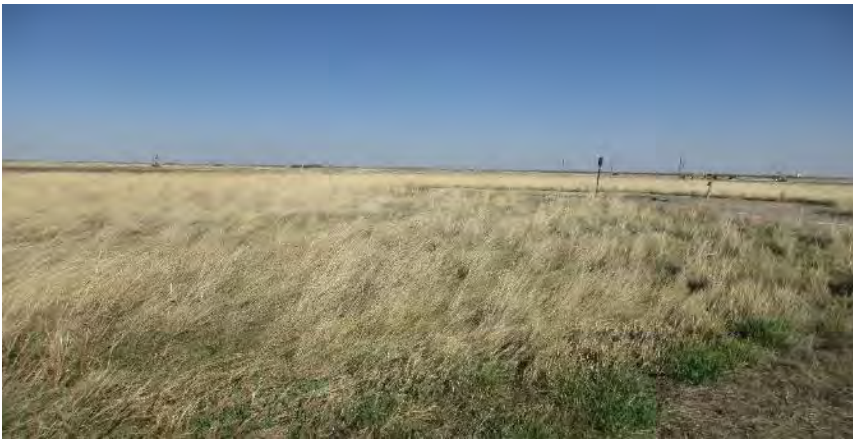
Photograph facing southeast to east off of oilfield lease road showing the site. No visual impacts were observed during the site visit. A flare and flare pit can be seen in the photograph.

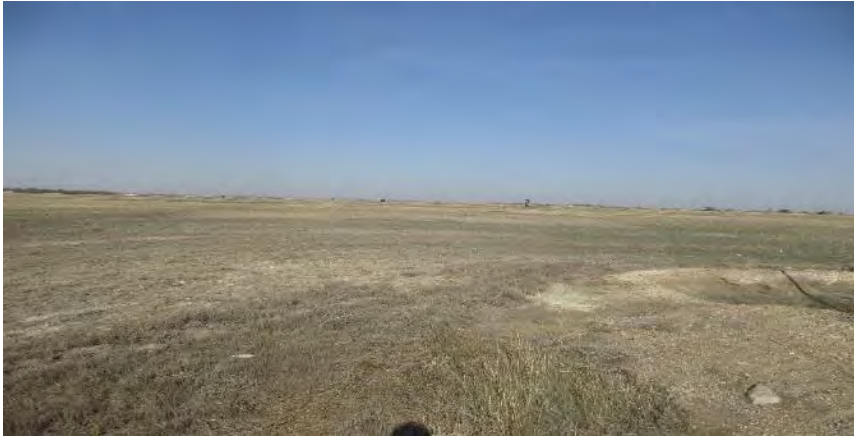
Photograph facing northwest off of an oilfield lease road showing visually impacted area with stressed vegetation; the impacted area measured approximately 150 feet by 150 feet. A flare pit can be seen in the foreground of the photograph.

R3-7 was inspected on May 15th, 2018 and is located approximately 500 feet west of 43rd Ave NW and just west of an oilfield lease road. The site is currently used in part for agricultural purposes and in part as an oil & gas facility. Agricultural fields lie to the north, south, and west. The oil & gas facility is located slightly to the east, consisting of three aboveground storage tanks, one heater-treater, and one flare pit. A wetland lies to the north of the site. Visual impacts were observed, including salt crusting and stressed vegetation; the area of visual impacts measured approximately 150 feet by 150 feet. The site topography is generally flat and slopes to the southeast. Two underground utility markers were observed to the east, and an aboveground powerline was observed to the east.

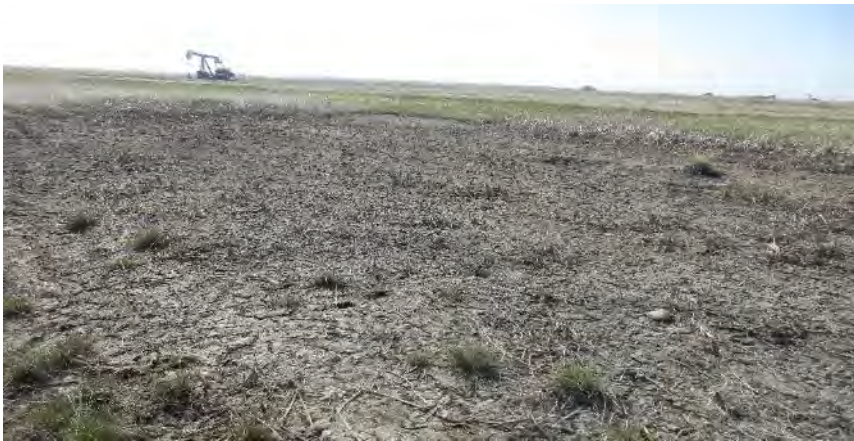
R3-11

Photograph facing south east showing a visually impacted wetland. The visually impacted area appears to have migrated and affected a wetland east of the site. A pump jack and an oilfield lease road can be seen in the background.

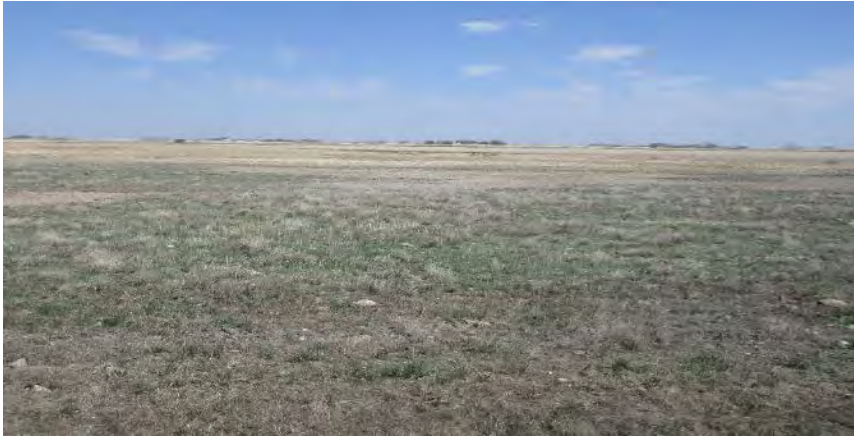
Photograph facing north off of an oilfield lease road showing visually impacted area including a lack of vegetative growth, which measured approximately 150 feet by 75 feet. A wetland is located north of the site.

R4-1 was inspected on May 15th, 2018 and is located approximately 100 feet north of an oilfield lease road. The site is currently natural grassland, and is surrounded by natural grasslands. A wetland was observed to the north of the site. Visible impacts were observed, including stressed vegetation; the area of visual impacts measured approximately 150 feet by 75 feet. The site topography is generally flat and drains to the northeast.

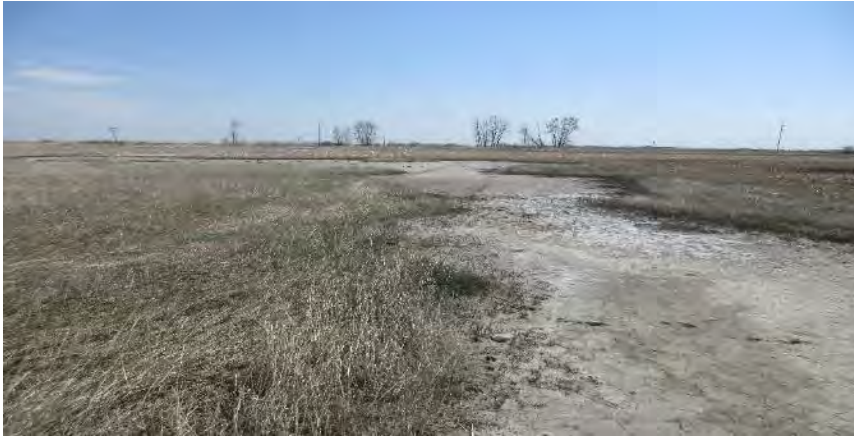
Photograph facing east off of an oilfield lease road showing the visually impacted area, including a lack of vegetative growth, cracking soils, and salt crusting. The area of visual impacts measured approximately 200 feet by 100 feet. A wetland is located to the south and east of the site.

R4-2 was inspected on May 15th, 2018, and is located approximately 200 feet south and 400 feet west of an oilfield lease road. The site is currently natural grassland, and is surrounded by natural grasslands. An oil & gas facility lies to the southwest, consisting of two aboveground storage tanks and a heater treater. A wetland was observed to the east of the site. Visible impacts were observed, including barren soils, stressed vegetation, and salt crusting; the area of visual impacts measured approximately 200 feet by 100 feet. The impacts appeared to have migrated to the wetland east of the site. The site topography is generally flat and drains to the northeast.

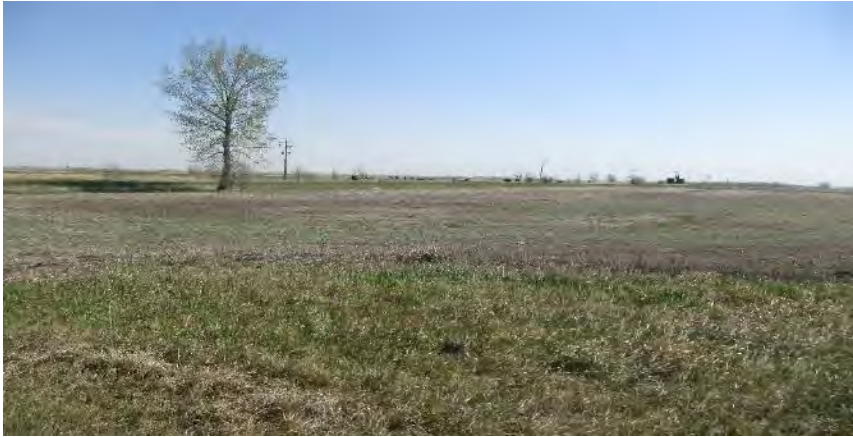
Photograph facing northeast off of an oilfield lease road showing the visually impacted area, including slightly stressed vegetation. The impacted area measured approximately 20 feet by 20 feet. An oil & gas facility is located to the west of the site.

R4-3 was inspected on May 15th, 2018 and is located approximately 150 feet south of 109th St. NW. The site is currently used for agricultural purposes. Agricultural fields lie to the east and south. Grazing pastures lie to the north. An oil & gas facility lies to the west, consisting of two aboveground storage tanks, a heater treater, a vehicle garage, a pump jack, and a flare pit. Visible impacts were observed, including slightly stressed vegetation; the area of visual impacts measured approximately 20 feet by 20 feet. The site topography is generally flat and slopes to the northwest. Aboveground powerlines were observed to the north and west of the site.

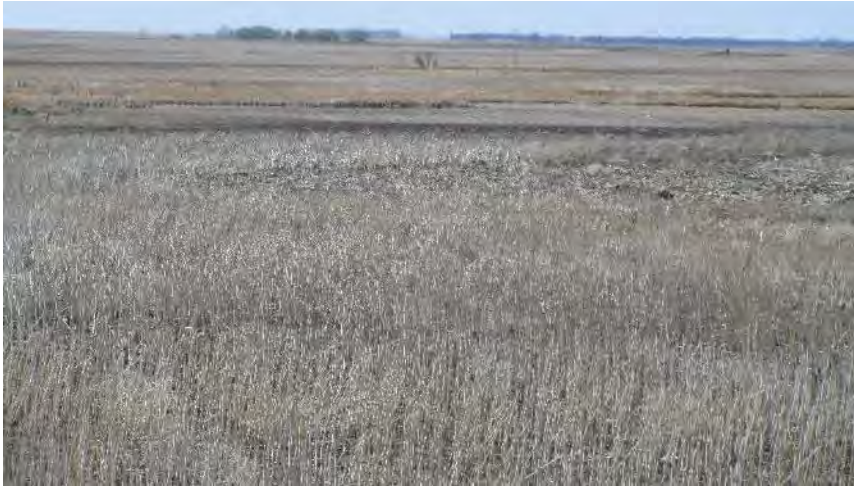
Photograph facing west from 50th Ave NW showing visually impacted area measuring approximately 200 feet by 100 feet. The site is on native grassland surrounded by agricultural fields.

R6-1 was inspected on May 9th, 2018, and is located on a private land approximately 400 feet west of 50th Ave NW. The site could not be accessed at the time of the site visit. The site is native grassland with wetlands directly northeast of site. Visual impacts were observed from a distance during the site visit. These impacts included an area with barren ground lacking vegetation. The area of visual impacts measured approximately 200 feet by 100 feet. Fields used in agricultural production surround the site. The site topography is relatively flat and drains predominantly to the southeast.

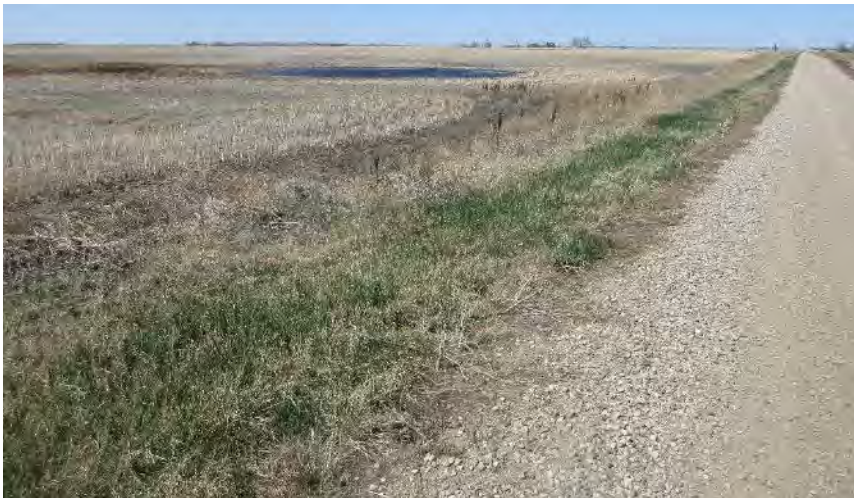
Photograph facing northwest from 50th Ave NW showing wetland adjacent to site.

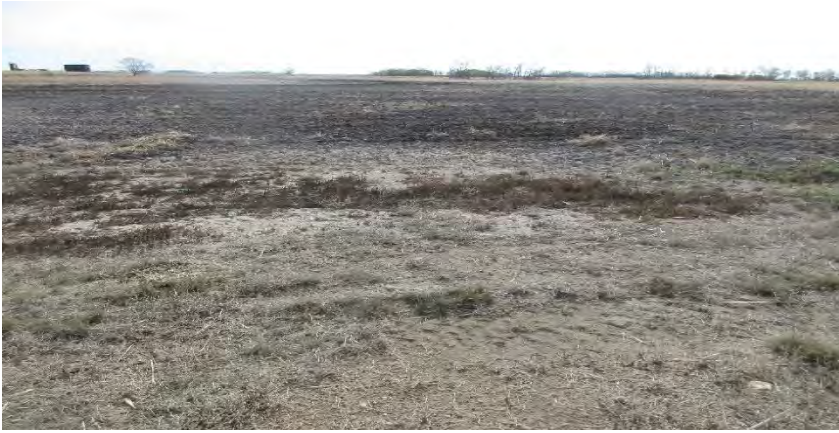
R7-2 (May 2018)

Photograph facing east from an oilfield lease road showing the visually impacted area measuring approximately 20 feet by 20 feet. The site is on agricultural land surrounded by agricultural fields and oilfield production.

R7-2 was inspected on May 10th, 2018 and is located approximately 350 feet south and 50 feet east of an oilfield lease road. The site is currently used for agricultural purposes and is surrounded by agricultural fields. An oil & gas facility was observed to the south and consisted of a single pump jack. Visual impacts were observed, including an area of lighter colored soil with no vegetation; the area of visual impacts measured approximately 20 feet by 20 feet. A wetland lies to the northeast. The site topography is generally flat and drains to the east/northeast. An aboveground powerline was observed to the west of the site.

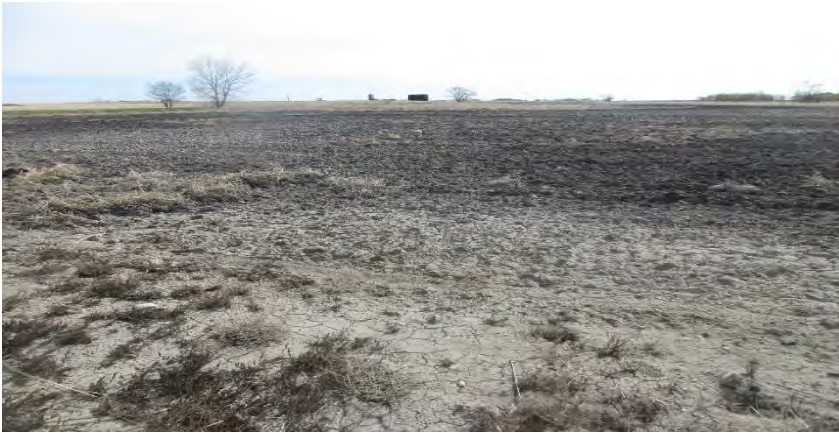
Photograph facing east from an oilfield lease road showing a closer view of the visual impacts at the site. Soil cracking and stressed vegetation can be seen. An agricultural field is in the background.

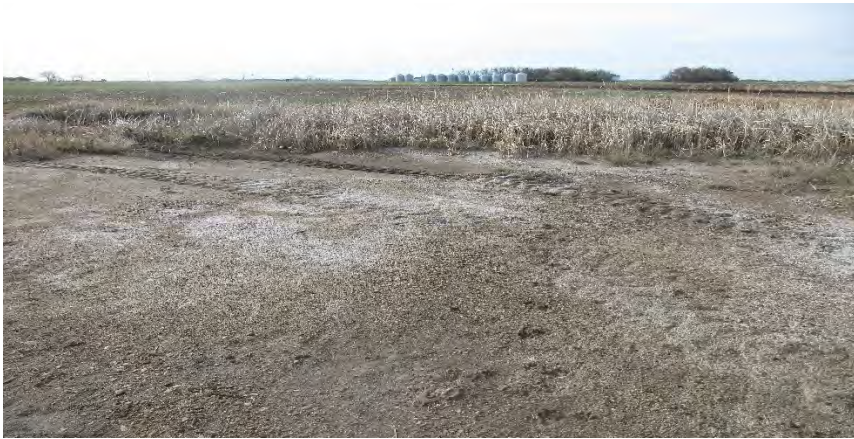
Photograph facing south from an oil & gas facility showing the visually impacted area, which measured approximately 40 feet by 15 feet. The area showed a lack of vegetation and salt crusting and lies directly north of a wetland.

R7-4 was inspected on May 10th, 2018 and is located approximately 400 feet west of 46th Ave NW and 50 feet south of an oilfield lease road. The site is currently used as an oil & gas facility. Oilfield equipment consisted of a pump jack, an aboveground storage tank, and pipeline risers. Agricultural fields lie to the north and west. Wetlands lie to the east and south, with agricultural lands beyond that. Visual impacts were observed, including an area of barren ground with no vegetation and salt crusting; the area of visual impacts measured approximately 40 feet by 15 feet. The site topography is generally flat and drains to the northeast. Utilities including an aboveground powerline and potential underground piping were observed to the north of the site.

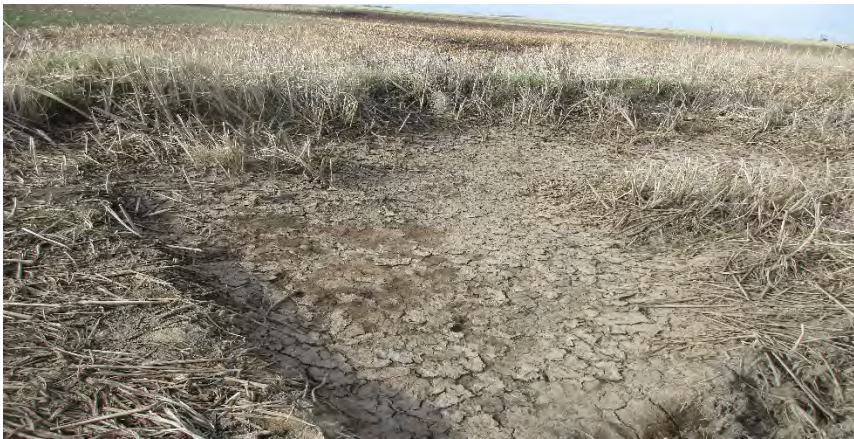
Photograph facing southwest from an oil & gas facility showing the location of the visually impacted area in relation to an adjacent wetland. Soil cracking and a lack of vegetative growth can be seen.

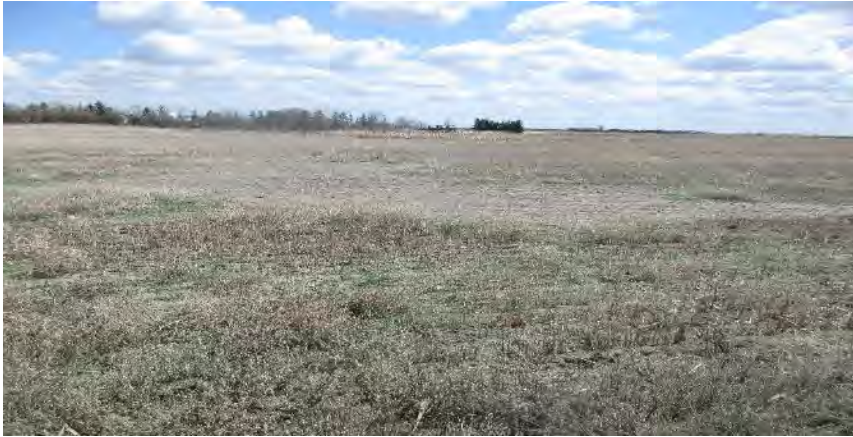
Photograph facing east off of oilfield lease road showing the visually impacted area with a lack of vegetative growth. The visually impacted area measured approximately 60 feet by 20 feet. An oil & gas facility is located west of site.

R11-1 was inspected on May 9th, 2018 and is located approximately 800 feet north of 93rd St NW and 50 feet east of an oilfield lease road. The site is currently used for agricultural purposes. Agricultural fields lie to the north, east, and south. A residence is located approximately 1,000 feet to the east. A wetland is located approximately 500 feet to the southeast. An oil & gas facility lies at the end of the lease road, to the southwest. Oilfield equipment consist of a pump jack, two aboveground storage tanks, and one heater-treater. Visual impacts were observed, including barren soils lacking vegetation and cracking soil; the area of visual impacts measured approximately 60 feet by 20 feet. The site topography is generally flat and drains to the southwest.

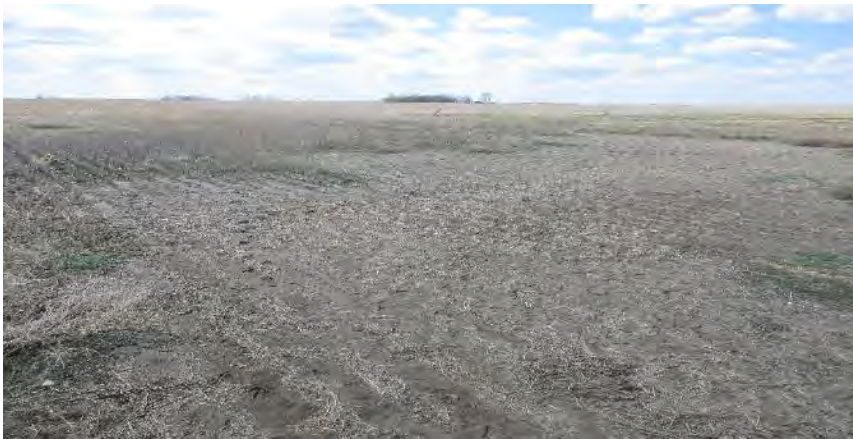
Photograph facing southwest showing the visually impacted area. A lack of vegetative growth and cracking soil can be seen.

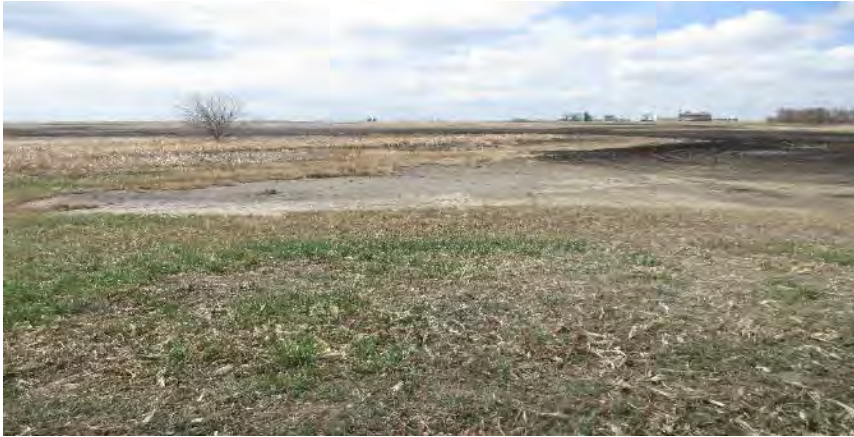
R15-1

Photograph facing southeast off of oilfield lease road showing the visually impacted area lacking vegetative growth. The impacted area measured approximately 100 feet by 40 feet. An oil & gas facility is located to the northwest of the site.

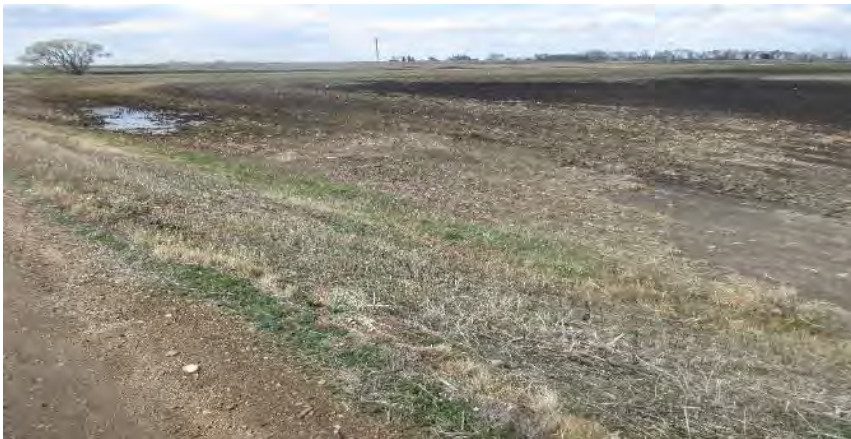
Photograph facing southwest off of oilfield lease road showing visually impacted area and the wetland located approximately 30 feet to the south of site. Aboveground powerlines running are visible in the background.

R15-2 was inspected on May 9th, 2018 and is located approximately 200 feet north of 86th St NW and immediately west of an oilfield lease road. The site is currently used for agricultural purposes, and agricultural fields surround the site. An oil & gas facility was observed to the northeast, and consisted of three aboveground storage tanks, one heater treater, and a pump jack. A wetland was also observed 30 feet to the south of the site. Visual impacts were observed, including lack of vegetation and grayish colored soils; the area of visual impacts measured approximately 20 feet by 10 feet. The site topography is generally flat and drains slightly to the south. Aboveground power lines were also observed to the east of the site.

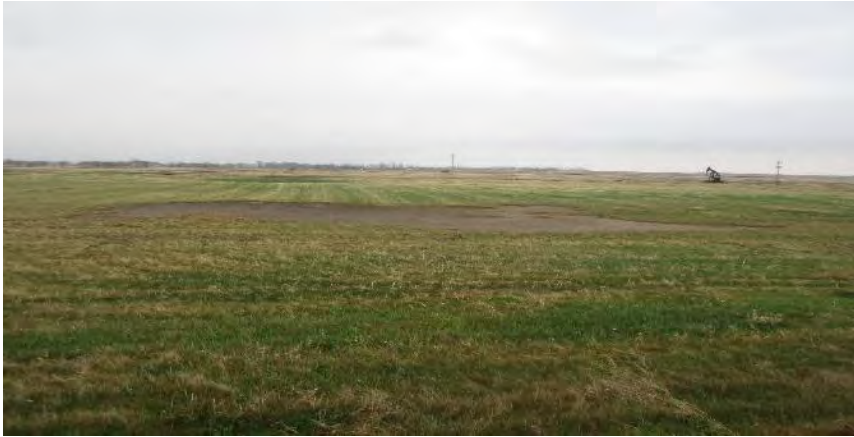
R17-2

Photograph facing south off of 80th St NW showing the visually impacted area lacking vegetation. The visually impacted area measured approximately 100 feet by 50 feet. An oil & gas facility is located west of the site.

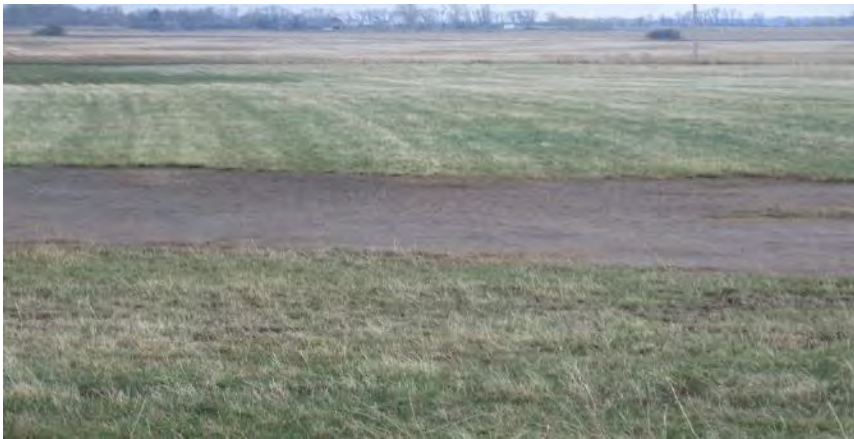
Photograph facing south off of 80th St NW showing a closer view of the visually impacted area with cracking soil. Aboveground power lines and a wetland can be seen in the background.

R17-2 was inspected on May 9th, 2018, and is located approximately 50 feet south of 80th St NW and 100 feet west of an 43rd Ave NW. The site is currently native grass land. Additional grassland lies to the south. Agricultural fields lie to the north and east. An oil & gas facility was observed to the west, and consisted of three aboveground storage tanks, a heater treater, and a flare pit. Visual impacts were observed, including barren ground lacking vegetation and cracking soil; the area of visual impacts measured approximately 100 feet by 50 feet. A wetland was also observed to the south. The site topography is generally flat and drains to the northwest. An aboveground power line was observed approximately 350 feet to the south of the site.

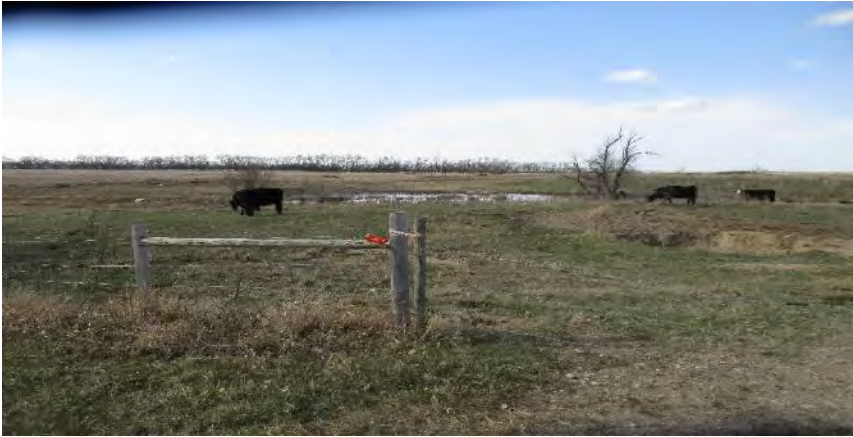
Photograph facing north off of an oil field lease road. The site was approximately 1,500 feet north of the lease road. The land is currently used as grazing land for cattle and is surrounded by a barbwire fence. No visual impacts could be seen from roadway.

R17-5 was inspected on May 8th, 2018 and is located approximately 0.2 miles east of 42nd Ave. NW. The site could not be accessed at the time of the site visit. The site is currently used as grazing land for cattle. No visual impacts could be observed during the site visit due to access limitations.

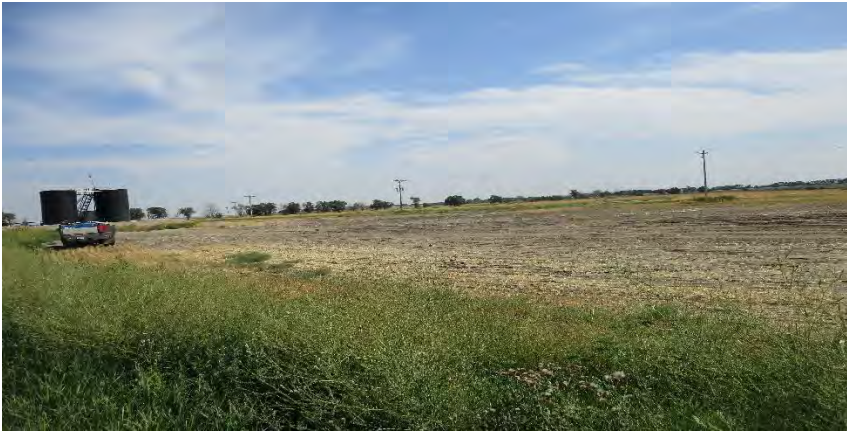
R17-6 (August 2018)

Photograph facing south off of 80th St NW showing the visually impacted area. Barren ground and were observed in an area measuring approximately 200 feet by 30 feet along the oilfield lease road.

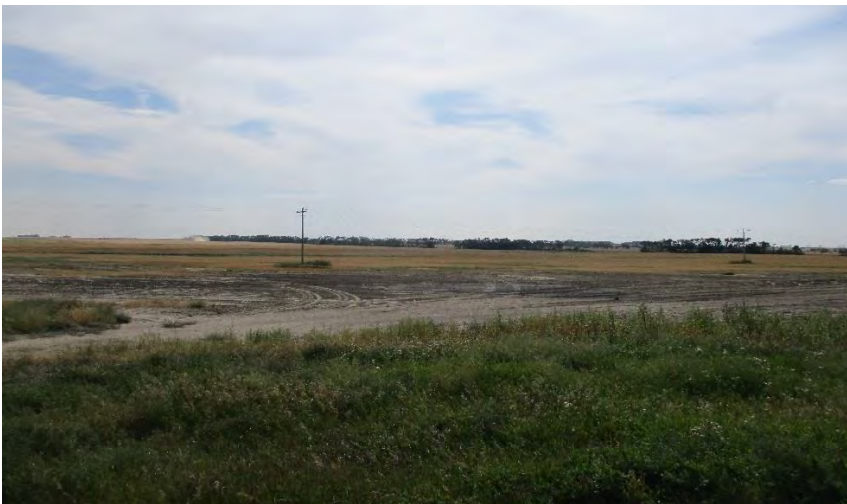
Photograph facing west off oilfield lease road showing the visually impacted area.

R17-6 was revisited on August 20th, 2018. During the initial inspection, the site had recently been plowed, and minimal visual impacts were observed. This area with lighter colored soils and slightly stressed vegetation measured approximately 100 feet by 30 feet. This follow-up investigation identified visual impacts consisting of barren ground and stressed vegetation in an area measuring approximately 200 feet by 30 feet.

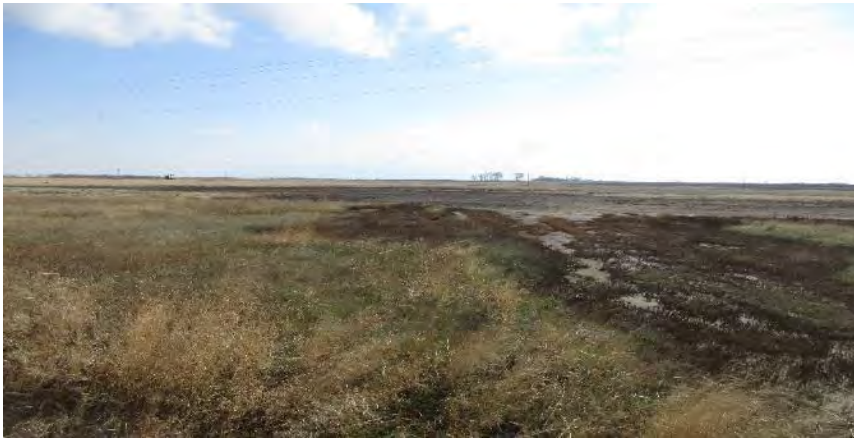
R18-1 (May 2018)

Photograph facing northeast off of an oilfield lease road showing the visually impacted area lacking vegetative growth. The visually impacted area measured approximately 300 feet by 15 feet. An oil & gas facility is located southwest of the site.

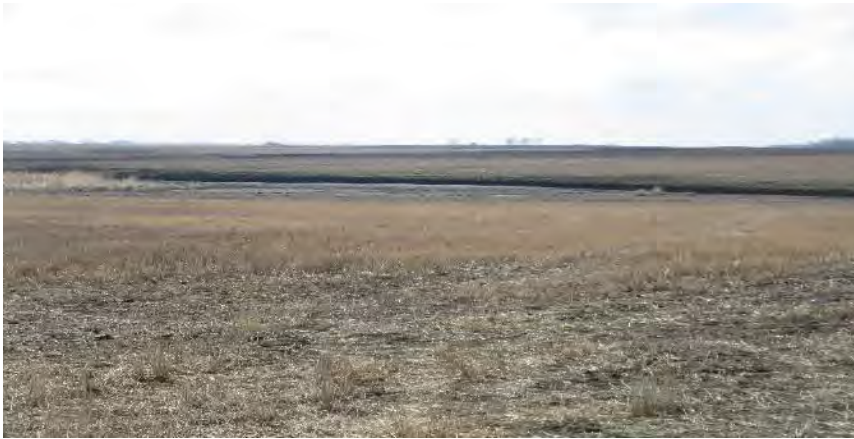
R18-3

Photograph facing east off County Road 9 showing the visually impacted area as observed from a distance. The site could not be accessed at the time of the site visit.

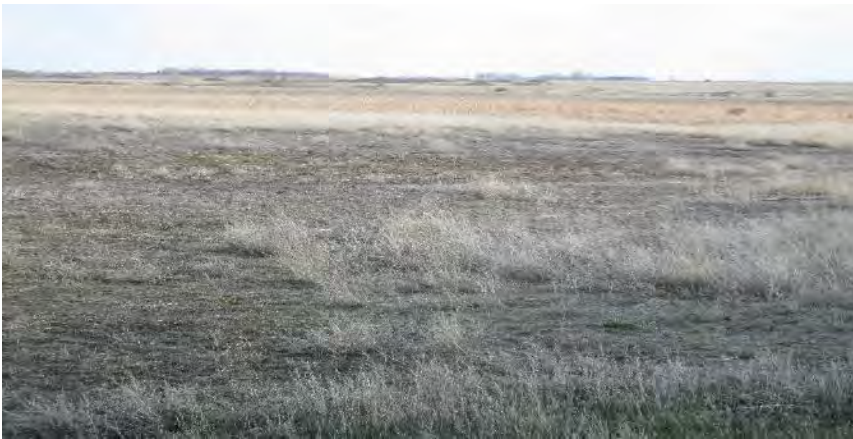
R20-4

Photograph facing south off of 77th St NW showing a closer view of the visually impacted area. A wetland can be seen in the background.

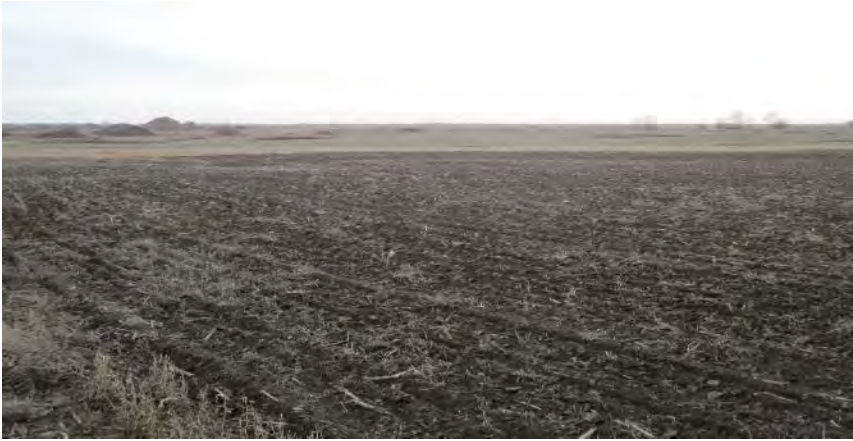
R23-1 (May 2018)

Photograph facing southwest off of an oilfield lease road showing the site. Visual impacts were observed, including slightly stressed vegetation and lighter colored soils; the area of visual impacts measured approximately 50 feet by 50 feet.

R23-1 was inspected on May 4th, 2018 and is located approximately 500 feet south of 78th St NW and 200 feet west of an oilfield lease road. The site is currently used for agricultural purposes, and is surrounded by agricultural fields. An oil & gas facility was observed to the east, consisting of eight aboveground storage tanks, a pump jack, and other miscellaneous oilfield equipment. A wetland is located approximately to the southwest. Visual impacts were observed, including slightly stressed vegetation and lighter colored soils; the area of visual impacts measured approximately 50 feet by 50 feet. The site is generally flat and drains to the south. The visually impacted area appeared to be a topographical low point.

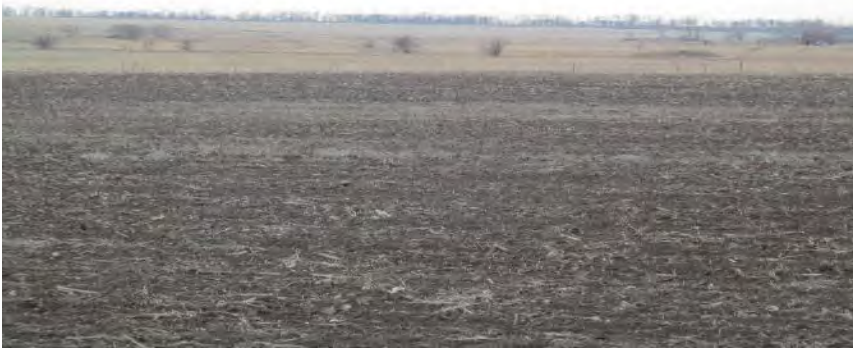
Photograph facing southwest showing a closer look at the visual impacts noted during the inspection. Slight slumping soil with a lighter color than the surrounding soil was noted.

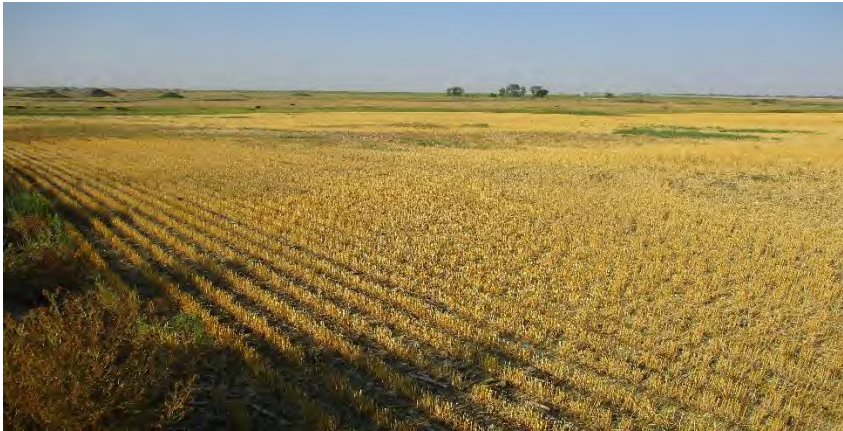
R23-1 (August 2018)

Photograph facing southwest off of an oilfield lease road showing the visually impacted area. Visual impacts included stressed vegetation and lighter colored soils in an area measuring approximately 50 feet by 20 feet.

R23-1 was revisited on August 20th, 2018. Visual impacts initially observed during the May investigation included an area of stressed vegetation and lighter colored soils. The area of visual impacts measured approximately 50 feet by 50 feet. This follow-up investigation revealed an area of barren ground and stressed vegetation measuring approximately 50 feet by 20 feet.

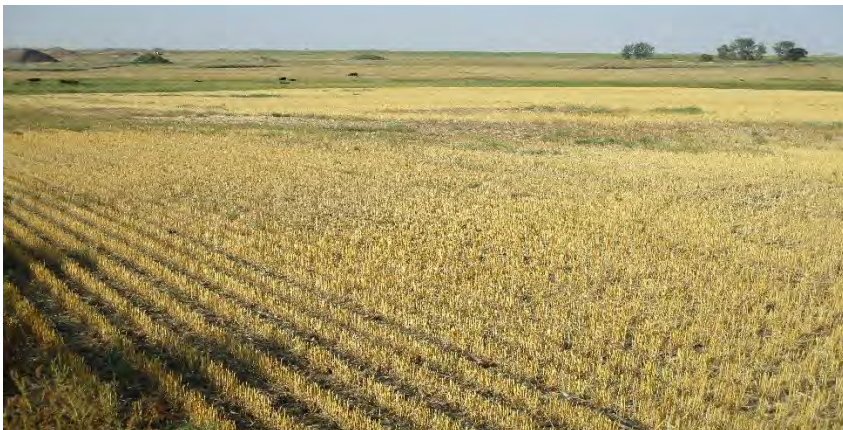
Photograph facing southwest showing a closer view of the visual impacts noted during the inspection.

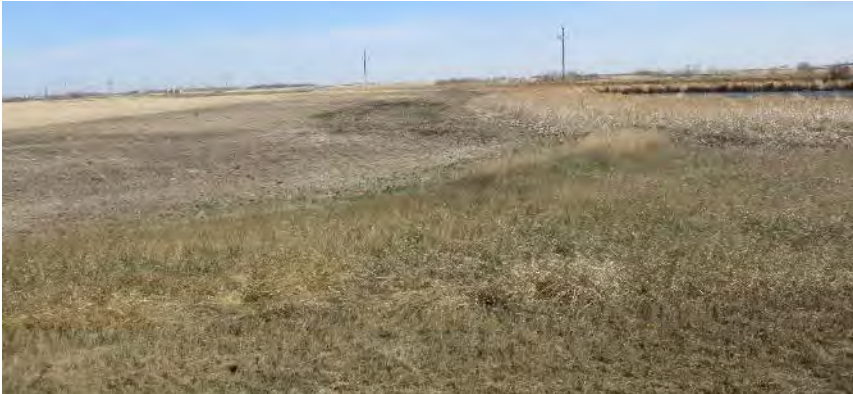
Photograph facing northeast from 76th St NW showing stressed vegetation and tan soils on the edge of an agricultural field. Wetlands were observed east of the site.

R23-7 was inspected on May 4th, 2018, and is approximately 400 feet north of 76th St NW and 900 feet east of 24th Ave NW. The site is currently used for agricultural purposes and is surrounded by agricultural fields. Wetlands and a pond were observed to the east, and residential properties were observed approximately 1,000 feet to the east. Visual impacts were observed, including an area of barren ground with stressed vegetation; the area of visual impacts measured approximately 20 feet by 20 feet. The site topography is predominantly flat and drains to the east. Aboveground powerlines were observed east of the site.

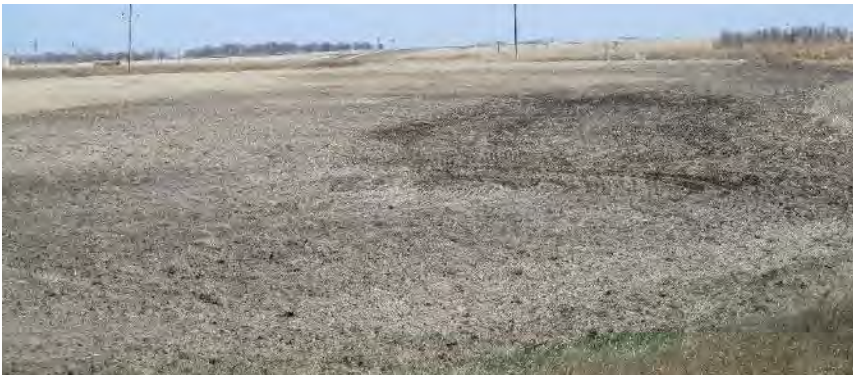
Photograph facing north from 76th St NW showing a closer view of the impacted area. Aboveground powerlines were observed east of the site.

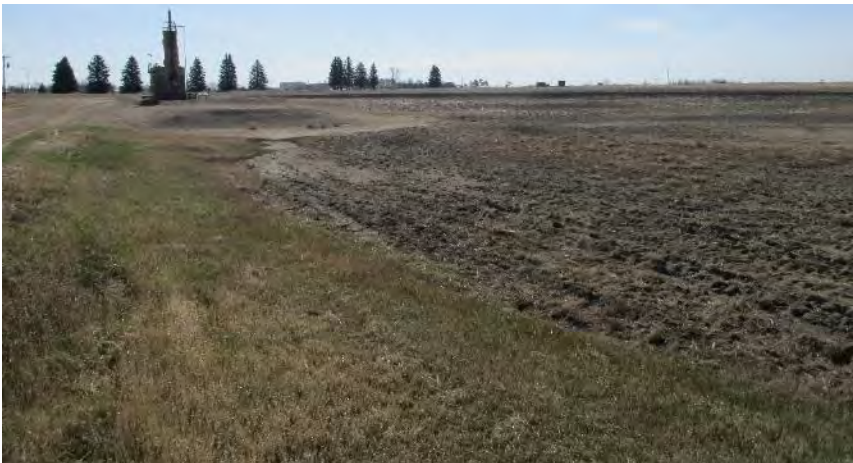
Photograph facing east off an oilfield lease road showing oil & gas facility next to agricultural fields. The town of Glenburn is visible in the background and is approximately 3,000 feet to the northeast.

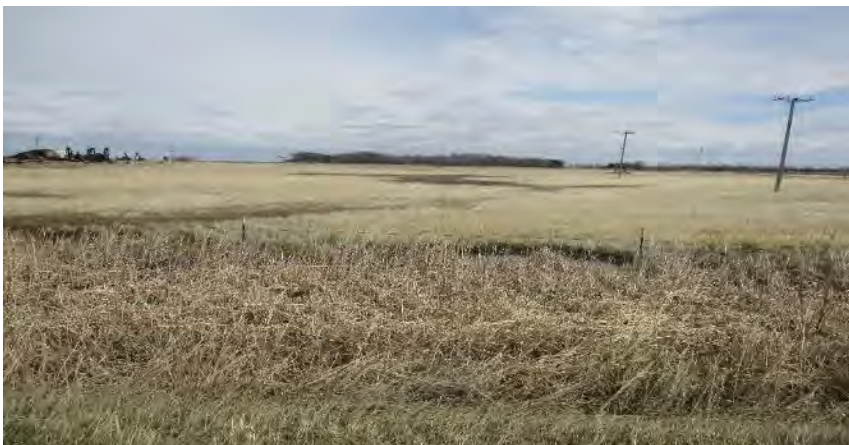
R24-6

View facing east showing the visually impacted area. A wetland and barbwire fence can be seen in the foreground. Aboveground powerlines and oilfield equipment can be seen in the background.

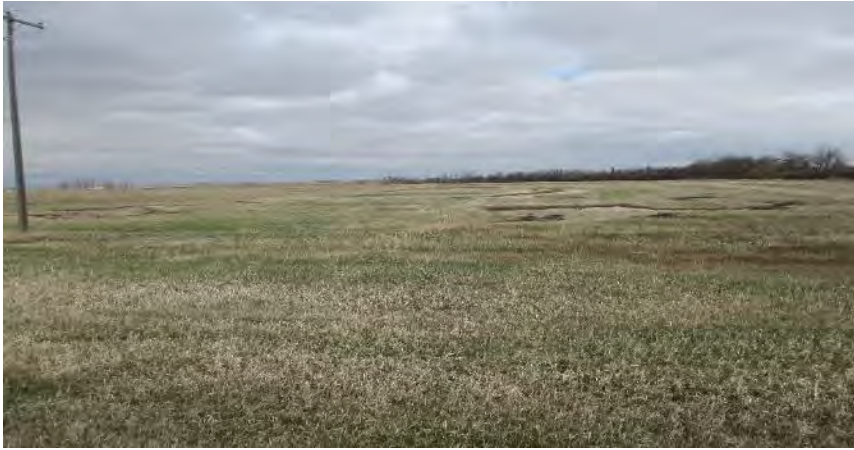
Photograph facing east off of 21st Ave. NW. A visually impacted area lacking vegetation can be observed. Aboveground powerlines can be seen in the foreground.

R24-7 was inspected on May 1st, 2018, and is located approximately 400 feet northeast of the intersection of 76th St NW and 21st Ave NW. The site could not be accessed at the time of the site visit. The site is currently native grassland, and surrounded by agricultural fields to the north and east. Grasslands lie to the south. A residential property with agricultural equipment and numerous grain bins lies to the west, across 21st Ave NW. Visual impacts were observed from a distance during the site visit. These impacts included an area lacking vegetative growth, which was estimated to measure approximately 225 feet by 150 feet. The site appeared to be a slightly depressed area in relation to the rest of the surrounding areas. Aboveground powerlines were observed to the west of the site.

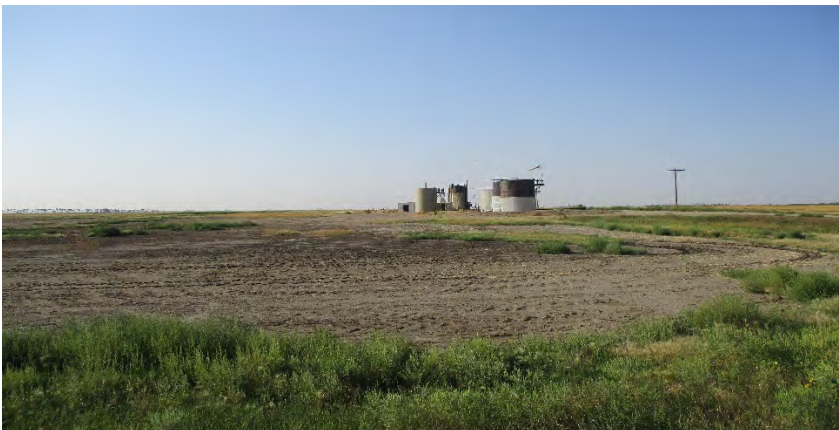
R24-8 (August 2018)

Photograph facing southwest taken off of 76th St NW showing the visually impacted area.

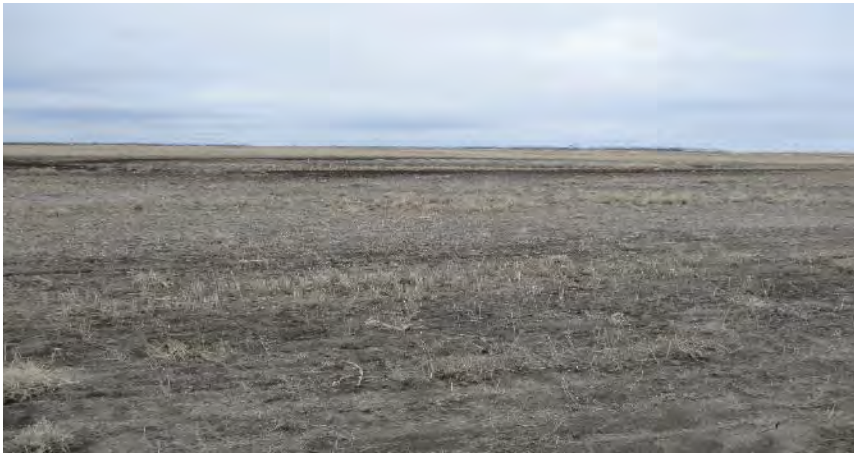
Photograph facing east taken off of 22nd Ave NW. Visual impacts including an area lacking vegetation can be seen in the foreground. A wetland east of the impacted area can be seen in the background.

R24-11 was inspected on May 1st, 2018 and is located approximately 125 feet east of 22nd Ave NW. The site could not be accessed at the time of the site visit. The site is currently used for agricultural purposes, and is surrounded by agricultural fields. A wetland was observed to the east. Visual impacts were observed from a distance, including an area slightly lacking vegetation. The area was estimated to measure approximately 100 feet by 75 feet. The site topography is generally flat, with the impacted area appearing to be a low spot compared to the surrounding areas. Aboveground powerlines were observed to the west.

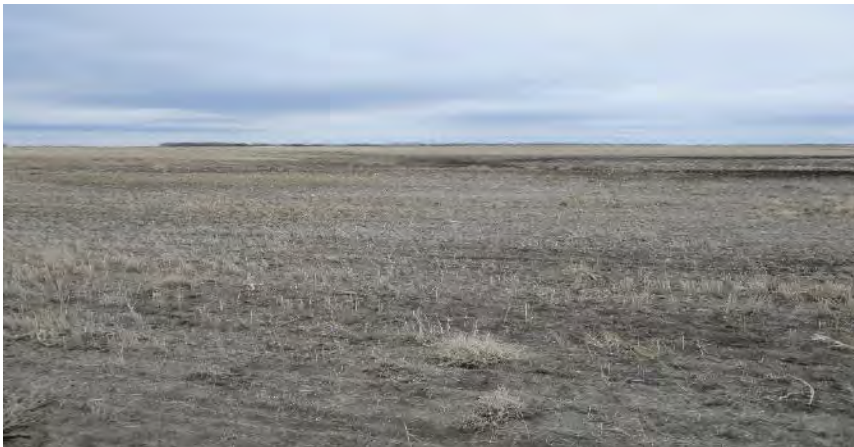
Photograph facing northeast taken off of 22nd Ave NW. The area lacking vegetation can be seen in the foreground. A wetland east of the impacted area is located in the background.

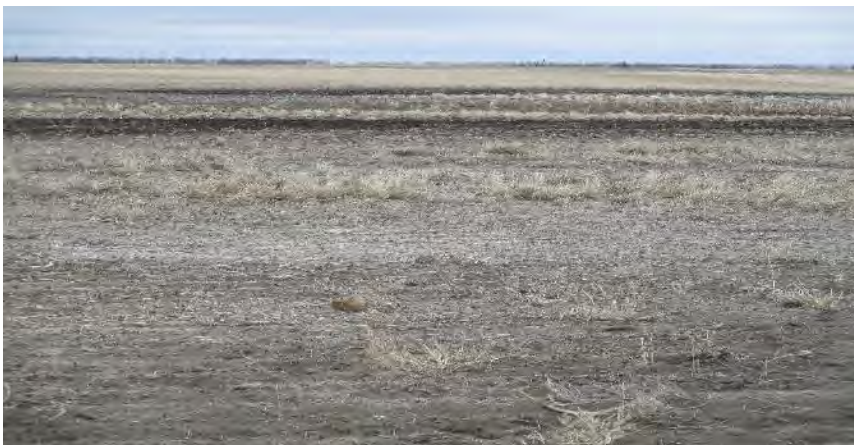
Photograph facing east taken off of 22nd Ave NW showing a closer view of the area lacking vegetation.

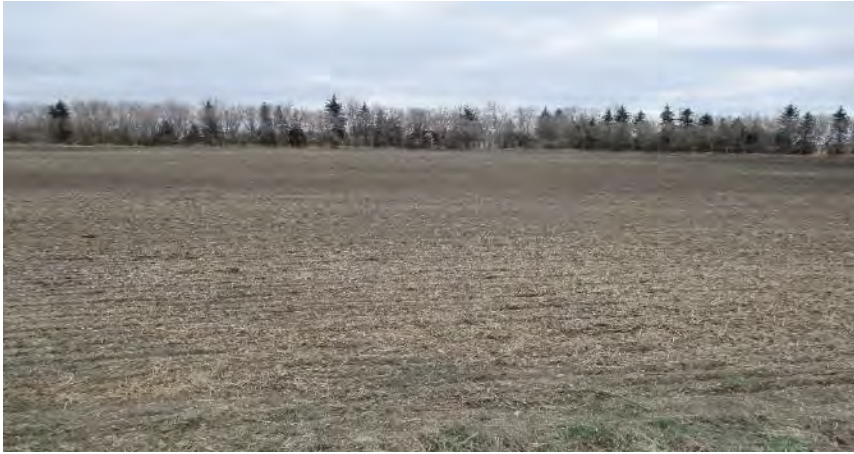
R24-12 (May 2018)

Photograph facing south taken off of an oilfield lease road. No visual impacts were observed at the time of the May 1, 2018 site visit.
