NDIC Brine Pond Study

Phase II: Site Assessments

June 25, 2018

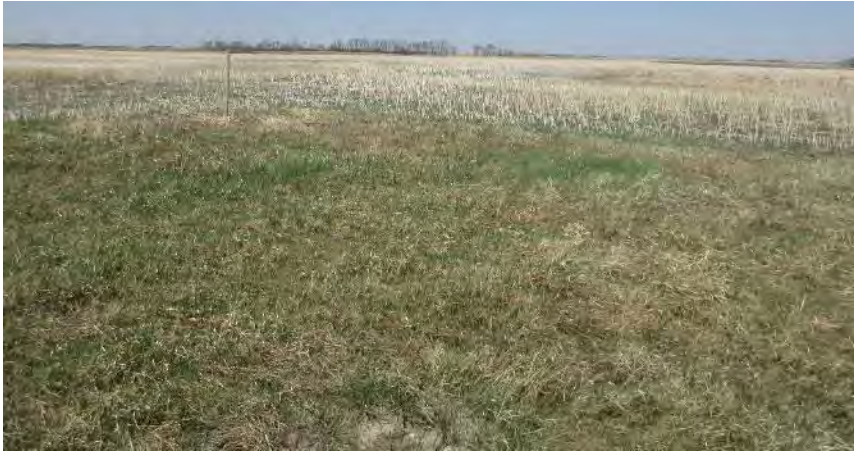
B1-1

Photograph facing north off of an oilfield lease road showing no visual impacts in agricultural field.

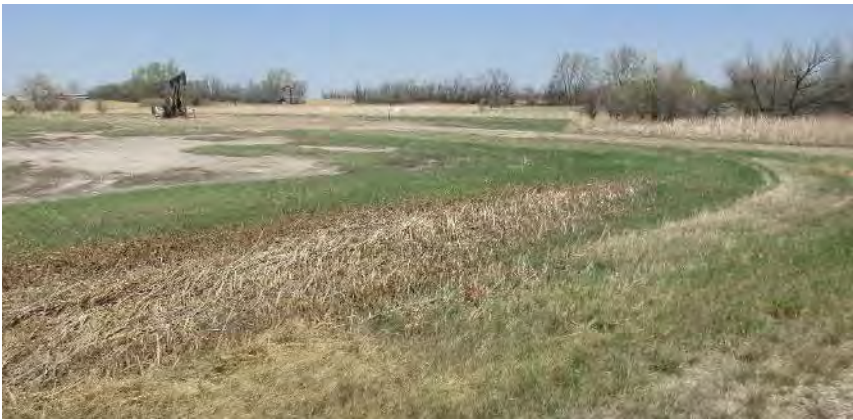
Photograph facing northeast off of an oilfield lease road showing visually impacted area and wetland located approximately 75 feet southeast.

B1-3 was inspected on May 15th, 2018, and is located approximately 200 feet east of 32nd Ave NW and 50 feet north of an oilfield lease road. The site is currently native grassland, and is surrounded by grasslands. An oil & gas facility consisting of one pump jack was observed to the northeast of the site. Visual impacts were observed, including an area of barren ground with stressed vegetation; the area of visual impacts measured approximately 100 feet by 100 feet. The impacted area appeared to have been migrating from the pump jack to the northeast. A wetland was observed to the southeast of the site. The site topography is generally flat and slopes to the southwest. Aboveground powerlines were observed to the west of the site.

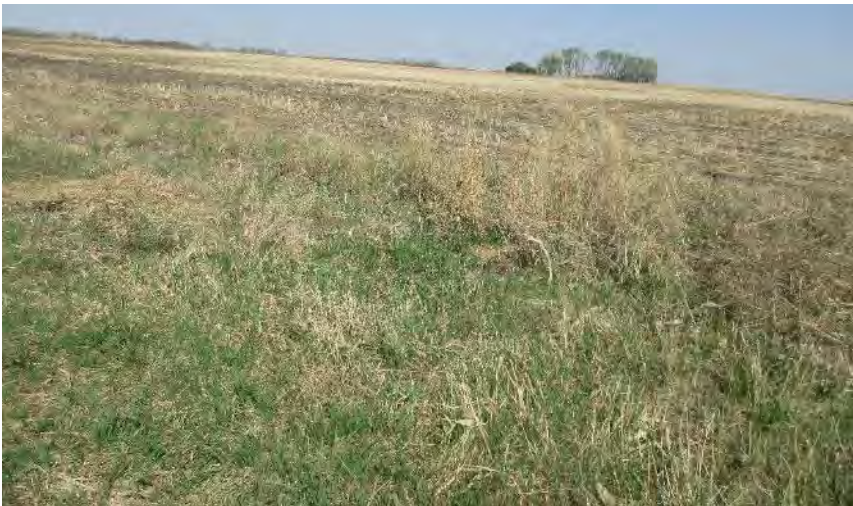
Photograph facing north off of an oilfield lease road showing an agricultural field. The site could not be accessed due to access limitations.

B1-5 was inspected on May 16th, 2018, and is located approximately 1,000 feet northwest of an oilfield lease road. The site could not be accessed at the time of the site visit. The site is currently used for agricultural purposes, and is surrounded by agricultural fields. No visual impacts could be observed at the time of site visit due to access limitations. The site topography is generally flat but a drainage direction could not be assessed due to access limitations.

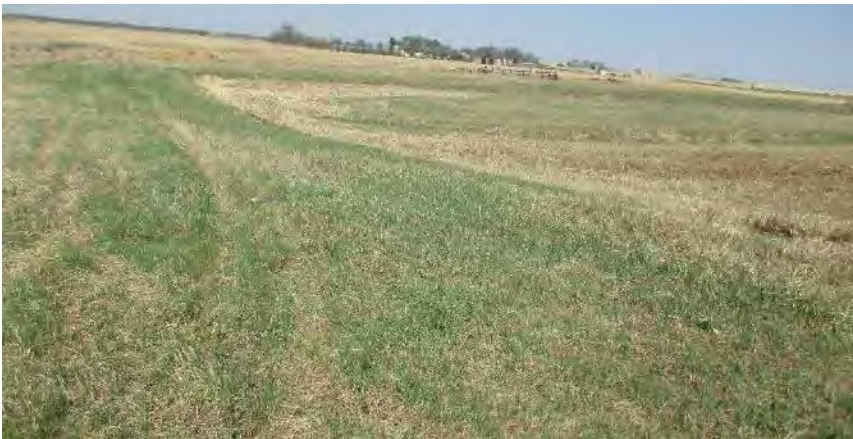
Photograph facing northwest off of 30th Ave NW showing a residential area approximately 1,000 feet northwest of the site.

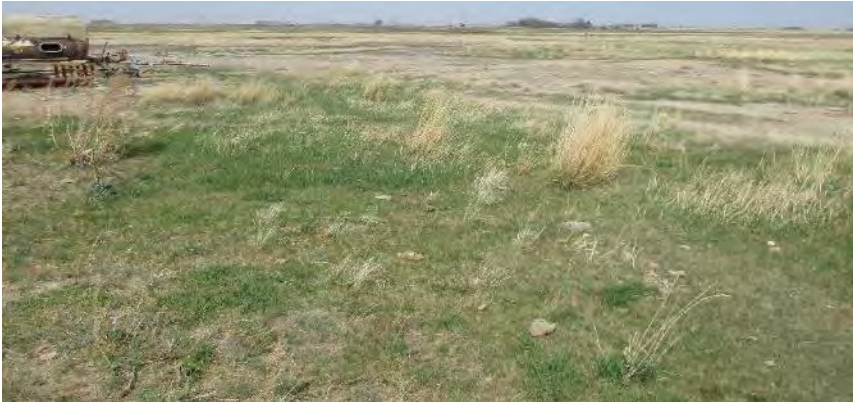
Photograph facing west off of an oilfield lease road showing a visually impacted area. Extensive dead zones, salt crusts, and soil cracks are visible in a 200 feet by 100 feet area. The impacted area is adjacent to pad containing oilfield equipment.

B1-9 was inspected on May 15th, 2018, and is located approximately 500 feet east of 31st Ave NW and 700 feet south of 104th St NW. The site is currently native grassland. Native grasslands lie to the north and south, and agricultural fields lie to the east. An oil & gas facility lies to the east, consisting of a field office, a pump jack, a pipeline riser, and miscellaneous field equipment. Visual impacts were observed, including an area of barren ground with little to no vegetation; the area of visual impacts measured approximately 200 feet by 100 feet. A wetland was observed to the north. The site topography is generally flat, and slopes to the south. A pipeline riser was observed to the west, indicating the likelihood of underground pipeline utilities in the vicinity of the site.

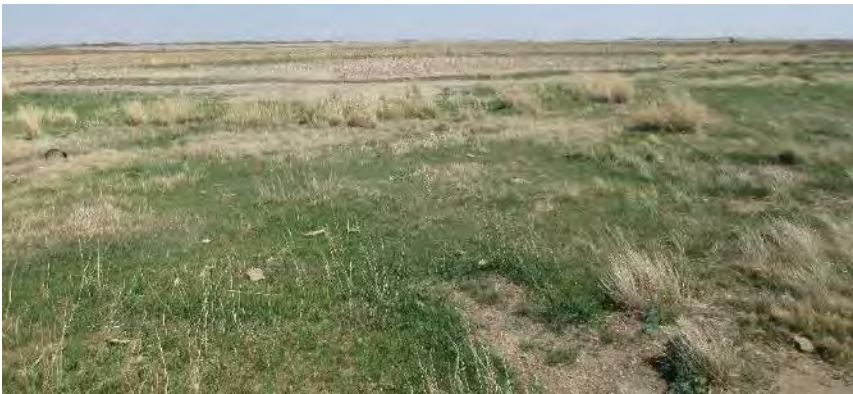
Photograph facing southwest off of oilfield lease road showing wetland adjacent to the south of the site.

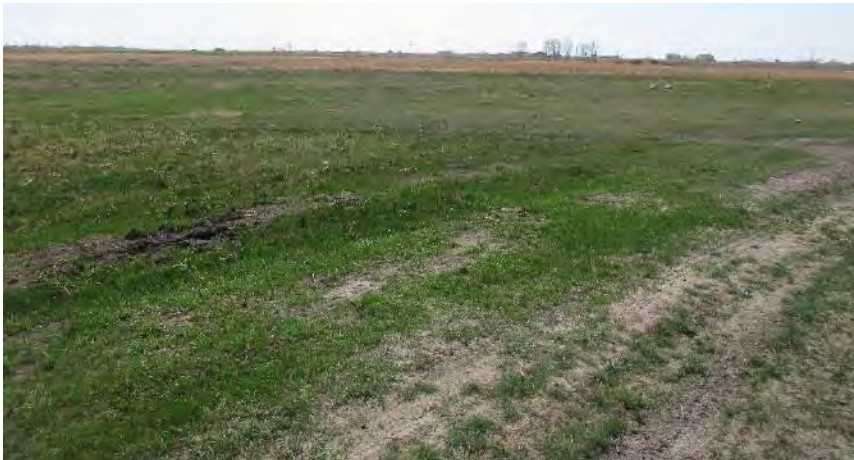
Photograph facing southwest off of oilfield lease road showing no visual impacts. A wetland is located approximately 100 feet south of the site.

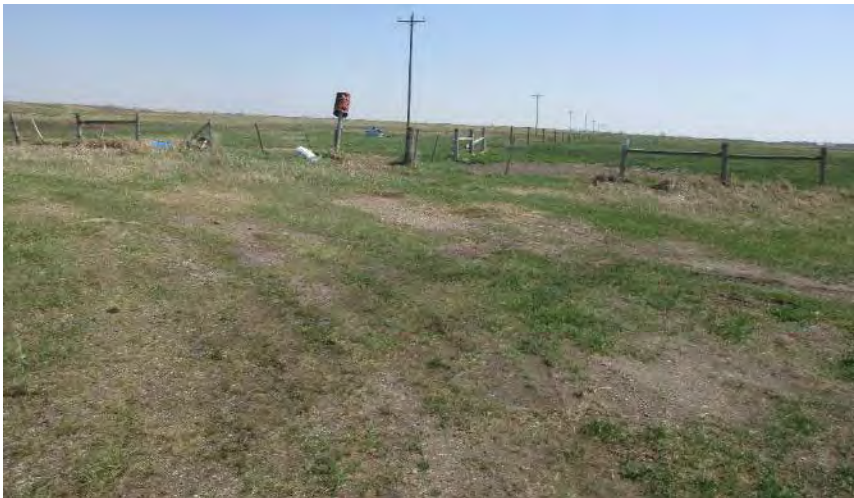
Photograph facing south off of 31st Ave NW. The site is located approximately 500 feet southeast in a fenced off field. Aboveground powerlines are located approximately 500 west of site.

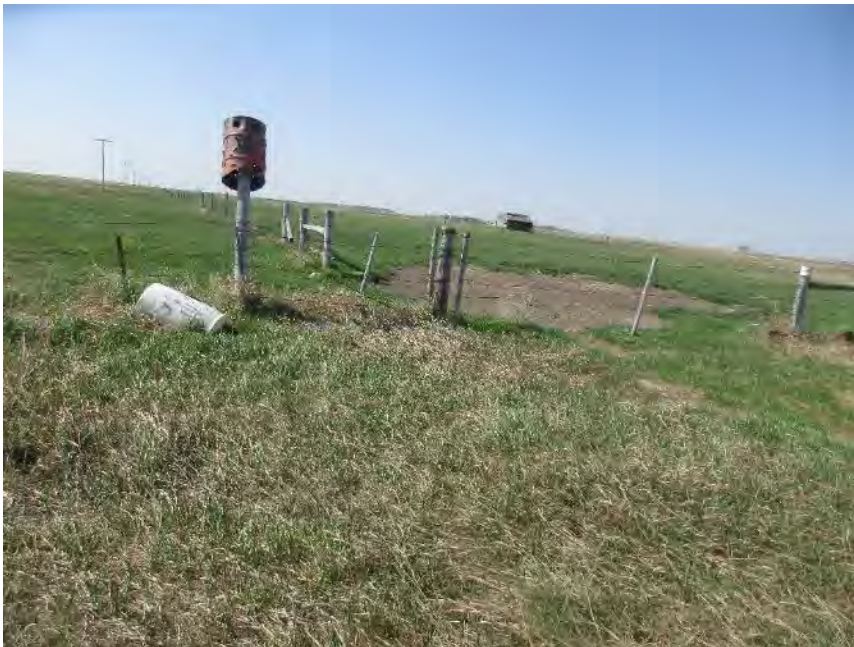
Photograph facing southwest from 31st Ave NW. Site could not be accessed due to fence.

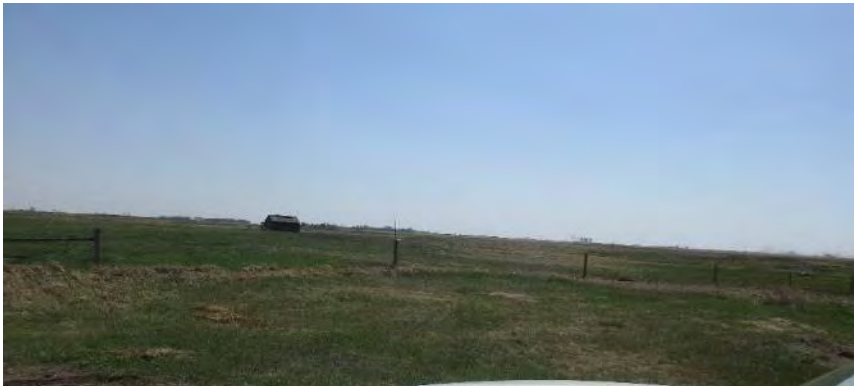
B1-13

Photograph facing southwest off of 31st Ave NW. Site is in fenced off pasture land approximately 1,500 feet further southwest.

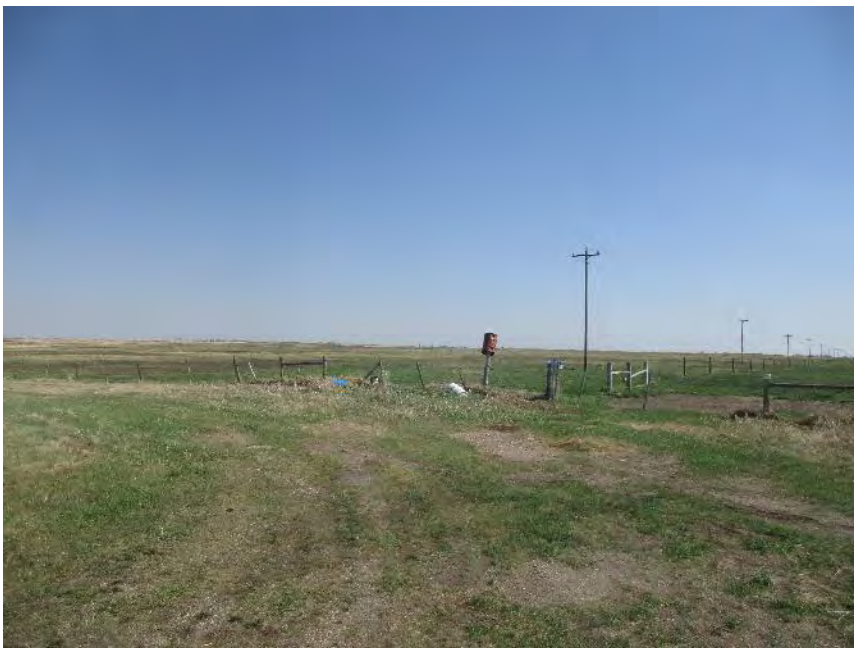
Photograph facing southwest off of 31st Ave. NW. The site is in fenced-off pasture land. Aboveground powerlines are located approximately 500 feet east of the site.

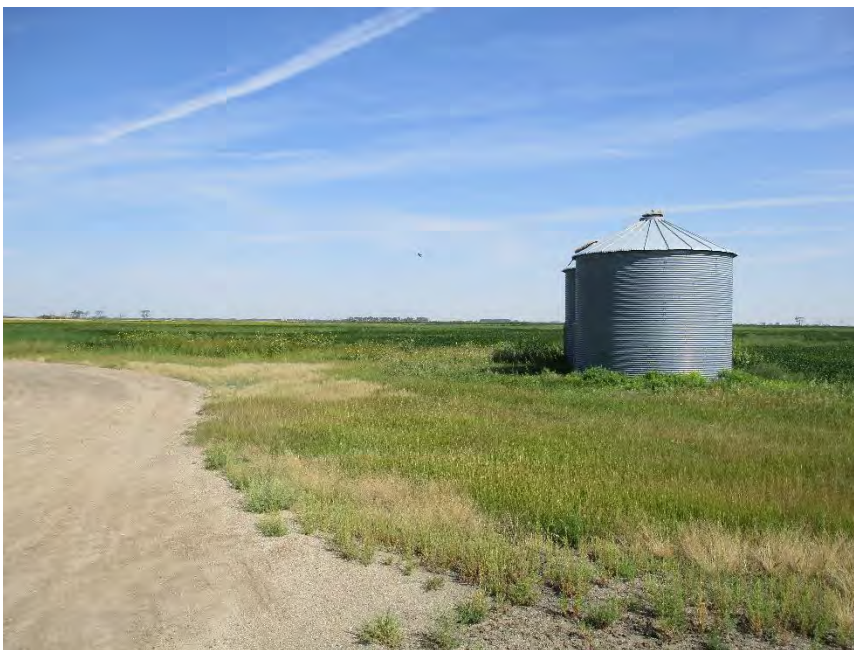
Photograph facing north off of an oil lease road showing two grain bins located at site and lighter colored grasses, which could potentially indicate stressed vegetation.

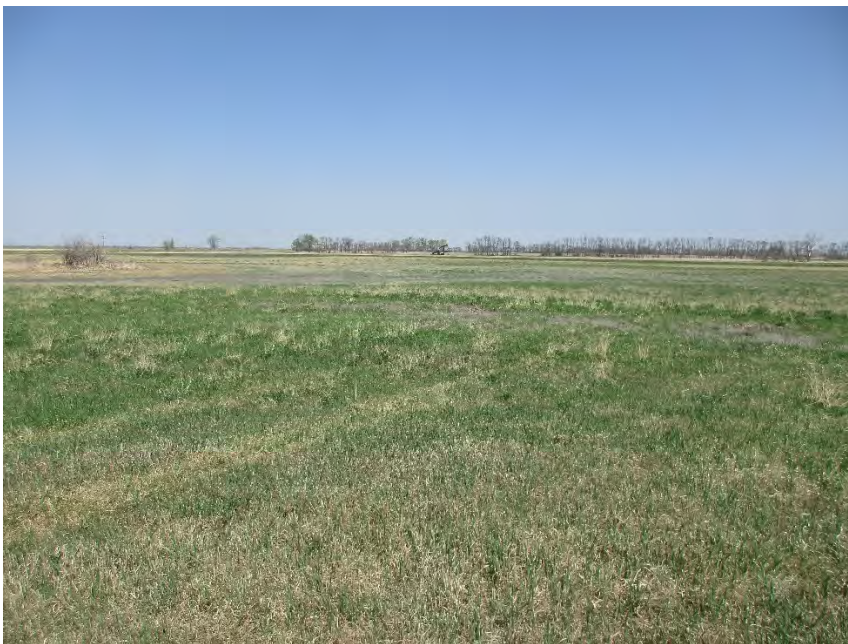
Photograph facing southeast, taken northwest of the wetland. The wetland lies northwest of the area of stressed vegetation. The site topography is generally flat and slopes to the west.

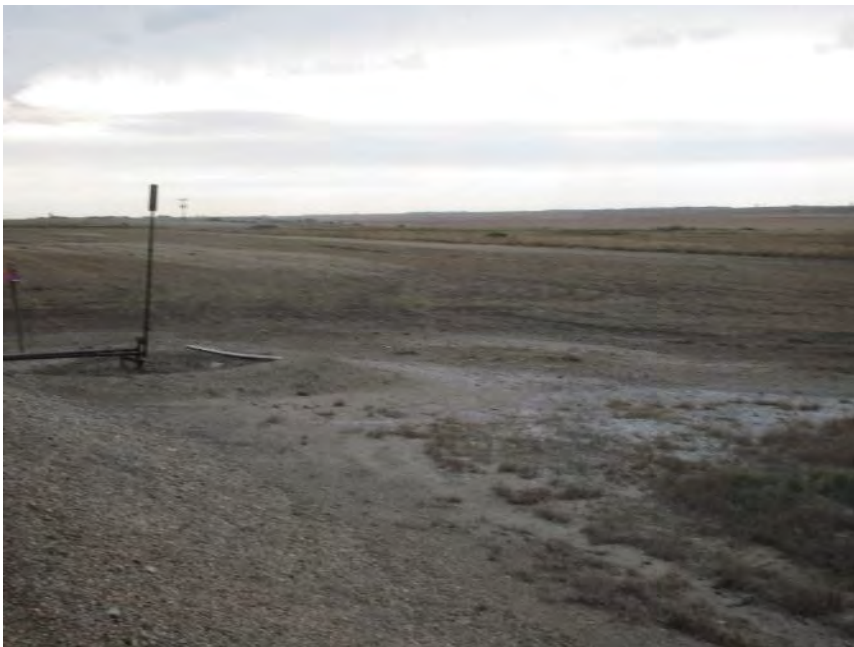
Photograph showing a closer view of the area of stressed vegetation and salt residues.

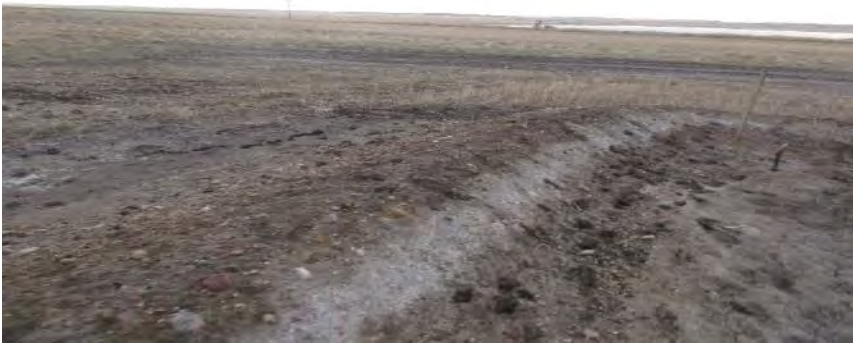
Photograph facing northeast off of the oil & gas facility showing the visually impacted area between the facility and an agricultural field. The Souris River can be seen in the background.

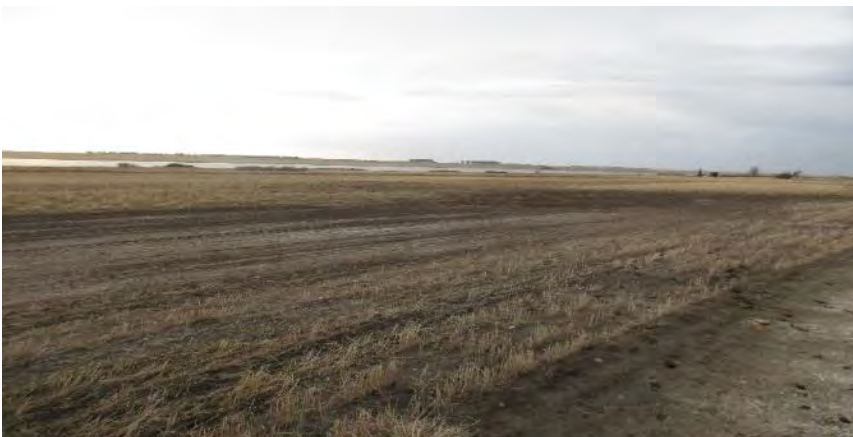
Photograph facing southeast off of the oil & gas facility showing the visually impacted area between the facility and an agricultural field. The Souris River can be seen in the background.

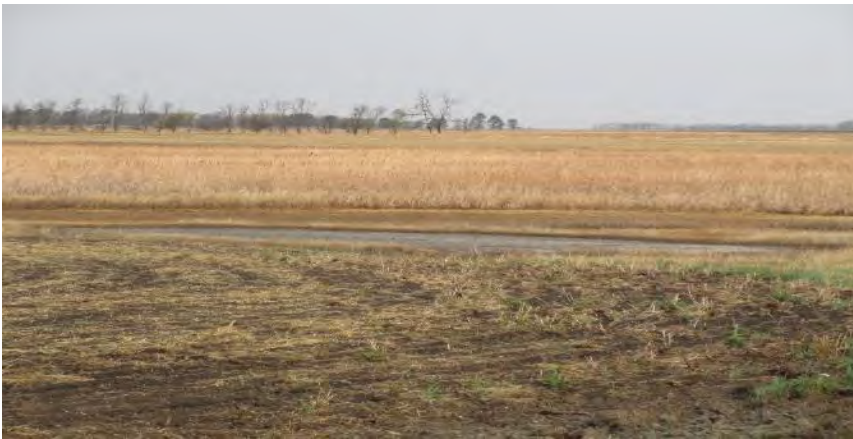
Photograph facing southwest off of an oil & gas facility showing the visually impacted area lacking vegetation. The visually impacted area is north of a wetland visible in the background.

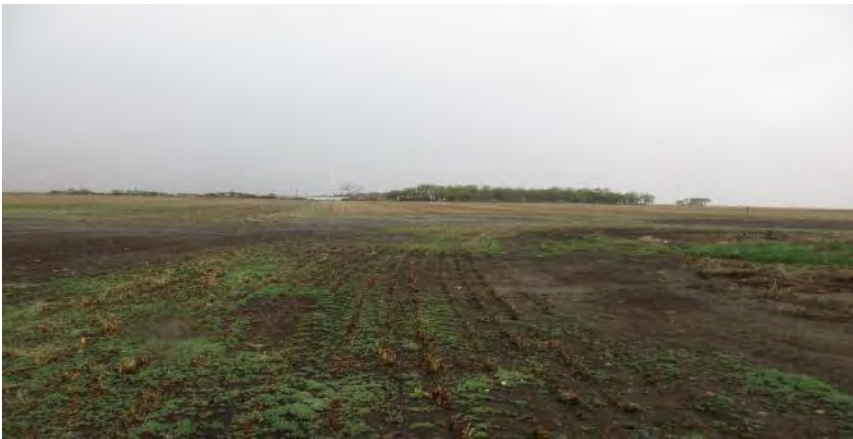
Photograph facing south off of an oil & gas facility showing the lack of vegetative growth in the visually impacted area.

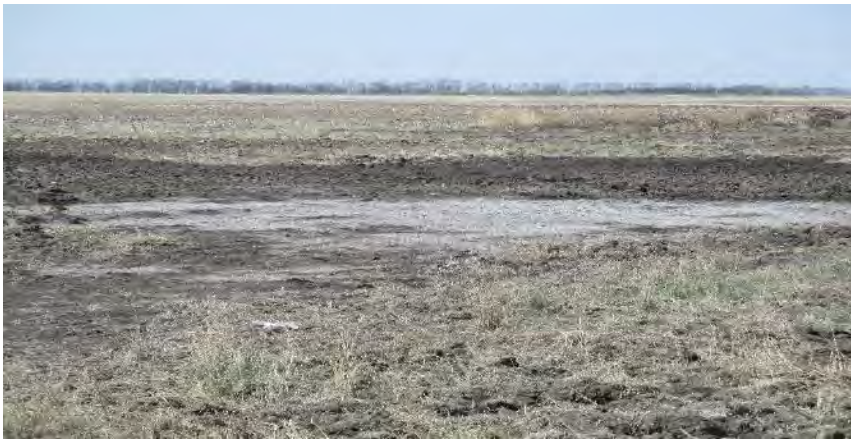
Photograph facing southwest showing a closer view of the visually impacted area.

B6-6 was inspected on May 17th, 2018, and is located approximately 100 feet south of 103rd St. NW. The site is currently used for agricultural purposes, and is surrounded by agricultural fields. A wetland was observed to the west. Visual impacts were observed, including an area of barren soils, stressed vegetation, and salt residues; the area of visual impacts measured approximately 120 feet by 120 feet. The site topography is generally flat and slopes slightly to the north.

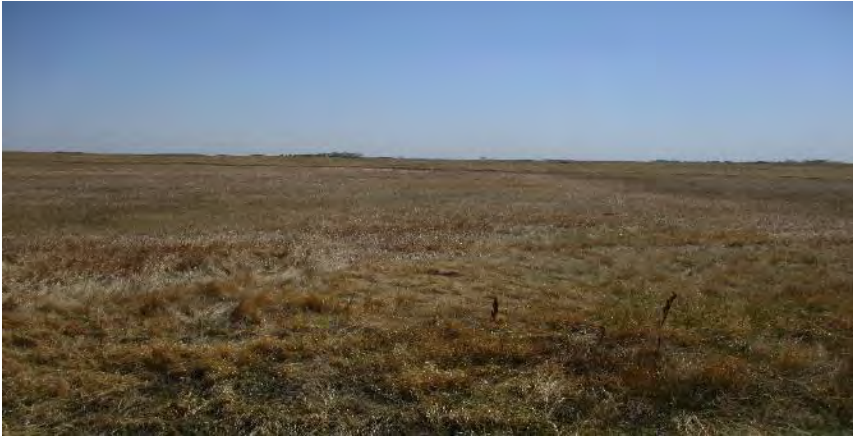
Photograph facing south off of 109th St NE showing the site. The site appears to have been recently reclaimed. No visual impacts were observed during the site visit.

B7-1 was inspected on May 16th, 2018, and is located approximately 300 feet south of 109th St NE. The site appears to be a recently reclaimed oil & gas pad. Agricultural fields lie to the south and west, and grasslands lie to the east. A wetland was observed to the east of the site. No visual impacts were observed at the time of the site visit. The site topography is generally flat and slopes to the northeast towards the wetland.

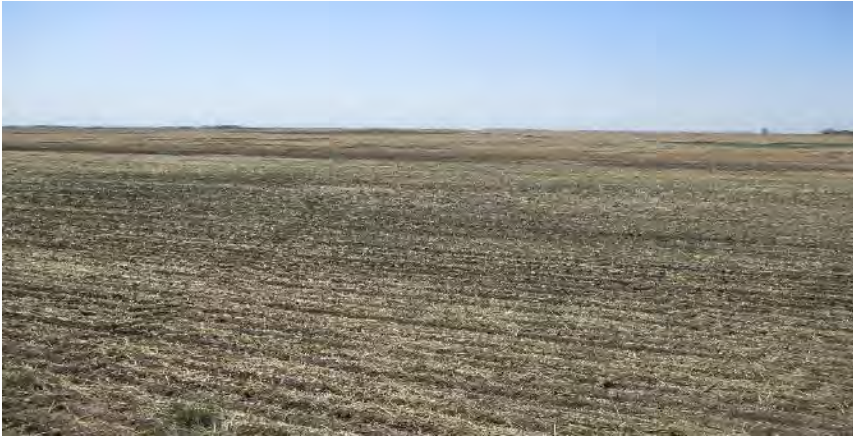
B7-2

Photograph facing west off of an oilfield lease road showing the site. No visual impacts were observed at the time of the site inspection.

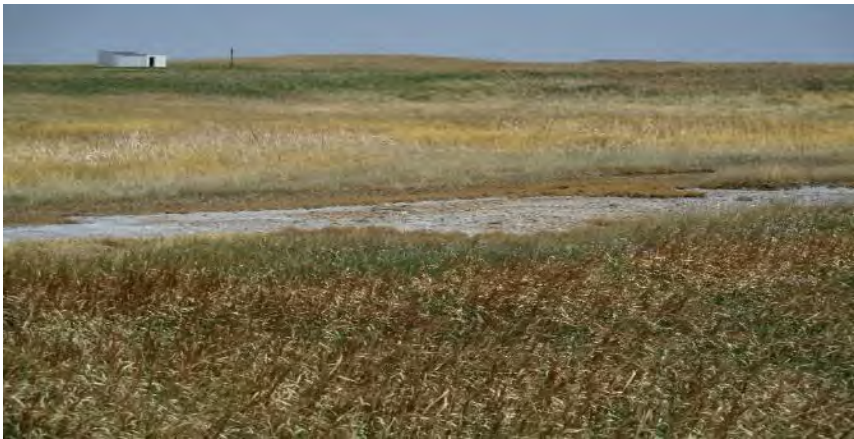
Photograph showing a closer view of the visually impacted area. A lack of vegetative growth and salt crusting can be seen. A wetland can be seen in the background.

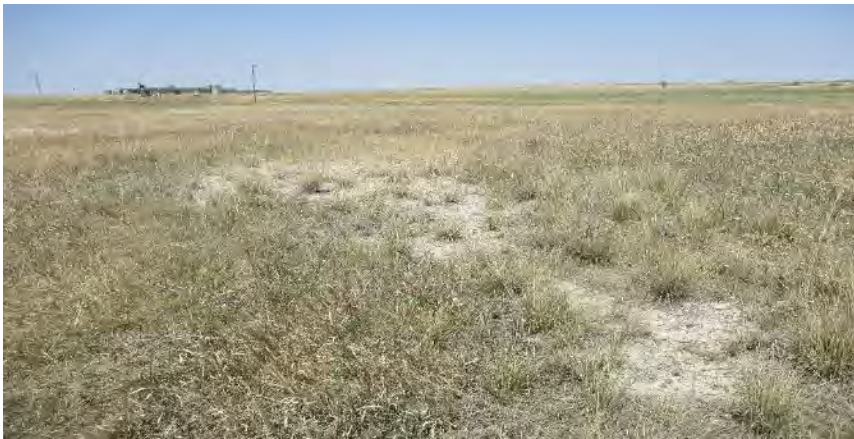
Photograph facing north off of an oilfield lease road showing the visually impacted area lacking vegetative growth.

B7-5 was inspected on May 16th, 2018 and is located approximately 50 feet north of an oilfield lease road. The site is currently native grassland and is surrounded by grasslands. A wetland was observed to the east/northeast of the site. Visual impacts were observed, including an area of barren soils with little to no vegetative growth, and salt crusting; the area of visual impacts measured approximately 30 feet by 10 feet. There is a slight rise to the east of the impacted area, and the site drains away from the hill. Aboveground powerlines were observed to the north of the site. A pipe was observed protruding from the ground west of the site, indicating there may potentially be underground utilities in the area.

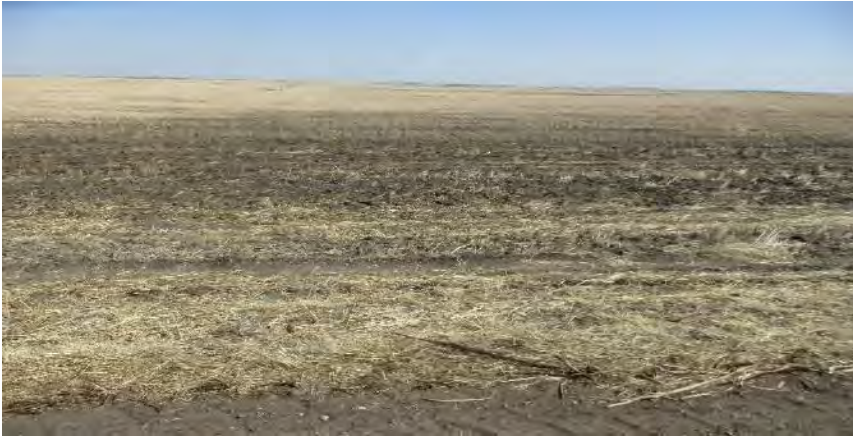
B11-1

Photograph facing south off of 101st St. NW showing the site. The site could not be accessed at the time of the site visit and no visual impacts were visible from the roadway.

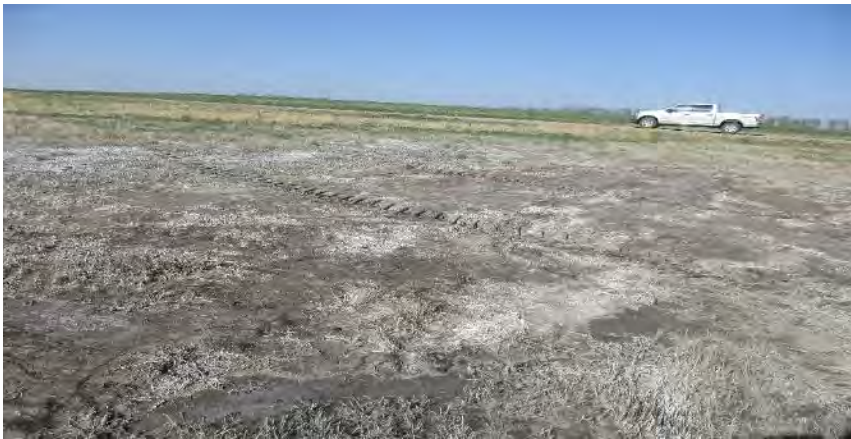
Photograph facing west from the east edge of the visually impacted area. Salt crusting and a lack of vegetation can be seen. The oilfield lease road can be seen in the background.

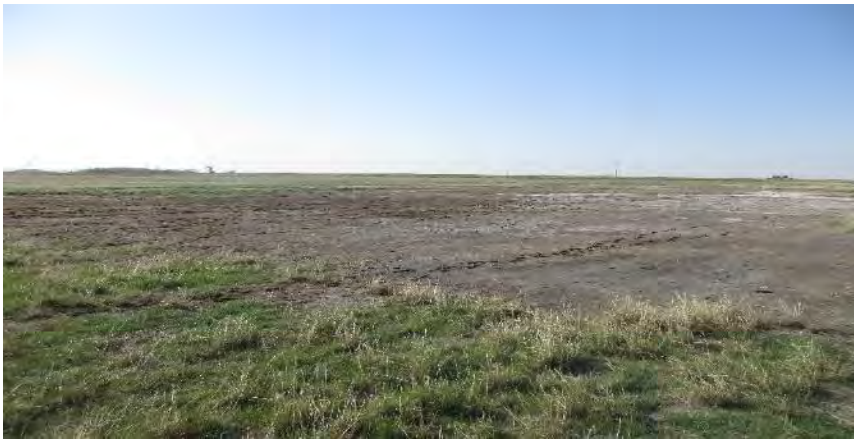
Photograph facing southeast off of an oilfield lease road showing the visually impacted area. Lack of vegetative growth and salt crusting can be seen.

B11-3 was inspected on May 16th, 2018 and is located approximately 150 feet north of 96th St NW and just east of an oilfield lease road. The site is currently used for agricultural purposes and is surrounded by agricultural fields. An oil & gas facility lies immediately to the west, consisting of one pump jack. A wetland was observed to the northeast of the site. Visual impacts were observed, including an area of barren soil and salt crusting; the area of visual impacts measured approximately 350 feet by 100 feet. The site topography is generally flat and slopes to the southwest. An aboveground powerline was observed west of the site running east-west, and an underground oil & gas pipeline was observed west of the site running north-south.

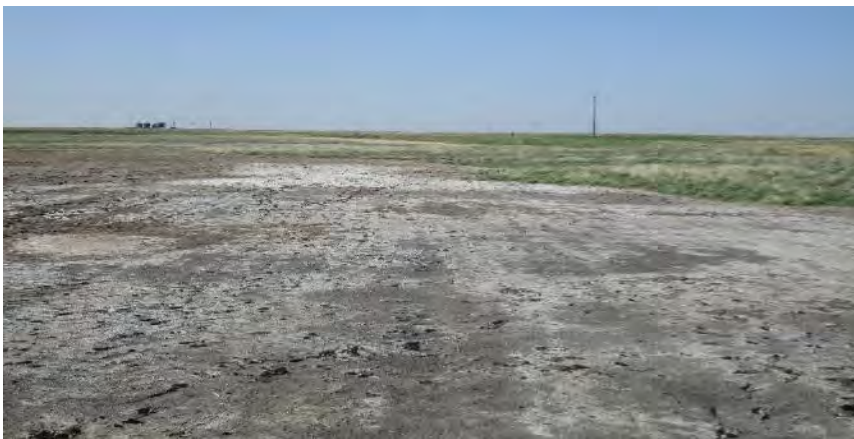
Photograph facing south showing a closer view of the visually impacted area and the salt crusting. Aboveground powerlines can be seen in the background.

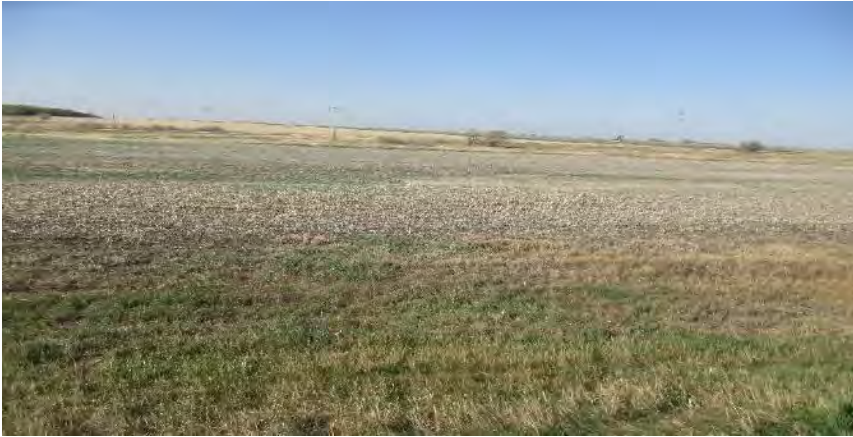
B11-4

Photograph facing southwest off of an oilfield lease road showing the visually impacted area lacking vegetative growth.

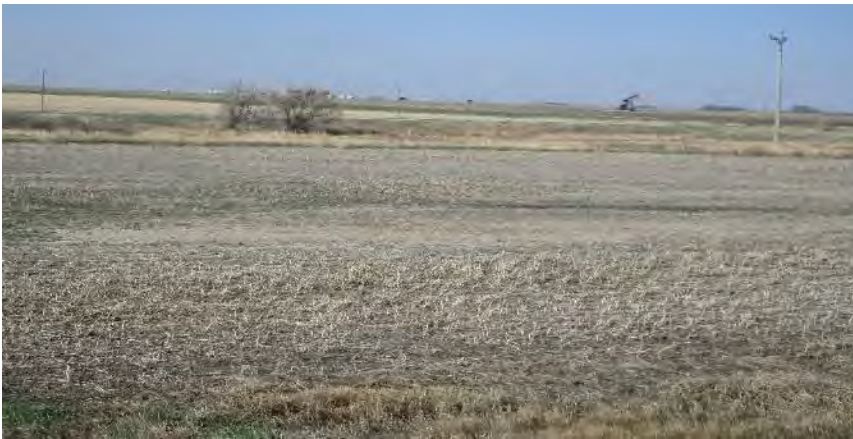
Photograph facing southwest showing a closer view of the visually impacted area located on agricultural land. Aboveground powerlines and an intermittent stream can be seen in the background.
